**CLEAN WATER ACT  
SECTION 319 NONPOINT SOURCE POLLUTION PROGRAM DEMONSTRATION  
PROJECT  
FINAL REPORT**

**SOLDIER CREEK 319 DEMONSTRATION  
UTAH COUNTY, UTAH**

**Utah Association of Conservation Districts**

**September 30, 2009**

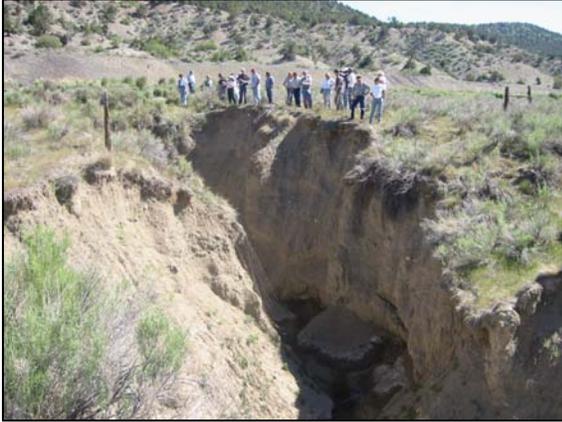
Following are pictures of the gully prior to project design and implementation. The existing culvert was installed during construction of Highway 6 many years ago. The photos were taken at the time of a District tour of the project.

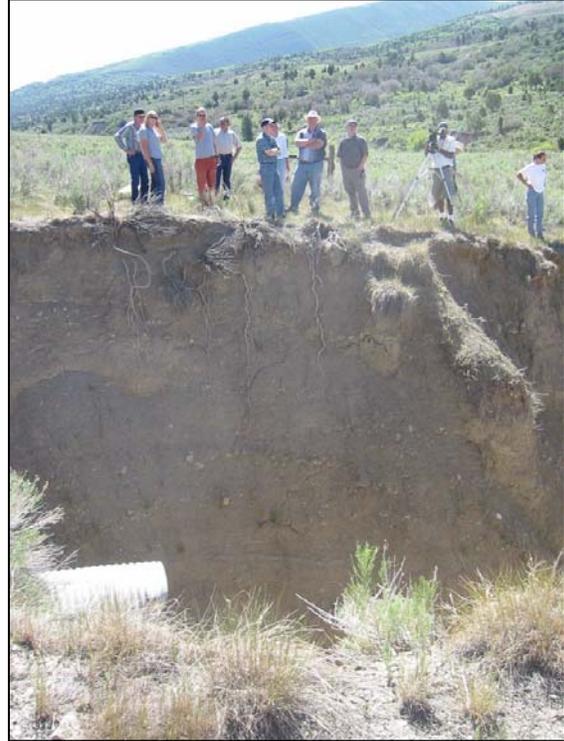
The photo on the right shows the UDOT culvert that extends into the gully. At the time the culvert was placed, there was no gully at the site. These pictures depict how one culvert can impact a watershed.

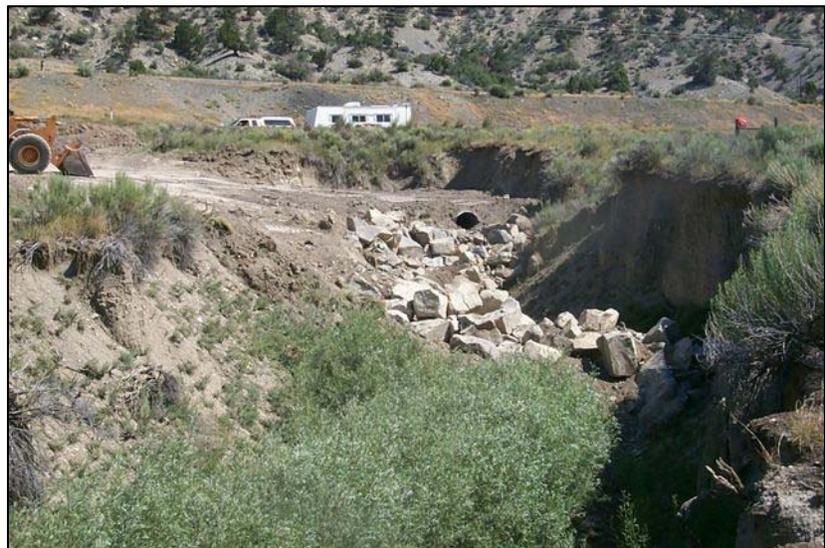
This photograph to the right shows the UDOT construction within their right-of-way. They extended the culvert past their property and placed some large rock to reduce velocity of water leaving the culvert. This was the primary source of match for the project. Their contribution amounted to \$17,150.00,

While plans were being designed and approved, UDOT constructed their portion of the project within their right-of way. Their right-of-way project consisted of adding 40 feet of 36" culvert to the end of the existing culvert under the highway. The cost for labor, equipment, and materials was valued by UDOT at \$17,150.00.

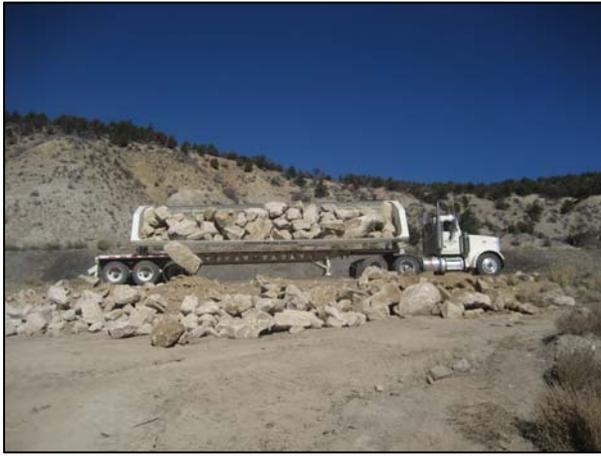
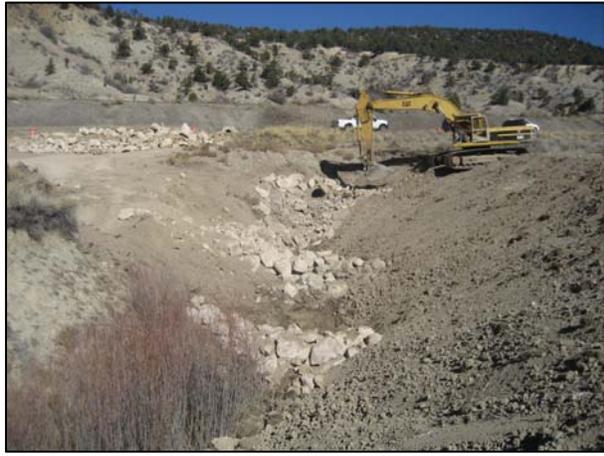
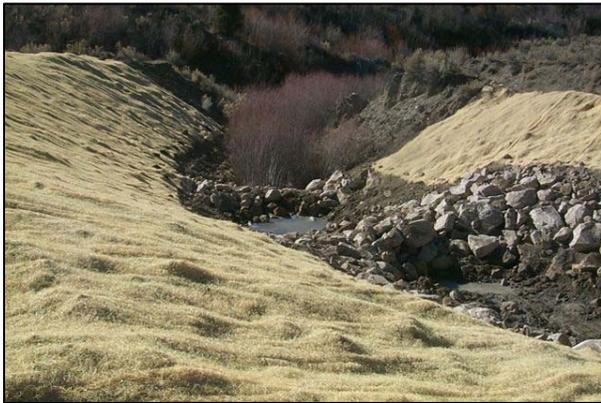
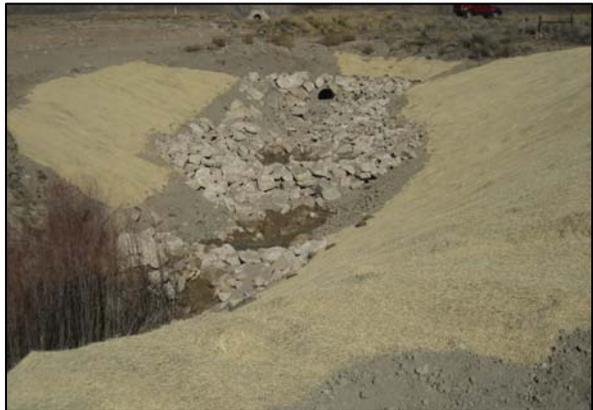
Below are photographs of Nielson Construction bringing rock to the site, installing the rock, and putting in the erosion control blanket.

Nielson Construction provided the traffic control signs (4) and orange barrels (30) for safety purposes. They laid back the vertical banks to a 2:1 slope. They hauled 60 ton of large rock to the site from another UDOT project at Colton, and installed the rock according to design. UDOT donated the rock valued at \$3,062.00 . After the rock was installed and the earthwork completed, the area was seeded with native seed donated by Utah Wildlife Resources, and an erosion control blanket was placed on the construction site to hold the soil in place until the vegetation established. The value of the donated seed was \$167.00.

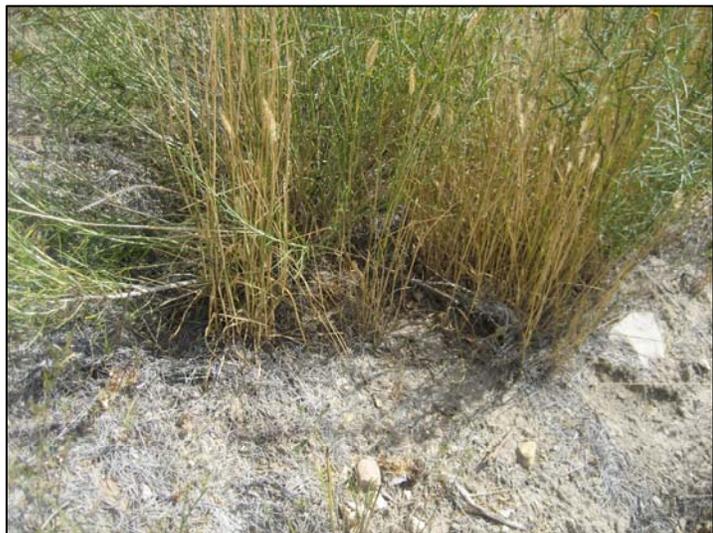
The photograph at the right shows the planted vegetation growing through the control blanket.

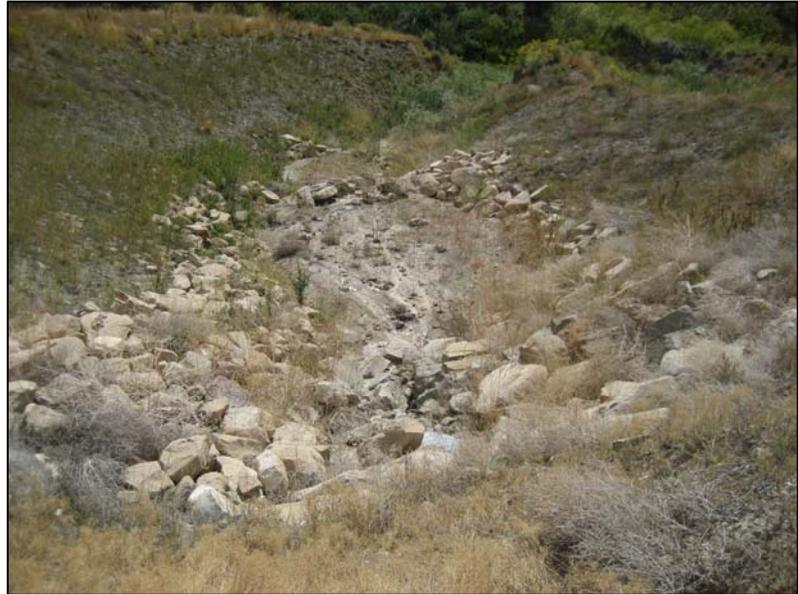
This photograph shows the finished project one year later, and after the single major storm event that was mentioned earlier. Notice in the picture the amount of sediment that was contained with just one single storm event. This leaves us wondering if any projects can really be built that will contain the sediment that comes from the uplands during major storms. The soils in the area are not conducive to thriving plant populations.

The project was constructed in the fall of 2007. During the spring of 2008, Conservation District staff went to the site and planted willows. However, a single major storm event filled the structures with sediment covering over the willows that were planted. Efforts will be made in the spring of 2010 to replant willows.

It was estimated in the original project proposal that the implemented gully project would reduce sediment delivered to Soldier Creek by 1,000 tons/year. Estimates from the single major storm event that occurred, following the project construction, indicates that the project trapped and contained 600 tons of sediment. Clearly, there was additional sediment that passed through the structure, but that amount is not known.

however it filled with sediment faster than was anticipated. Willows that were planted were covered with the sediment. More willows will be planted in the spring of 2010.
