SECTION 319 NONPOINT SOURCE POLLUTION
CONTROL PROGRAM
UPPER BEAR RIVER WATERSHED
RESTORATION PROJECT
FINAL REPORT

Upper Bear River Watershed Restoration Project-Norm Weston-FY-06

Mitch Poulsen
Executive Director
Bear Lake Regional Commission

Sub-Grant #07-0895

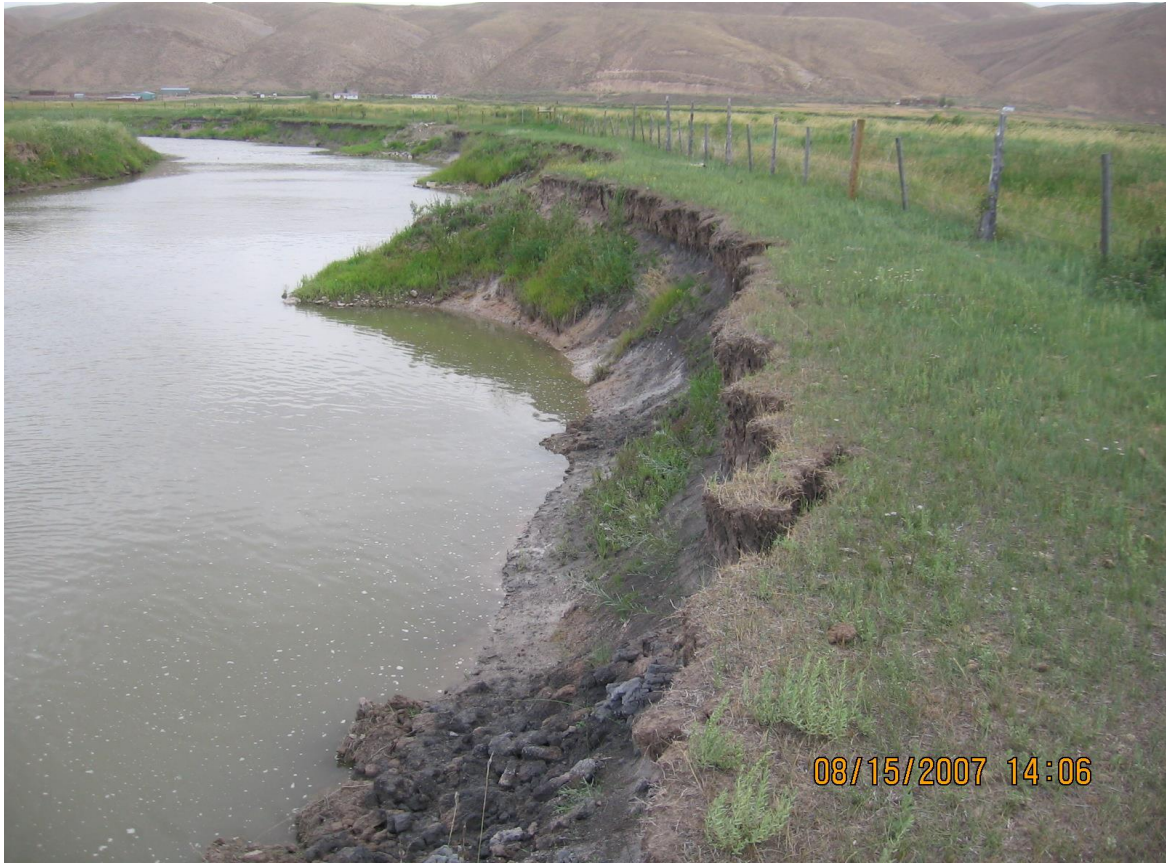
Figure 3. Photo taken midpoint along the length of the project prior to treatment implementation.

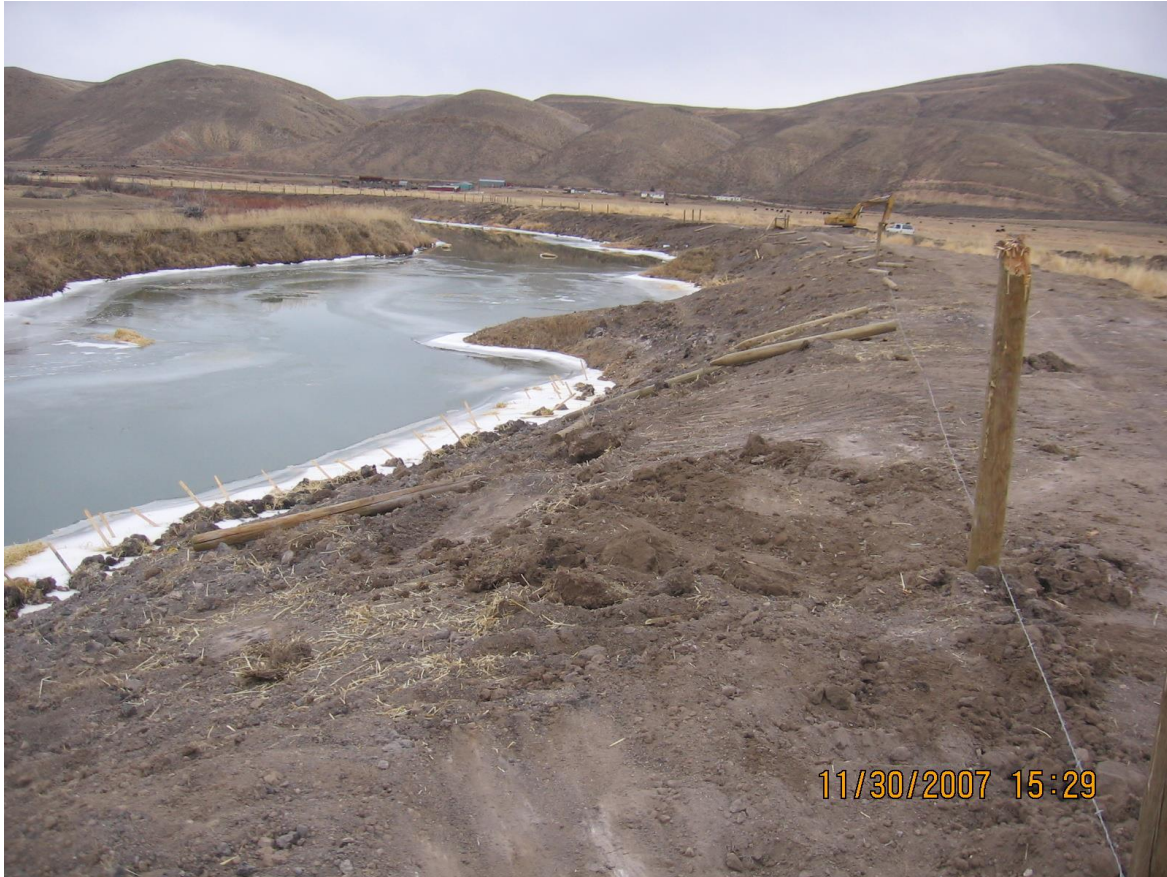
Figure 4. Photo taken midpoint along the length of the project looking west with treatments in place minus fencing wire.

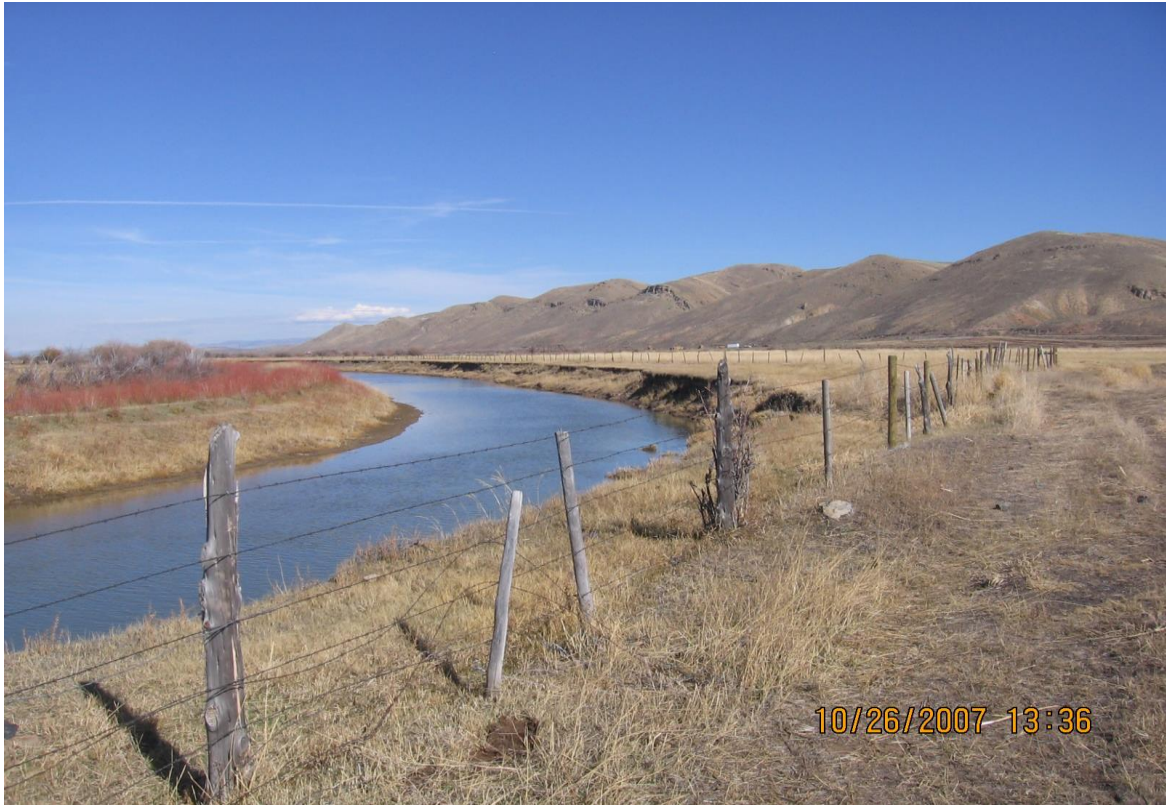
Figure 5. Photo taken at the upstream end of the project looking west with no treatments implemented.

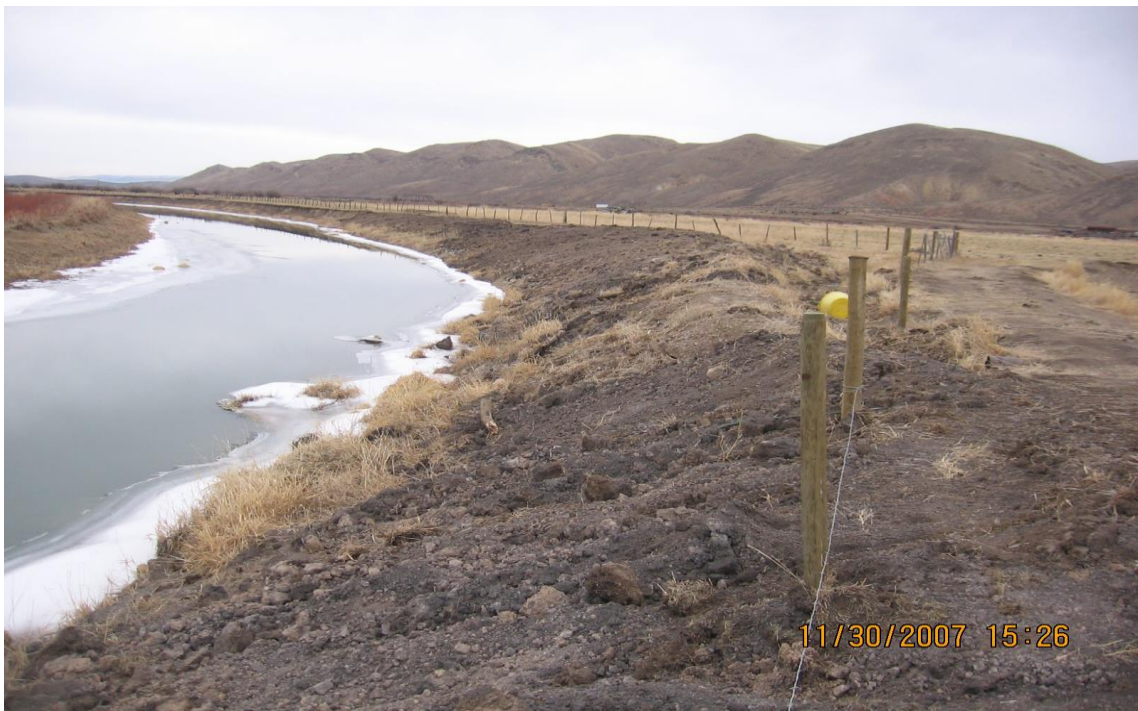
Figure 6. Photo taken at the upstream end of the project looking west with most treatments in place minus deformable revetments and fencing.

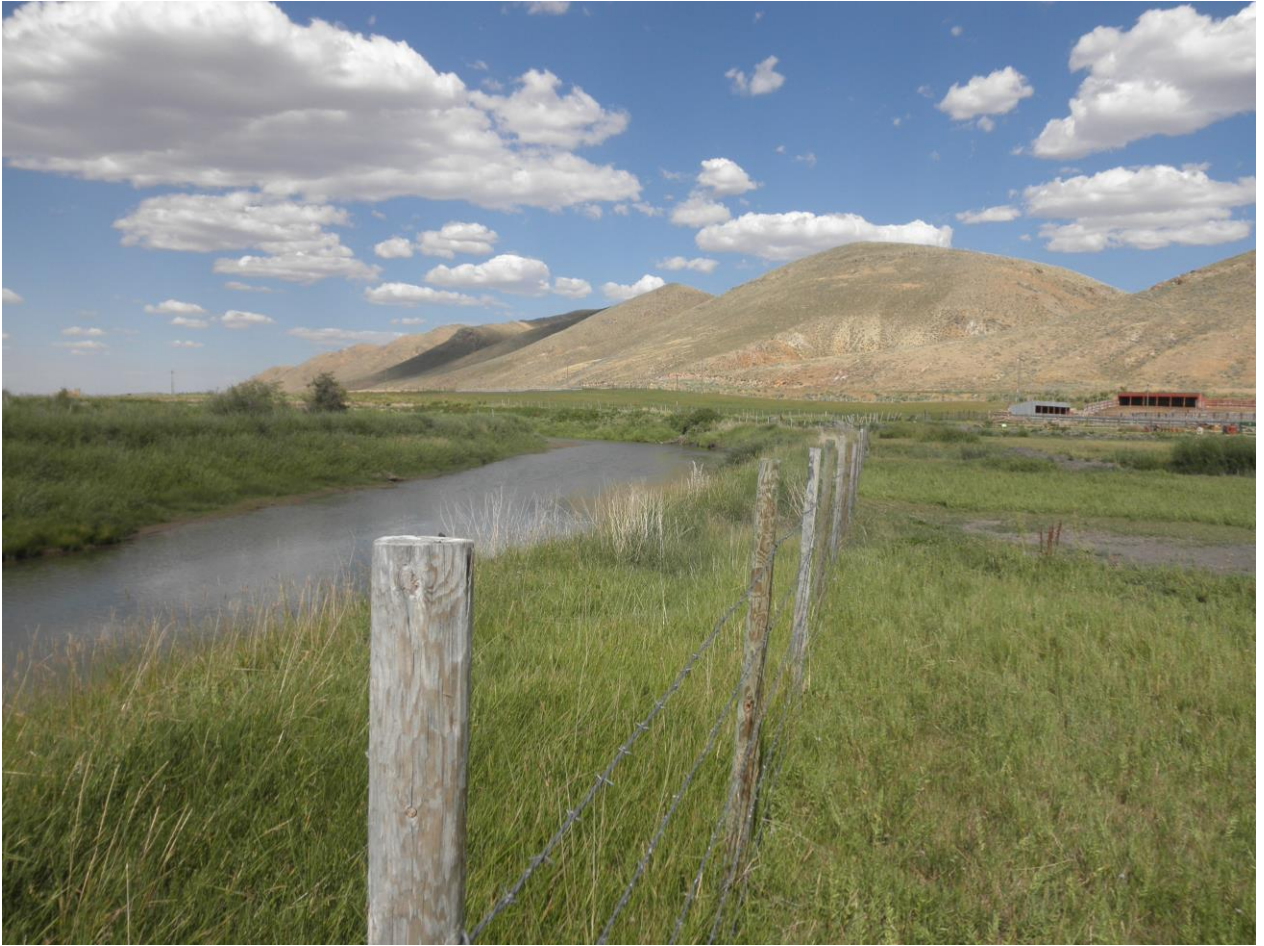
Figure 6 a) Upstream location of project, late summer 2010.

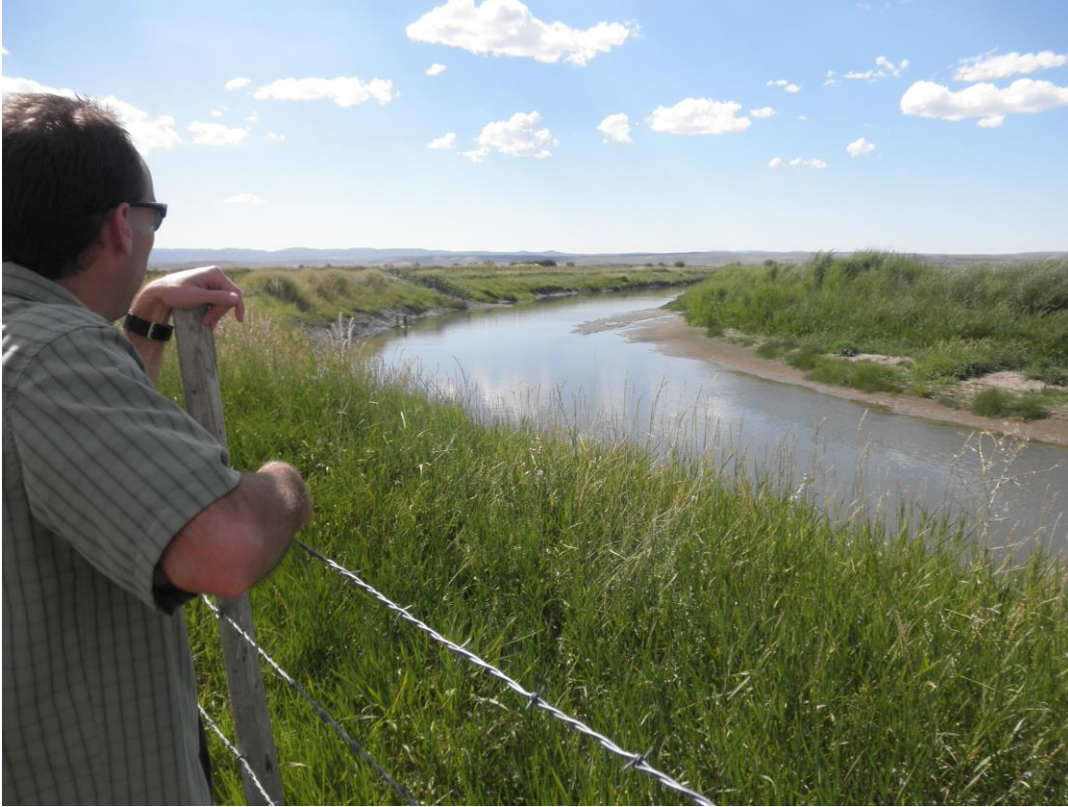
Figure 6 b) At the upstream end, looking upstream (southeast), summer 2010.

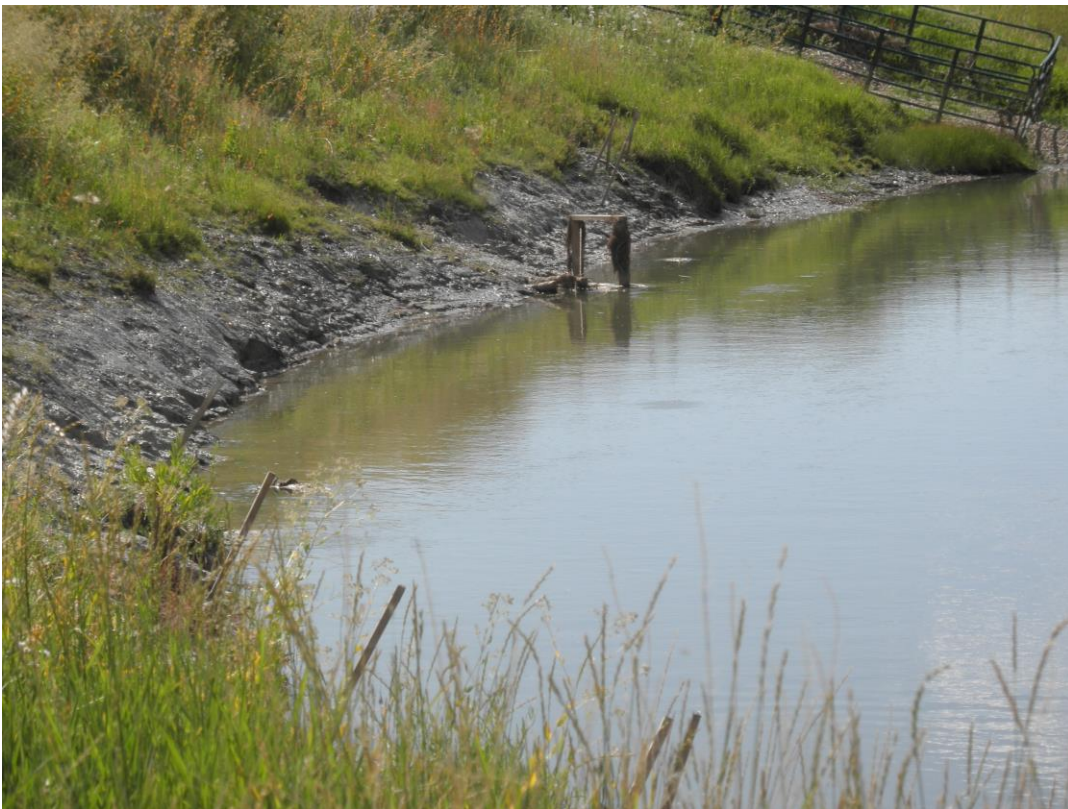
Figure 6 c) Remnants of hay bale used for bank stabilization, summer 2010.

While constructing the straw bale revetments the longevity of the bales came into question. Bales in and of themselves are not a durable product. Under natural circumstances the bales decompose and disintegrate leaving little or no protection for the disturbed sites. Concern was expressed by those implementing the bales whether or not they would even maintain their integrity to the first high water event. If the bales are intact after the first high water event, then there is no question as to their usefulness. Only a few short weeks after the bales had been in place, it was observed that grasses were growing out of the interface where the bale meets the exposed soil. Modifications had to be made to standards for deformable structure retention. Deformable revetments retention required posts to be driven through the bales in the river. Several 6 inch diameter posts were shattered while pounding them in place due to the clay layer underlying the bank and composing the riverbed. Also, pounding grade stakes into the small bales on the edge of the bank proved to be exhausting and heavy handed. An alternative was to pound the grade stakes into each end of the bale parallel to the edge of the bale.

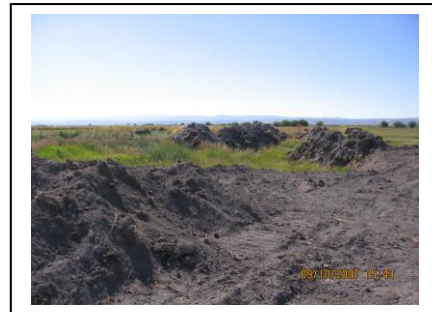
Several years ago the landowner lost a significant amount of pastureland as a result of a nearby irrigation ditch breaching a dike. Weeks of heavy irrigation weakened a dike that crumbled and spilled 10 cfs of water across his pastureland eventually creating an expanse 40 feet wide and 12 feet deep. Much of the overburden soil from this project was used to fill this void. Soil deposited at this location to fill the void reconnected two pastures and enhanced travel through the field (Figure 13).

Figure 13. View of the depression where overburden was deposited
