**Clean Water Act**  
**Section 319 Nonpoint Source Pollution Control**  
**Program**  
**Watershed Project Final Report**

**Chalk Creek Watershed Project – Summit County, Utah**

Project Sponsor  
Summit County Soil Conservation District

Prepared by  
Shane Green, Project Coordinator  
Range Conservationist, NRCS  
July 29, 2005

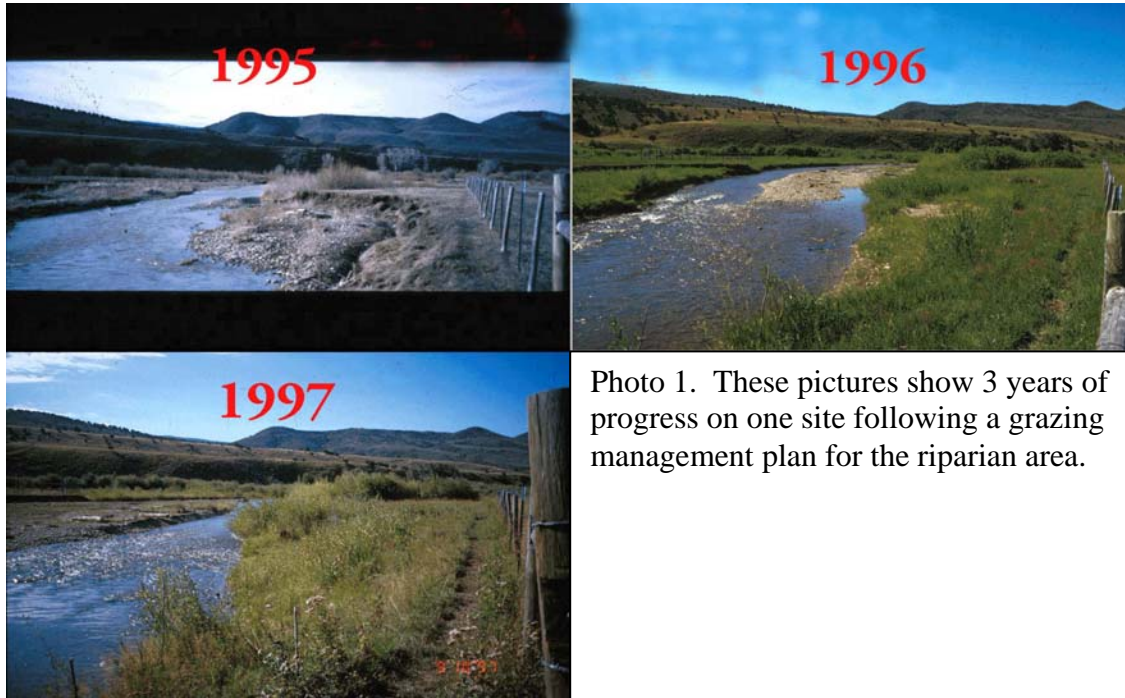
Photo 1. These pictures show 3 years of progress on one site following a grazing management plan for the riparian area.

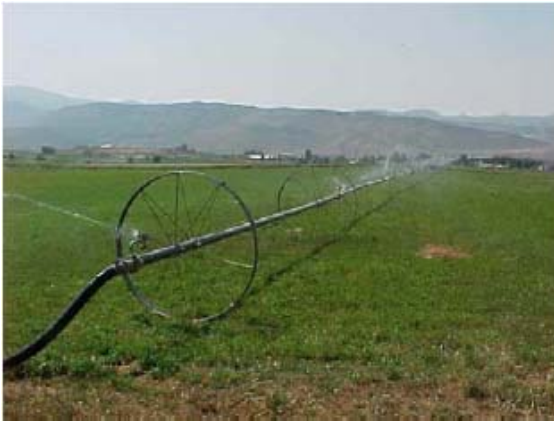
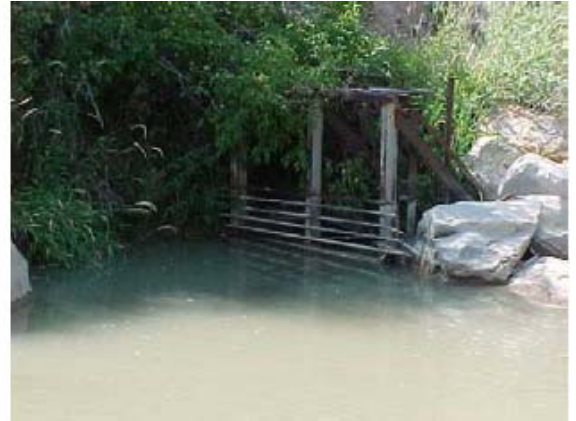
Photo 2. The new pressurized system has eliminated water turns and allowed producers to water at their convenience in addition to increasing overall production. This has eliminated the need for maintenance of ditches and head-gates associated with the old flood system.

B. Water turns were eliminated with the new system. Under the old flood irrigation system there was down time waiting for water turns. Now with the new sprinkler system, as soon as the hay crop is out of the field watering can begin again; unlike past years where you may have to wait days for a water turn. Also there is no downtime for plant growth. Plants are actively growing all the time while sprinkling, unlike the flood system where plant growth, particularly grasses are retarded while the plants are submerged.

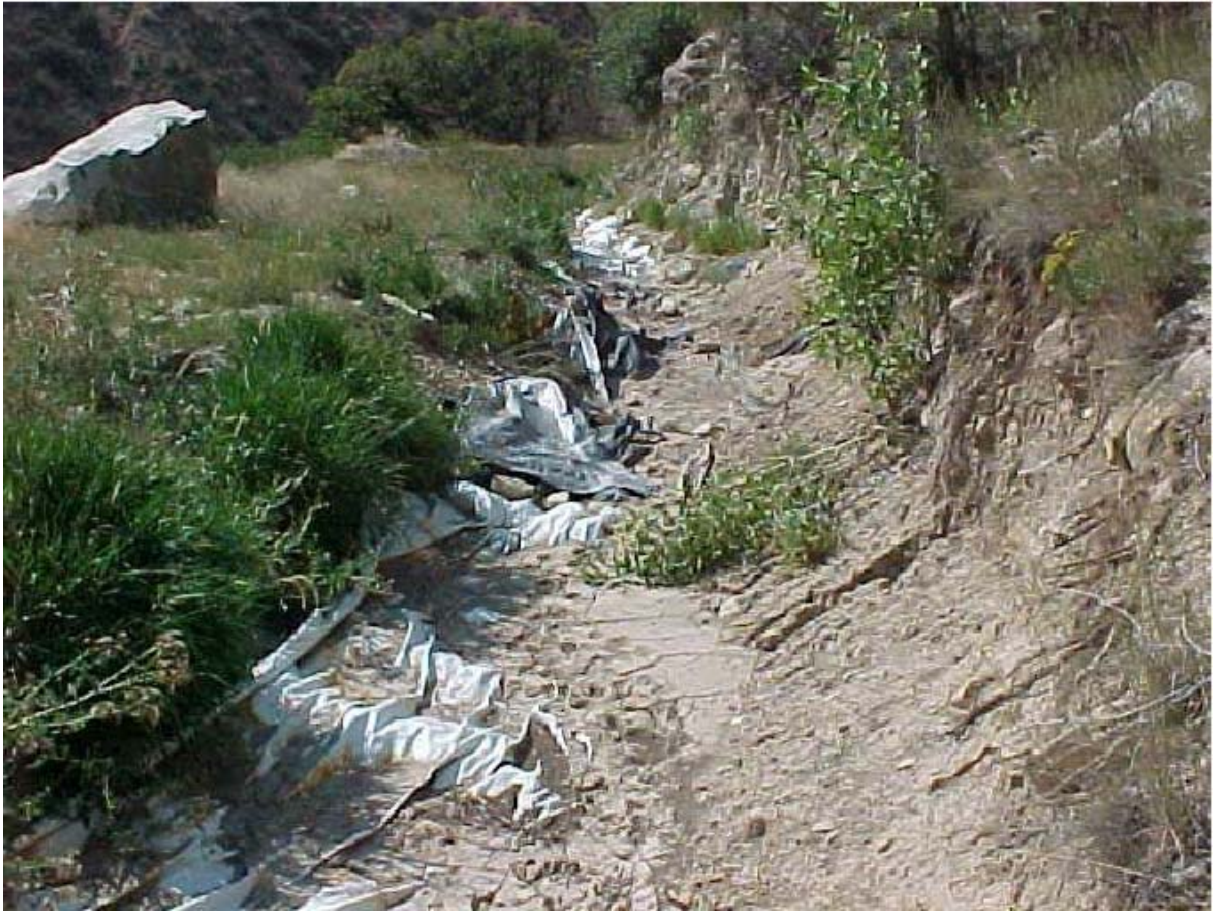
Photo 3. This portion of the Chalk Creek ditch in the “narrows” illustrates one of the problems associated with the previous less efficient flood irrigation system. Here attempts were made to line the ditch with plastic in order to prevent water loss from seepage which resulted in significant water loss and ditch failure.

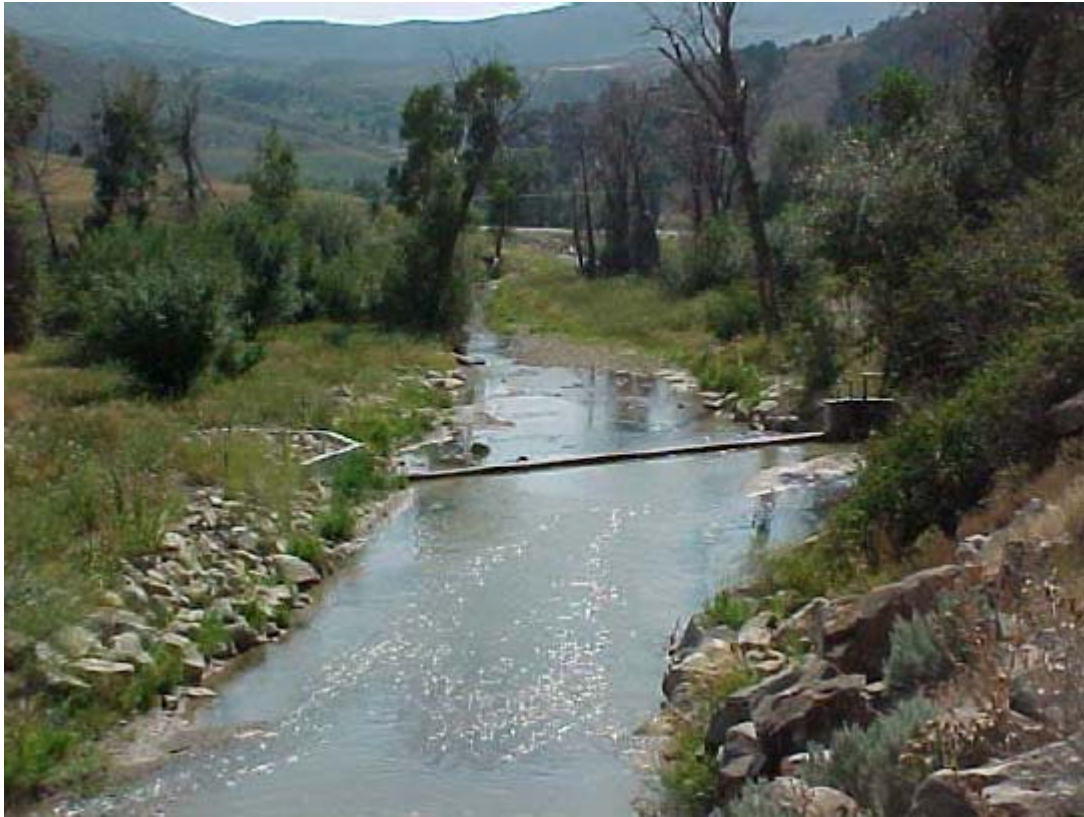
Photo 4. Above the diversion In-stream flows are significantly enhanced by privately owned water being released from a storage reservoir in the East Fork of Chalk Creek. View of new diversion structure across Chalk Creek in the narrows, 8/18/03.

D. Private water held in storage was released throughout the summer from high mountain reservoirs. This allowed shareholders of this private water to sell excess water to those who did not have shares of private water. This provided a double benefit by allowing private water shareholders to earn extra income from their excess water shares and at the same time provide water to non-shareholders whom otherwise

would have been out of water. In addition the releases of private water helped maintain critical in stream flows above the diversion.

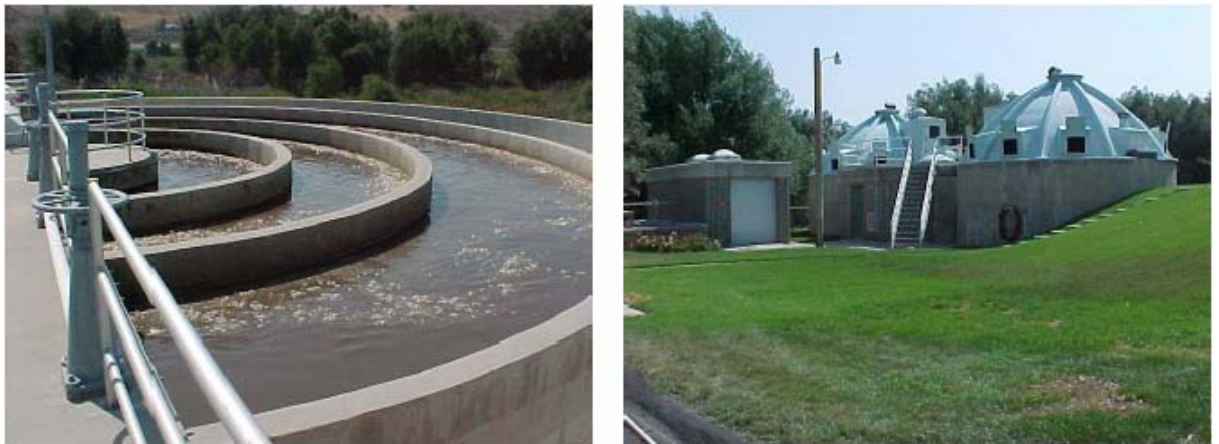
Photo 5. The Coalville City Sewage treatment facility has benefited from dramatic reductions in irrigation infiltration, resulting in less cost and no longer overwhelming the system.

A. Conversion from flood to sprinkler irrigation dramatically reduced sewage infiltration. In past years the Coalville City sewage treatment plant has consistently observed large increases in the volume of water entering the plant that coincided with the onset of irrigation season beginning in May of each year. Prior to the implementation of the Chalk Creek Sprinkler Irrigation Project the treatment plant was processing between 450,000-500,000 gallons of sewage/day during the irrigation season. This was due to irrigation water leaking into an antiquated sewage collection system. Beginning in May of 2002 with the irrigation project online the volume of water entering the plant dropped to 200,000-225,000 gallons of sewage/day, a 50% reduction in the amount of water entering the plant from prior years. It should be noted that Coalville City also replaced much of the old sewage collection system to reduce infiltration at approximately the same time they were installing their secondary system. Dennis Gunn, Coalville City sewage treatment plant operator attributes the 50% reduction in inflow equally to both the new irrigation system and new collection system.

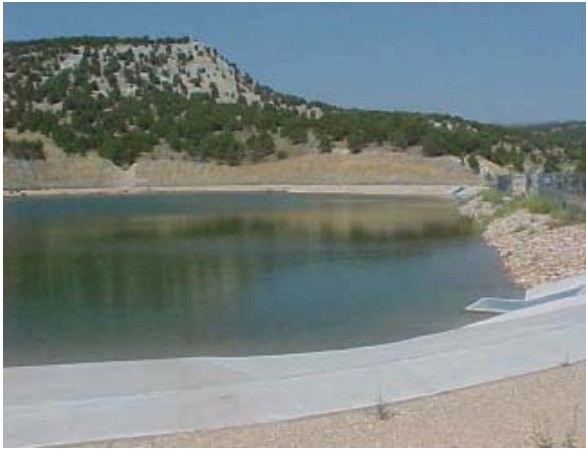
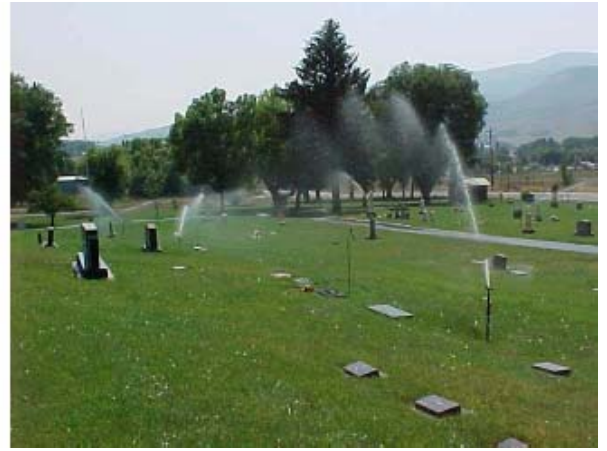
Photo 6. Coalville City's new secondary water storage reservoir (left) provides additional storage capacity for the city's secondary water needs.

B. Secondary water is available to Coalville City residents. Coalville City had expressed interest in the Chalk Creek Sprinkler Irrigation Project from its outset because of its limited sources of water. Prior to the completion of the project many city residents have only had culinary water to water lawns and gardens. In drought years the city has had to place water restrictions on residents because of a shortage of drinking water. With completion of the project secondary water is now available to residents and it has reduced the demand on Coalville's culinary system.

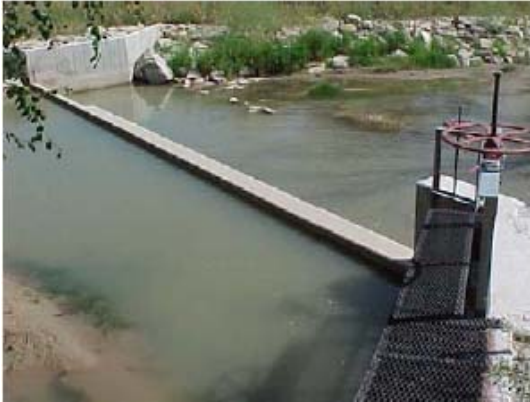
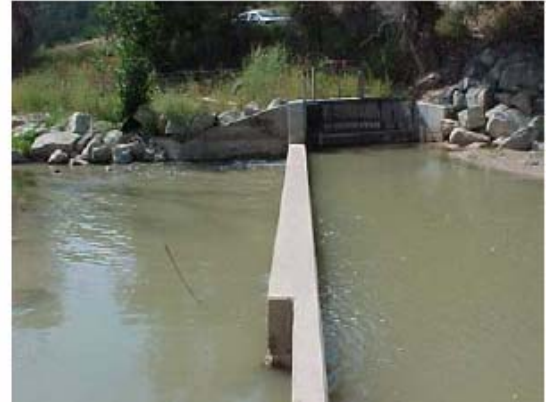
Photo 7. During the months of July and early August flows in the stream can reach levels where most of the water coming down Chalk Creek is diverted for irrigation at the diversion shown above. Photos taken 8/18/03.

B. Critically low in-stream flows during drought years. One aspect of the project that was not anticipated was the effect drought would have on in-stream flows from the diversion point downstream to Coalville. Chalk Creek has historically maintained viable in-stream flows throughout the summer, even in critically dry years. Historically in-stream flows were maintained by return flows from irrigation tail water or water that subbed back up along the stream course from deep percolation and springs. Water is now applied by sprinkler and encased in pipe; return flows are now eliminated below the diversion. For a period of about two weeks during the summer of 2002 stream levels dropped to critically low levels in early July. Almost all water was diverted at the diversion to meet water demands. This left approximately 5 miles of the stream from the diversion to Coalville essentially dry except for isolated pools. This occurred at a critical time of year when fish are stressed due to warm water conditions and decreased levels of dissolved oxygen. Once water stored in an upstream reservoir was released by mid July, in-stream flows below the diversion returned to levels that would support fish. It should be noted that this problem of de-watering the stream

below the diversion would not occur in average years of precipitation because there would typically be excess water to move downstream past the diversion. During drought years there may be a critical window in July where demand for irrigation water may use all water supplied by Chalk Creek. This could result in the lower portions of Chalk Creek being de-watered until storage water is released.

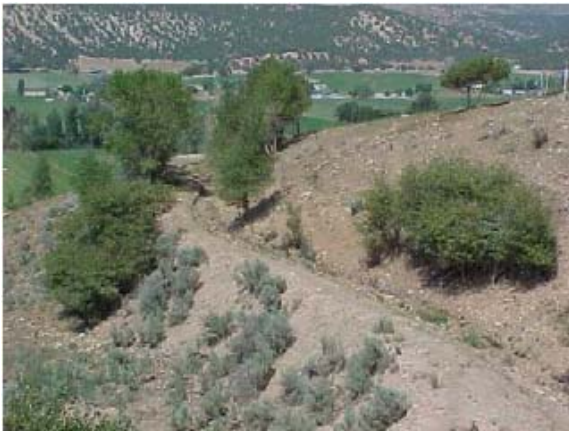
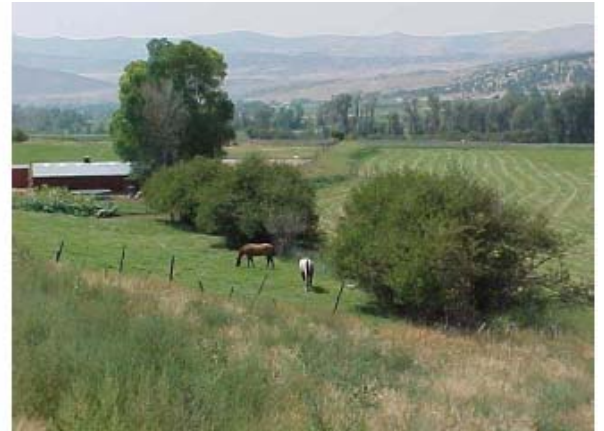
Photo 8. Because irrigation water is no longer flowing in the ditches, it is expected there will be a significant decline and loss of trees and shrubs which have established themselves along irrigation ditches over the decades.

C. Loss of riparian vegetation species from ditch-banks. Irrigation ditches in lower Chalk Creek have been established for decades. Riparian vegetation such as large Cottonwoods, Hawthorns and other trees and shrubs have established significant distribution along the irrigation ditches. The tree-lined ditches provide significant wildlife habitat. The ditches have either been abandoned or filled in or no longer carry water. Because of the loss of water it is expected that there will be a significant decline in riparian vegetation along the ditches and a reduction in tree and shrub cover along the margins of these ditches.

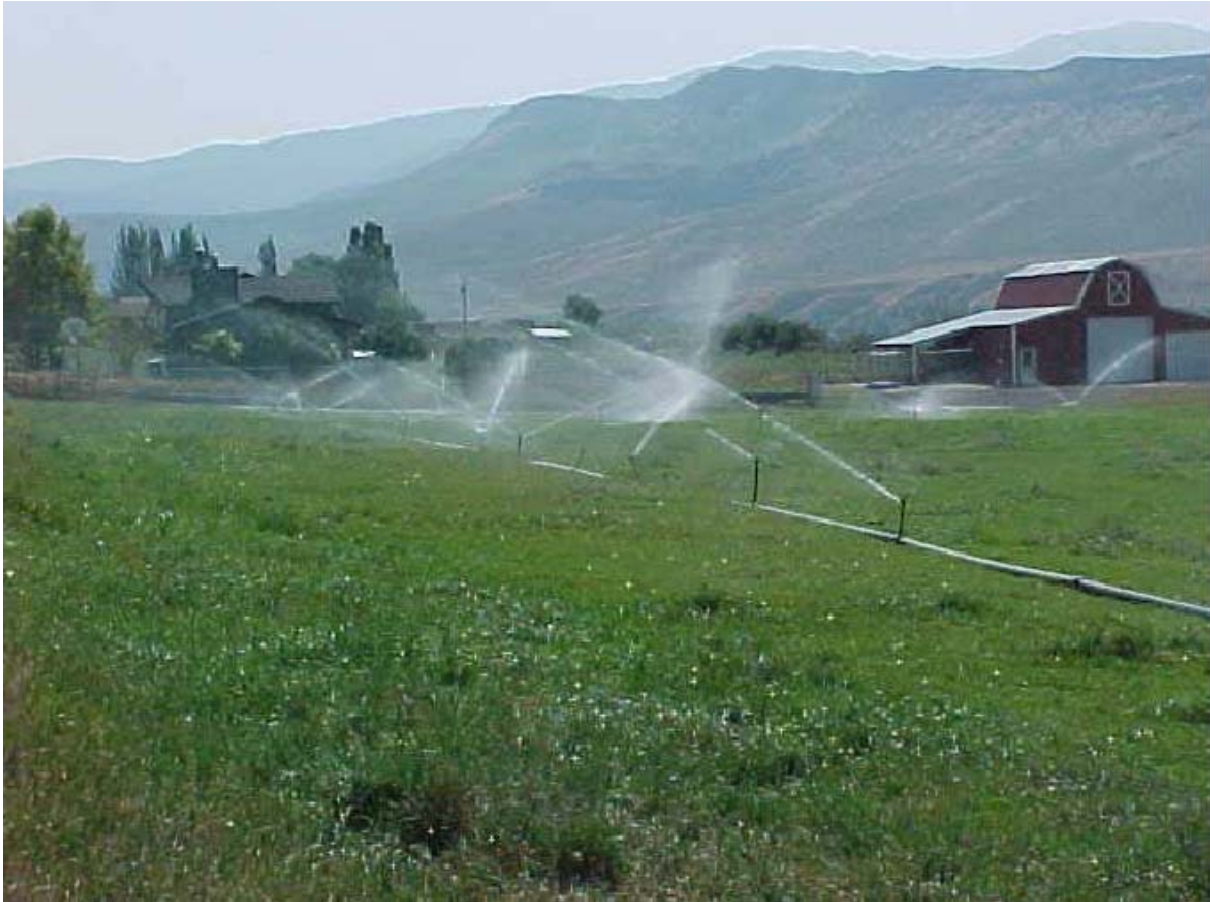
Photo 9

The Chalk Creek Pressurized Sprinkler Irrigation Project is producing the desired result of improving water quality in lower Chalk Creek.

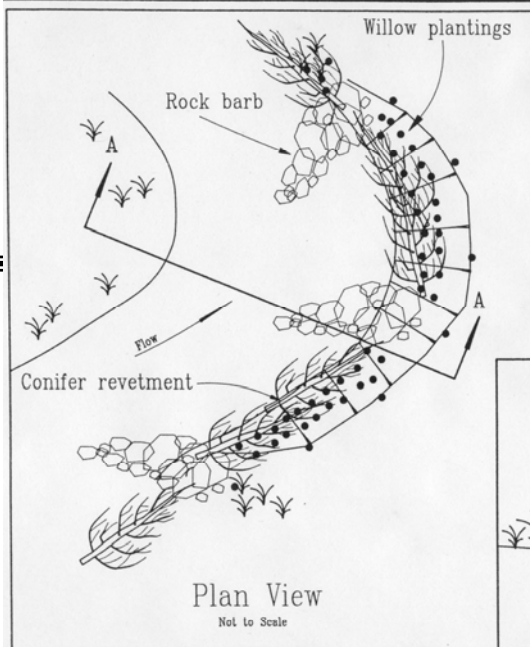
Bankful Width: minimum 45', maximum  
85'

Bankful Depth: minimum 2.2', maximum

1. The entire streambank length between the barbs should be protected with conifer revegetment.
2. Large tree type willows should be installed prior to the establishment of the 2:1 slope.
3. Willow pole plantings should be installed just inside and above the conifer revegetments.
4. Willow fascine bundles should be installed on the channel side but not underneath the conifer revegetments.
5. See the rock barb, conifer revegetment, dormant willow planting, and fascine bundle detail drawings.

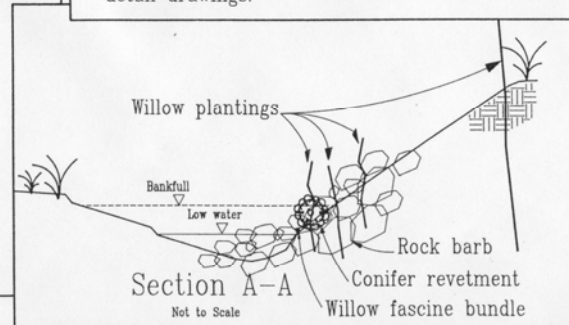
Typical Treatment Reach Detail

Rock size was calculated using the  
Far West  
Design Standards 6-13b:

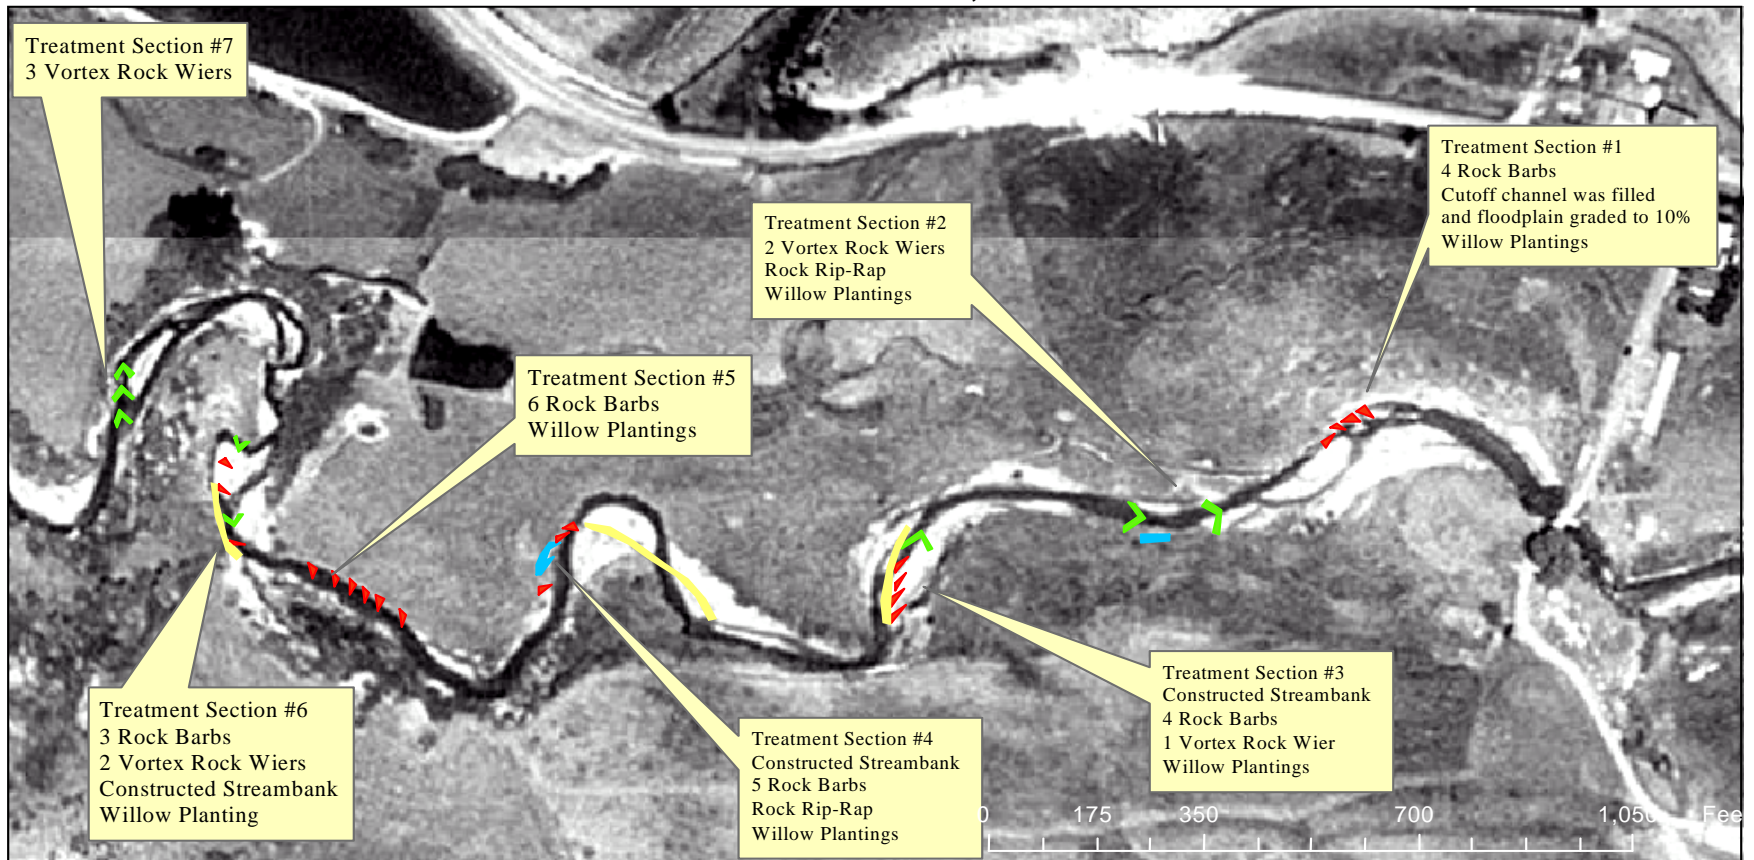
### Pre-treatment view, 1989

Treatment section #1 - the actively eroding bank was protected with a combination of rock barbs and willow plantings. A braided channel condition apparent in the photo was corrected by filling the cutoff channel and grading the floodplain to 10%.

Treatment section #2 - vortex rock wiers were installed to prevent downcutting following the installation of a bridge and the resulting constriction of the floodplain (see 2001 photo). A small section of rock rip-rap was installed on adjacent to a vulnerable bridge abutment structure.

Treatment section #3 - an overwidened and braided channel condition was corrected by installing a berm, or constructed streambank. This structure was protected by rock barbs, and a vortex wier was installed to prevent downcutting.

Treatment section #4 - an oversize meander condition was corrected by installing a berm, or constructed streambank. Actively eroding banks protected with rock barbs, and later rock rip-rap was installed between two of the barbs (see 2001 photo).

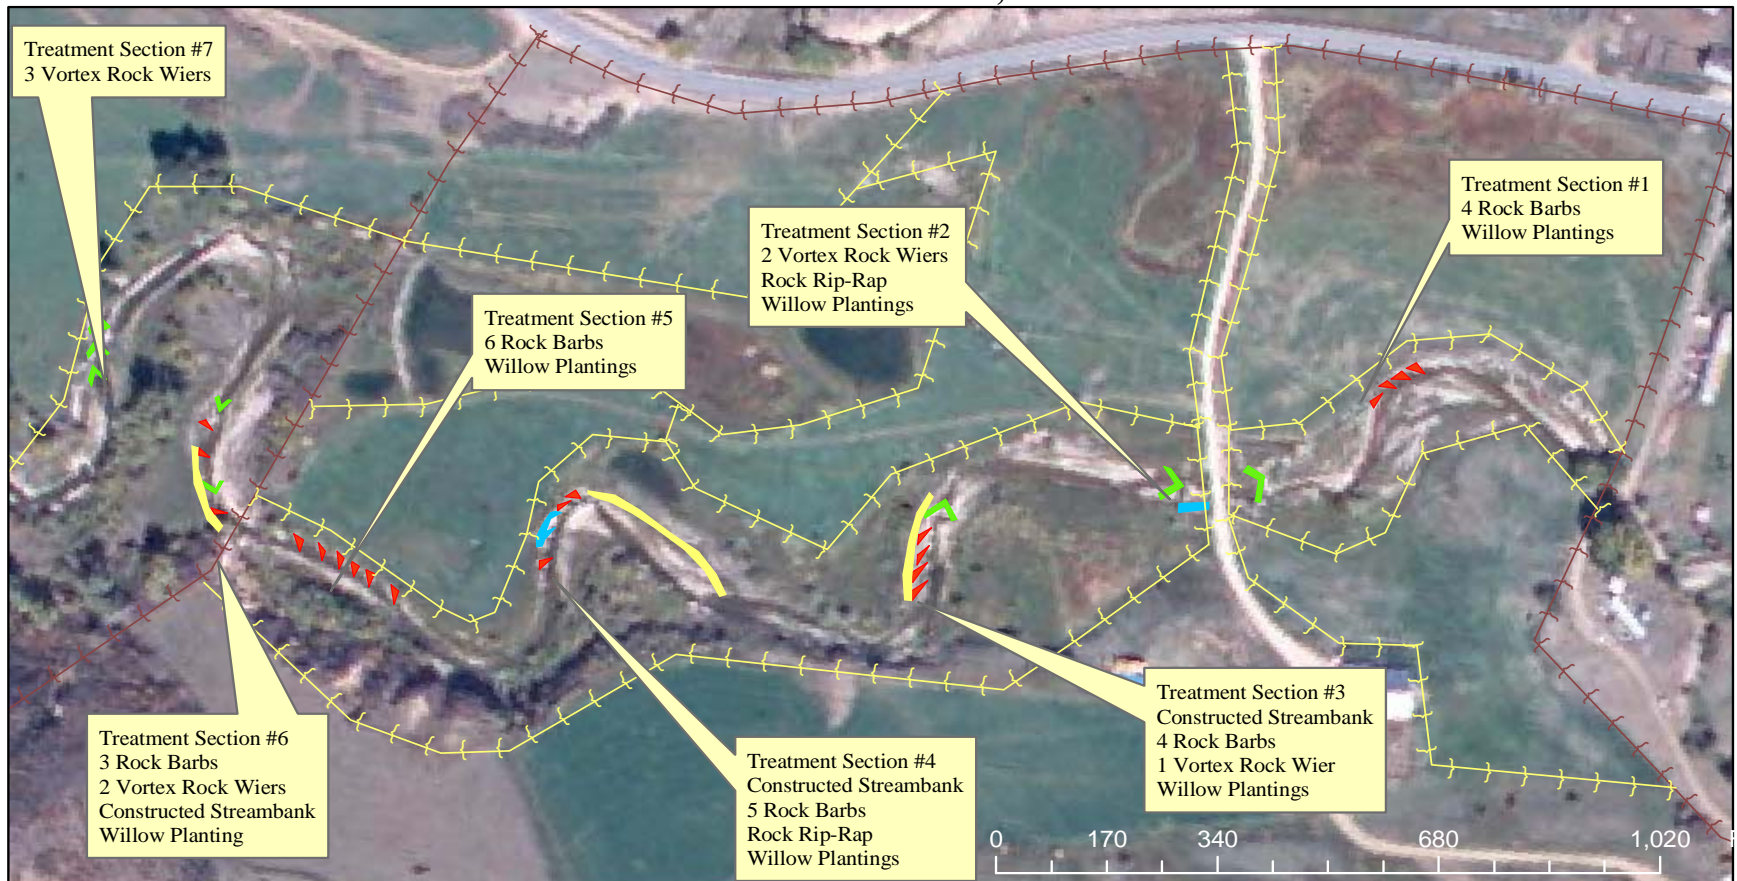
## Chalk Creek Example Project Post-treatment view, 2001

Treatment section #1 - The rock barbs were successful in stopping the active bank erosion, the willow plantings suffered from high mortality.

Treatment section #2 - The vortex wiers were successful in preventing downcutting of the stream. The upstream one was buried with a pulse of bedload and is no longer visible, however the braided channel condition did not return and the current channel is closer to the appropriate width to depth ratio. The willow plantings were unsuccessful here.

Treatment section #3 - All structures were successful and remain intact and functioning, willow plantings were also successful. The braided condition of the channel did not return and the current channel is closer to the appropriate width to depth ratio.

Treatment section #6 - All of the structures and plantings were successful at this site. The braided condition did not return and the current has an appropriate width to depth ratio.

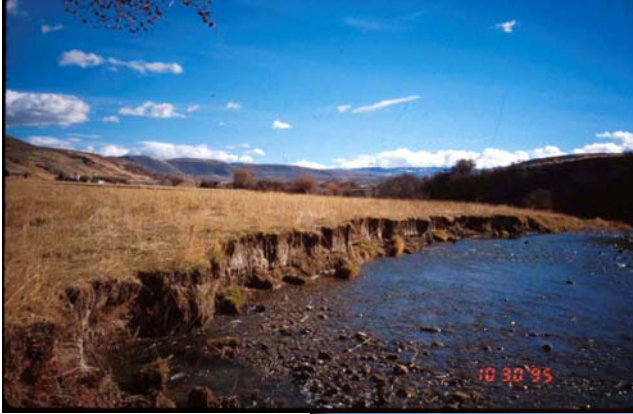
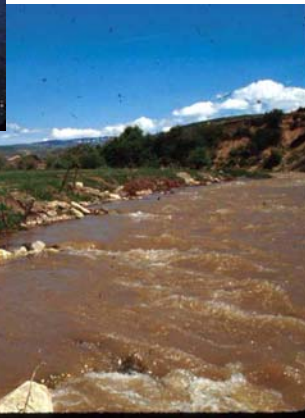
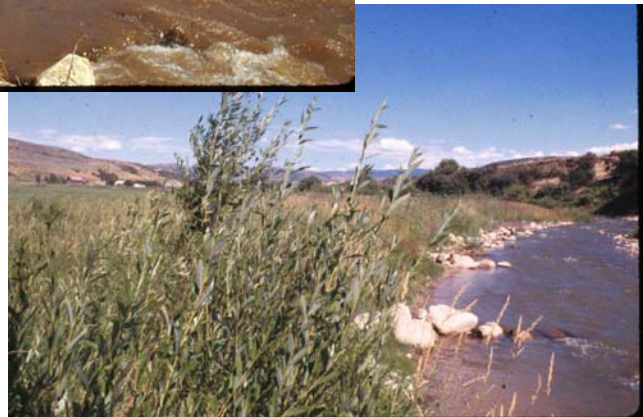
### Photo 10.

*Treatment section #4 in 1995 prior to treatment, 1996 immediately following treatment, and in 1998. Bank erosion has ceased and woody riparian vegetation is recovering. Willow planting techniques here included dormant pole plantings and willow facines. Note the function of the rock barbs as the current is turned away from the bank downstream of each barb.*

changing course and cutting off a large meander at treatment section #6 has been alleviated. As discussed on the map view pages of this report, a few of the practices installed were not successful. Most notable was the

failure of the barbs to stop bank erosion in treatment section #4. We

expected the stream to follow the contour of the installed berm, but it started to curve away

from the berm in subsequent years (see map view). This caused a very tight radius of curvature on the bend where the erosion occurred between the barbs. A more careful analysis of the oversized meander and design of the placement of the berm may have prevented this.

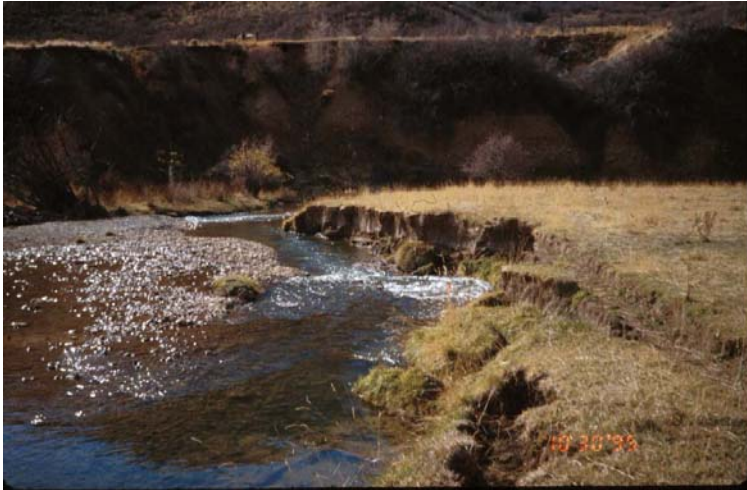
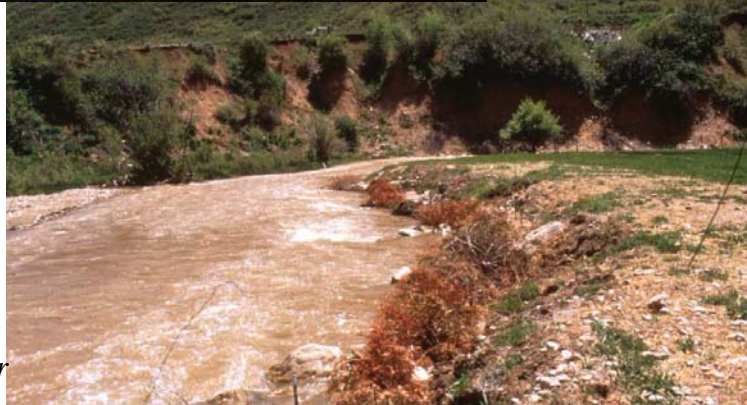
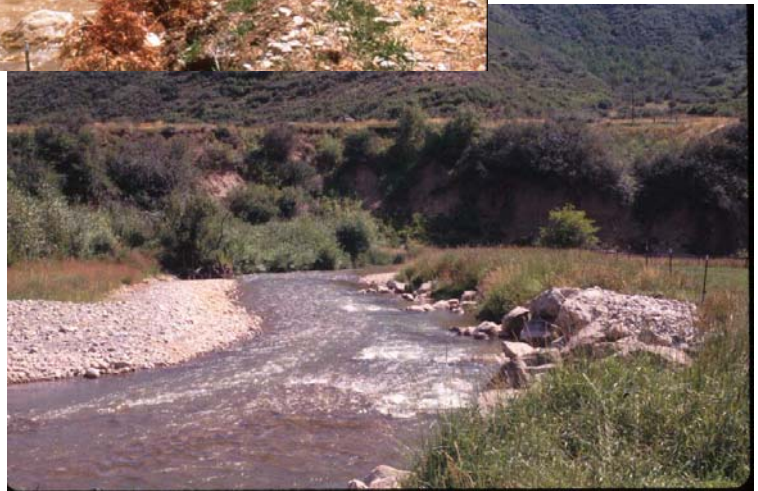
**Photo 11.**

*Treatment section #3 in 1995 prior to treatment, 1996 immediately following treatment, and in 1998. Bank erosion has ceased and woody riparian vegetation is recovering. The conifer revetment shows well in these photos, and by 1998 it has accumulated silt and vegetation has established on top of these revetments. The conifer revetments were necessary to provide protection in addition to the rock barbs for the excavated material used to construct the new streambank. Note the improved width to depth ratio of the channel and removal of the braided condition.*

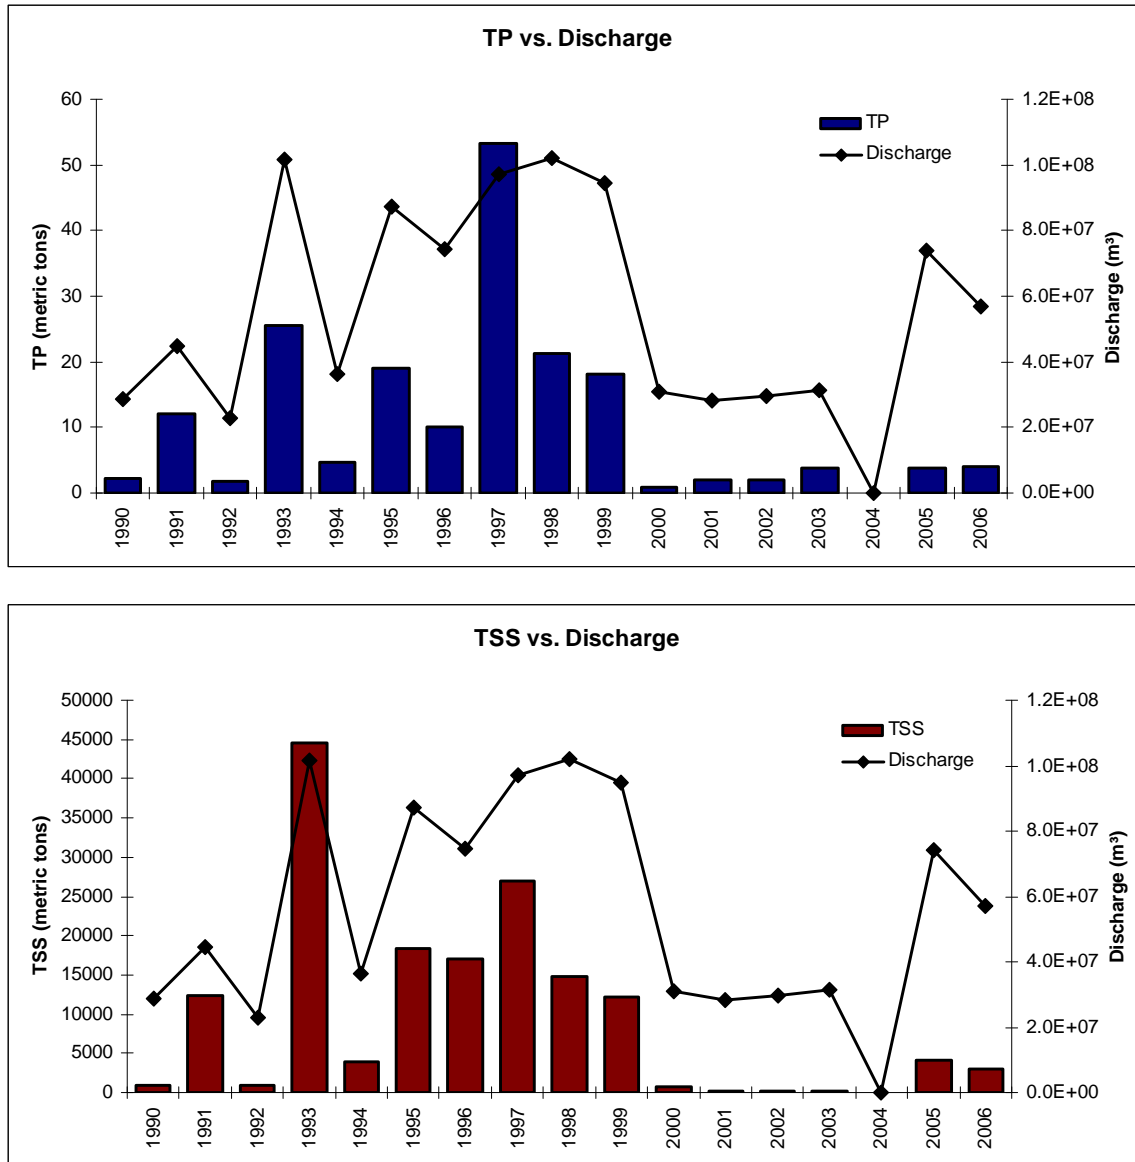
Figure 5. Annual loading and discharge data for Chalk Creek Site 4926350 at US189 crossing.

Annual loads for TP and TSS were calculated using daily streamflow data from the USGS gaging station near Coalville and concentration levels collected from water samples. The results are plotted in Figure 5, along with annual discharge values. As expected, the graph shows an association between TP and TSS. It is important to note that the decrease seen in the annual loads of both TP and TSS beginning in 2000 corresponds to drought conditions in the watershed. It is likely that, due to the association of TP with TSS, the reduction in phosphorus loads is closely related to the decrease in sediment supply to the stream during the drought years rather than actual improvement due to the implementation of BMP's in the watershed. However, an examination of years in which discharge values are similar indicates some improvement not related to discharge. For example, comparing 1996 to 2005 (two years with similar discharge levels), there is a dramatic decrease in both TP and TSS loads. The decrease in TP from 10 metric tons to 3.7 (63% reduction) and TSS from 17008 to 4034 metric tons (76% reduction) indicates that the improvements may not be related to discharge levels. In this case, the BMPs put in place appear to be having an effect on the water quality of Chalk Creek.

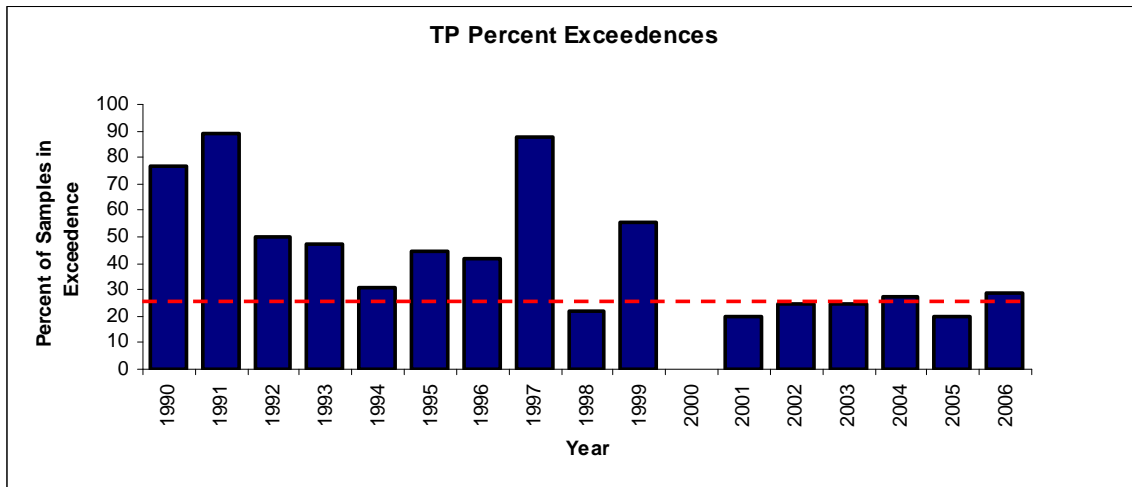
Figure 6. Percentage of TP samples exceeding the pollution indicator levels.

The TMDL for Chalk Creek lists total phosphorus (TP) and total suspended sediments (TSS) as the major pollutants of concern. The pollution indicator level for TP concentration is 0.05 mg/L. Currently, an applicable pollution indicator level for TSS in the Chalk Creek drainage does not exist. The previous value of 35 mg/L was removed from the standards in 2004, as it was determined to only be applicable in the Bear River watershed. Figure 6 displays the percentage of samples exceeding the TP pollution indicator. Since 2000, the number of samples exceeding TP pollution indicator levels has been below 25% in 3 years. TP concentrations have not improved as dramatically, reaching non-supporting status 3 times since 2000; however, there is a downward trend in the percentage of samples exceeding the pollution indicator, indicating some improvement.

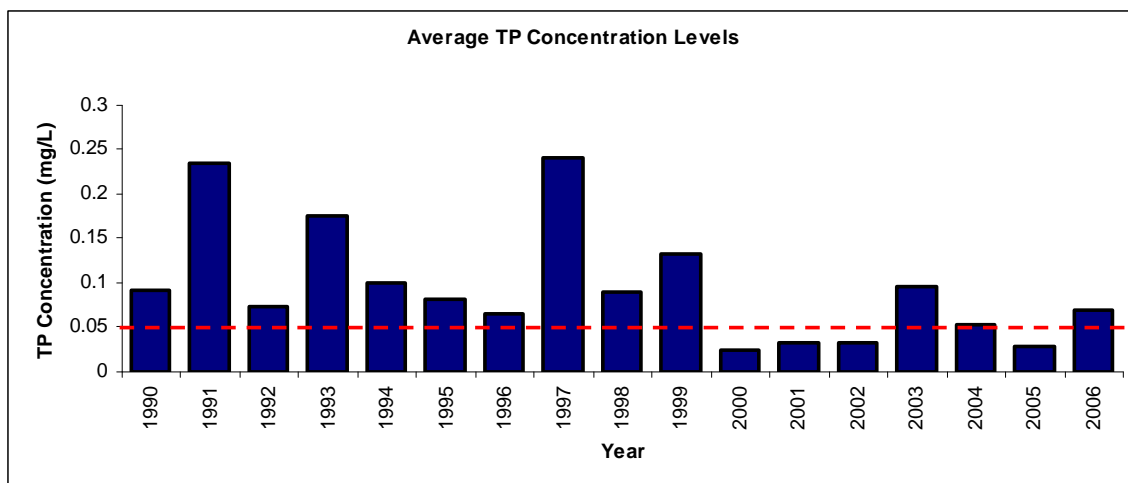
Figure 7. Mean annual concentrations for TP from 1990-2006.

Figure 7 presents the annual mean concentration levels for TP during the time period 1990-2006. Mean concentrations have been below 0.05 mg/L 4 times since 2000. These dramatic reductions in mean concentrations are probably more drought-related than an indication of successful implementation of the BMPs in the watershed.

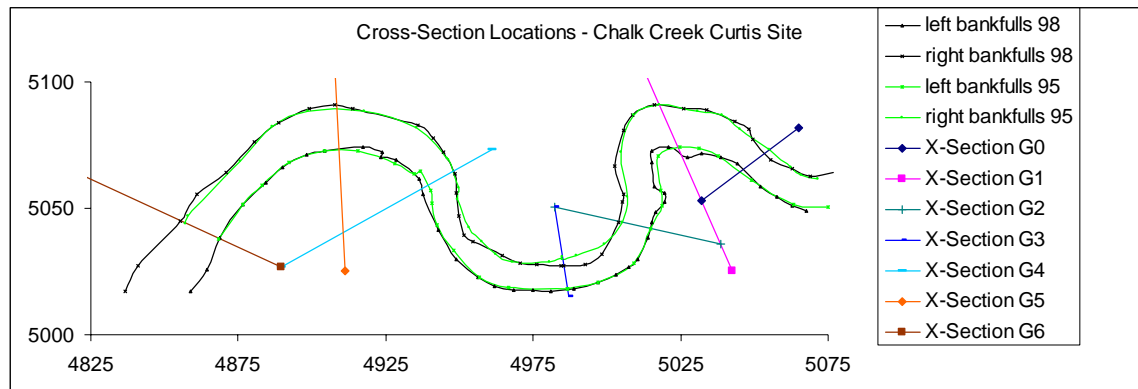
Figure 8. Plan view of Chalk Creek at the Curtis site, showing bankfull estimates and transect locations.

Seven transects of Chalk Creek at the Curtis site were measured in 1994, 1995 and 1998. The reach containing these cross-sections (G0-G6) was also surveyed along both banks to determine the bankfull location. The bankfull location, presented in plan view, is shown in Figure 8, along with the locations of the transects.

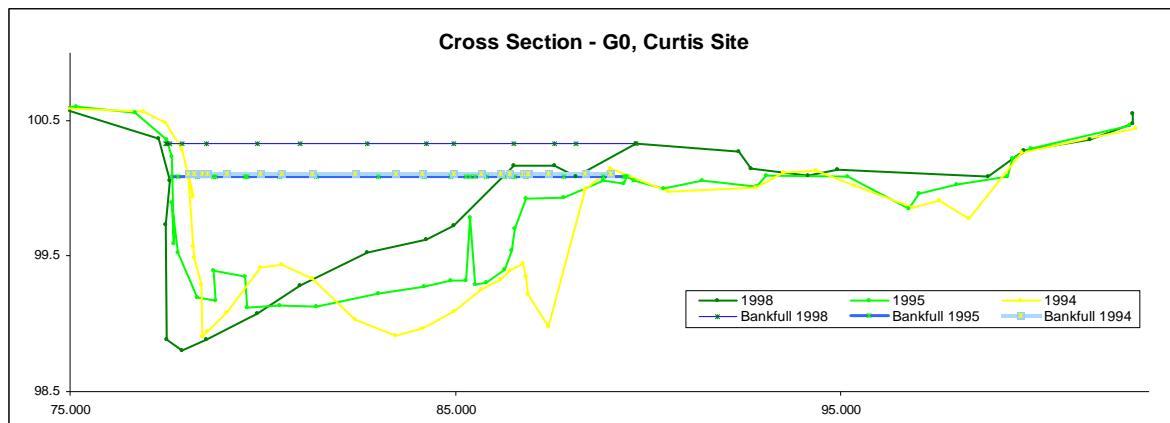
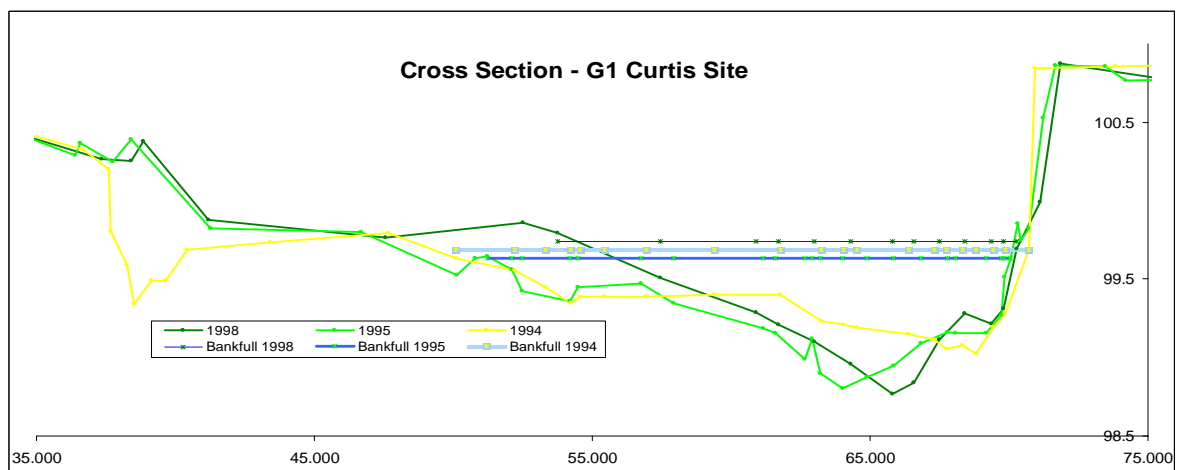
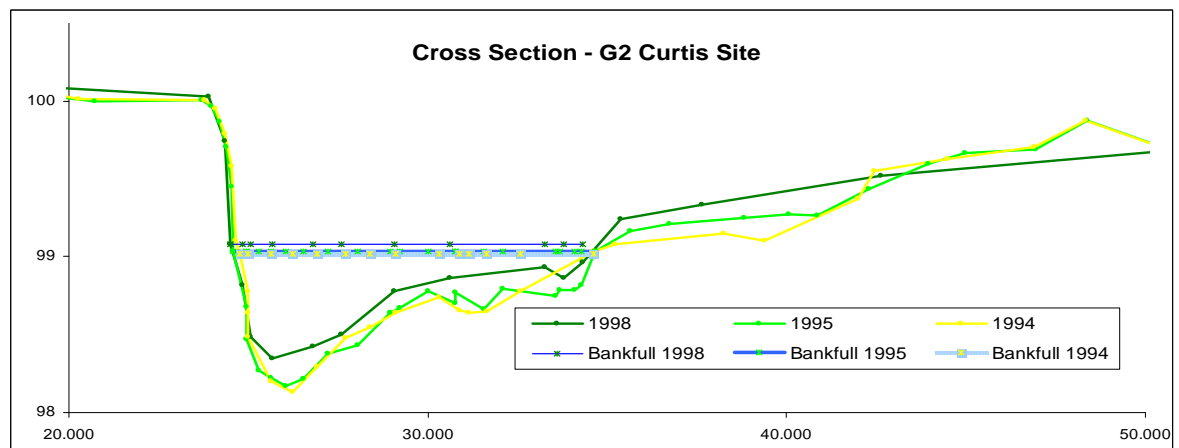
Figure 9. Transects G0-G2 on Chalk Creek at the Curtis Site.

Figures 9 and 10 present transects G0-G6, with surveys taken in 1994, 1995 and 1998.

An improving stream will generally narrow and deepen, and this can be seen in Transects G0, G1, G3 and G6. Table 11 displays the calculated width/depth ratios, which indicate some improvement, with ratios still fairly high. This data indicates that the stream is improving, but a continued narrowing and deepening is needed.

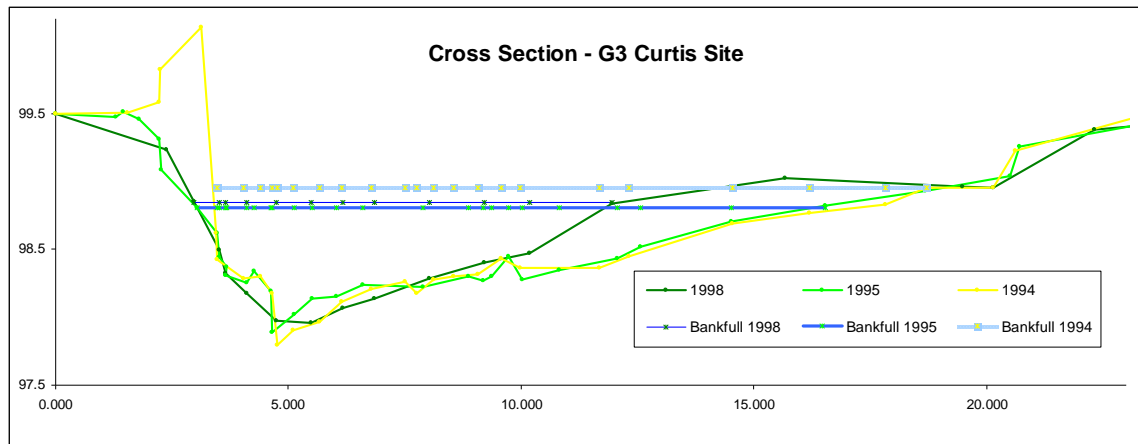
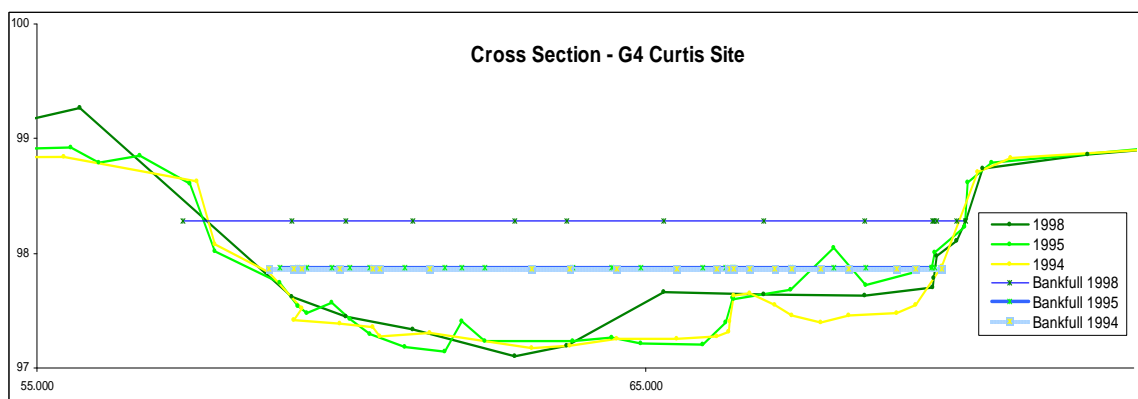
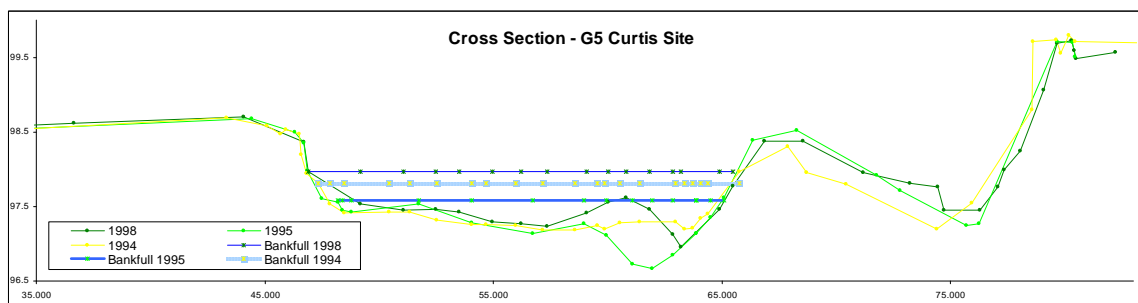
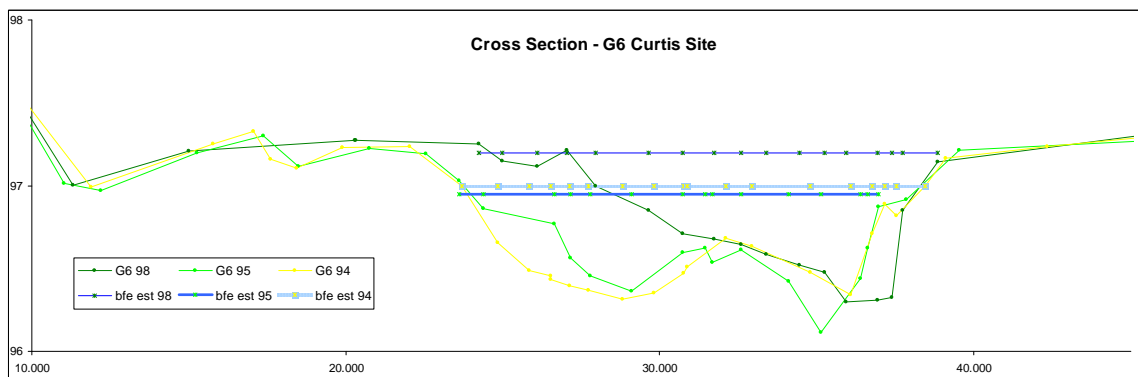
Figure 10. Transects G3-G6 on Chalk Creek at the Curtis Site.
