SECTION 319 NONPOINT SOURCE POLLUTION CONTROL PROGRAM INFORMATION/EDUCATION/TRAINING/DEMONSTRATION PROJECT FINAL REPORT

Duchesne River Watershed Demonstration Projects

The Duchesne County Conservation District

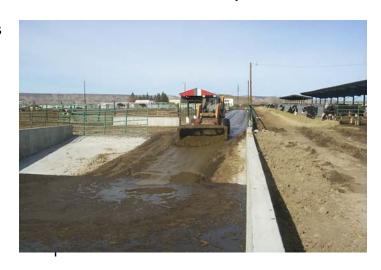
Manure bunker at one dairy

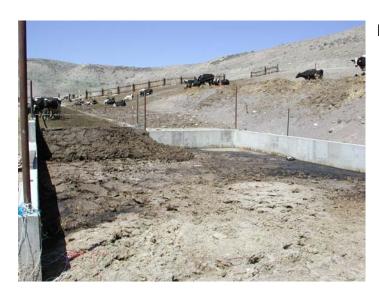
Manure Bunker in use

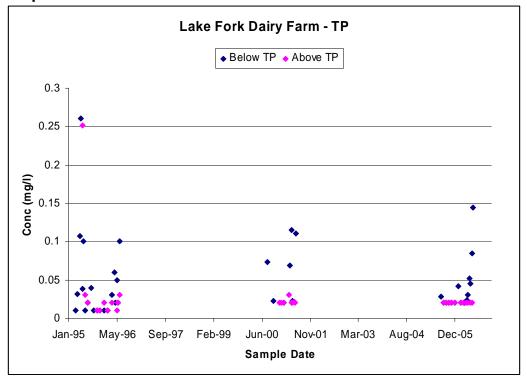
Graph 1: TP Concentrations in Lake Fork River.

For the Lake Fork River dairy farm, the above WQS #1 (4935800) is approximately 6 miles above the point of discharge and the downstream WQS #2 (4935740) is roughly 2 miles below. See Table 2 below for the parameter mean concentrations for these 2 sites. Data collected from these sites ranged from 1995 – 2006.

Using one-way ANOVA calculations, only 3 significant differences resulted. The first was a significant decrease in TDS at both sites before and after 2004, however since both sites reflected the same result nothing can be concluded. The second was a significant increase in NH3 concentrations at the downstream site before and after 2004. The third was a significant increase in TDS when compared the upstream WQS to the downstream site. Given that these sites are relatively far away from the point of discharge, no absolute conclusions can be made based on available data. Note: The Duchesne and Lake Fork River have an approved TMDL for TDS.

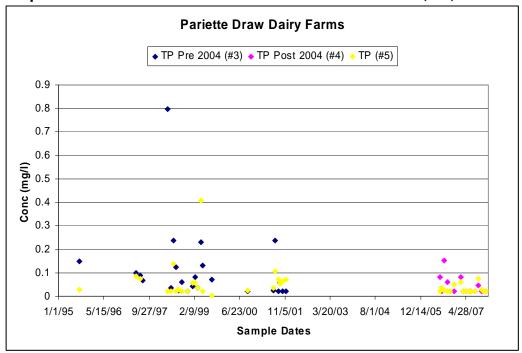
Graph 4: TP Concentrations in Pariette Draw at WQS #3, #4, and #5.

The same parameters were analyzed for the 3 Pariette Draw WQS: TP, N, NH3, and TDS. NH3 was not collected after 1999 thus no conclusions can be made about this parameter. See Table 3 for mean concentrations.

Using one-way ANOVA calculations, there were no significant differences when comparing pre and post 2004 data in any parameter. Pariette Draw is a major designated wetlands managed by the BLM. It is on the 2008 303d list for TDS. A TMDL is currently underway.
