# Section 319 Nonpoint Source Pollution Control Program Watershed Final Report

## East Daniels Grazing Allotment Fencing Project FY2008

November 25, 2013

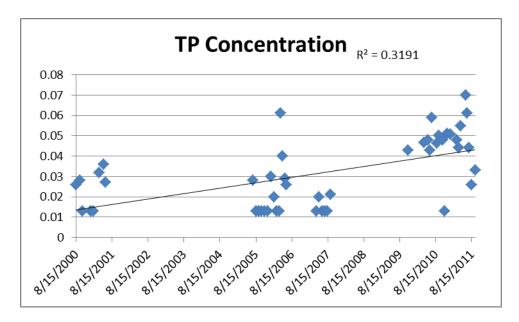
**Figure 2. Strawberry River TP Concentration**

The fencing from this project will both promote better grazing practices and protect riparian areas from further degradation. There were approximately 50 water samples collected between August, 2000 and September, 2011 from Strawberry River, which can be found below. A graph showing the trend of TP concentration and loading can be seen in figures 2 and 3. Although the data shows a slight increase in TP over time, once the project is complete a 12% reduction is expected from the BMPs. The Total Phosphorus (TP) load data from these samples was averaged and the reduction is taken from that average. Based on that data a load reduction of 70 lbs/year can be expected from this project. This number is based on a conservative 12% TP reduction for riparian fencing (Meals, 2002). The Strawberry TMDL calls for a watershed reduction of 1,015 lbs/year and 75 lbs/year from the Strawberry River.

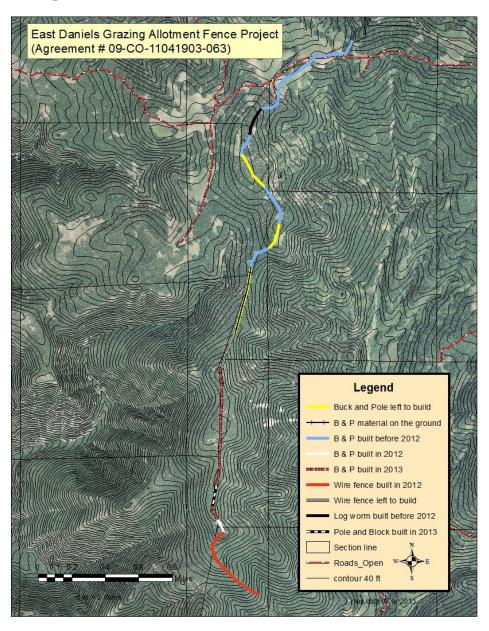
Figure 4: Map of Fence Constructed and Planned

Planning for this project began in FY-08 and the project will continue for at least one year after this report is submitted until complete. 3 miles of fence have been constructed including 3 gates and one cattle guard. One more mile of fence has yet to be constructed, including one more gate. Approximately .5 mile of two track trail will also be removed.

The next steps for this project will be to finish the fence. Approximately 1 mile of fencing supplies has been purchased and is ready to be installed. The fence should be finished by end of 2014.

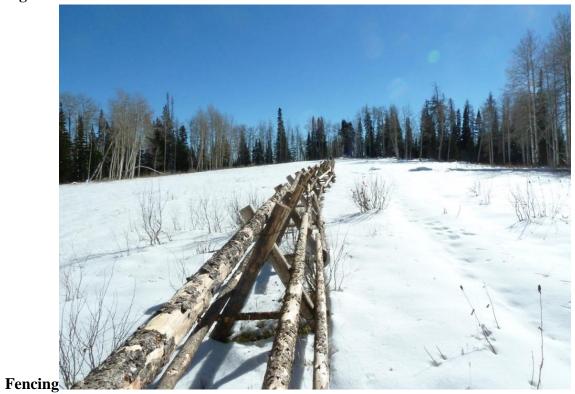
Figure 5: Buck and Pole

- 2.2 miles of buck and pole fencing
- 0.2 miles of log worm fencing
- 0.5 miles wire fencing
- 0.12 miles block and pole fencing
- 3 gates
- 1 cattle guard

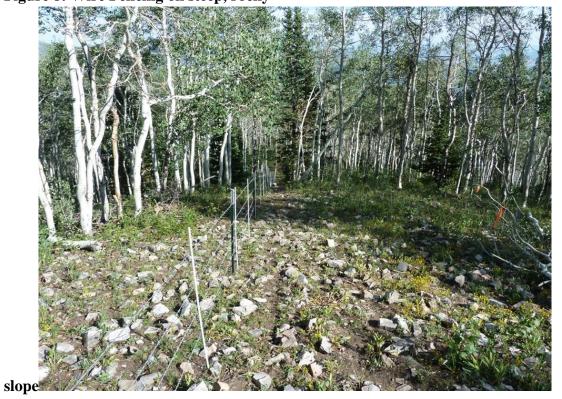
Figure 8: Wire Fencing on steep, rocky

Complications arose in several areas. The first was the weather. Work had to be scheduled around the weather that was typical for higher elevations, which would impeded project implementation or access to the project location. Lack of volunteers also slowed the progress of the work, though the volunteers that did participate were greatly appreciated. The terrain on which the fence was to be built was also a complication. The natural forest provided many obstacles that had to be removed before the fence could be built. The terrain was extremely steep and rocky in many places. Because of this, much of the work had to be done by hand.

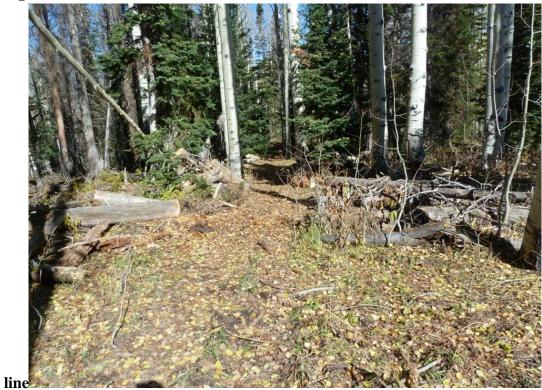
Figure 10: Cleared Fence

The fence line was cleared by hand and then was used for the route to deliver materials. Most of the materials were delivered by ATV and snow machines. The construction of the fence was and is being completed with human resources such as Dedicated Hunters, Boy Scouts, Youth groups, clubs and Youth Conservation Corps. As of November 7, 2013 a total of approximately 3 miles of fence has been completed. In addition, 0.4 miles of buck and pole fence supplies are on site and ready to install. The remainder has not been started but the Forest Service will complete the project.
