SECTION 319 NONPOINT SOURCE POLLUTION CONTROL PROGRAM

ASSESSMENT/PLANNING PROJECT FINAL REPORT

**Upper Jordan River Ecosystem Restoration  
8600 South to 9000 South  
Section 319 Funding  
Fiscal Grant Year 2009**

December 27, 2012

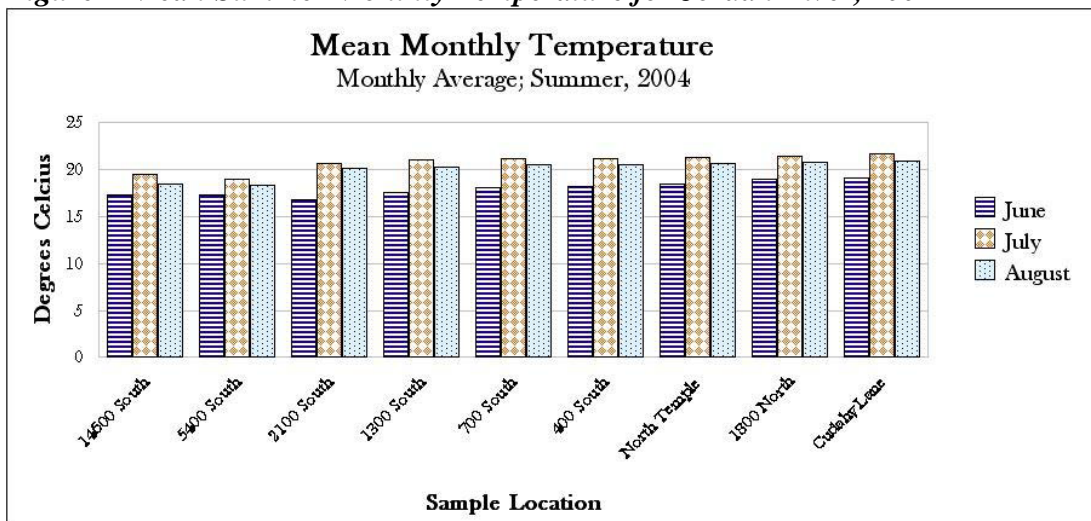
**Figure 2-Mean Summer Monthly Temperature for Jordan River, 2004**

As with mean summer temperature, 30 day average water temperatures increased as the River progresses downstream. Overall, temperatures were highest in the month of July (varying between 19.57 °C and 21.7 °C) and lowest in the month of June (varying between 17.31 °C and 19.15 °C). August temperatures were slightly lower than July temperatures but remained above the values observed for June, varying between 18.48 °C and 21.0 °C (Salt Lake County Jordan River Water Quality TMDL Assessment, 2004).

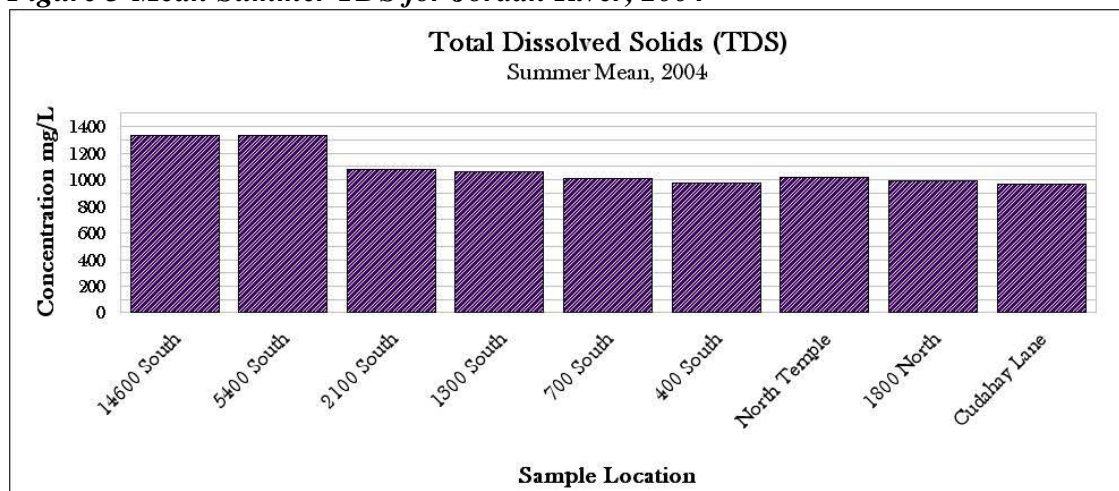
**Figure 3-Mean Summer TDS for Jordan River, 2004**

The irrigation standard for TDS along the Jordan River is 1200 mg/L. As can be seen in the figure below, this standard was violated at the Bluffdale sample location (1330.56 mg/L) and the 5400 South sampling location (1332.44 mg/L). In general, TDS levels appeared to decrease as the river progressed downstream with a low of 970.56 mg/L observed at the Cudahy Lane sample location (Salt Lake County Jordan River Water Quality TMDL Assessment, 2004).

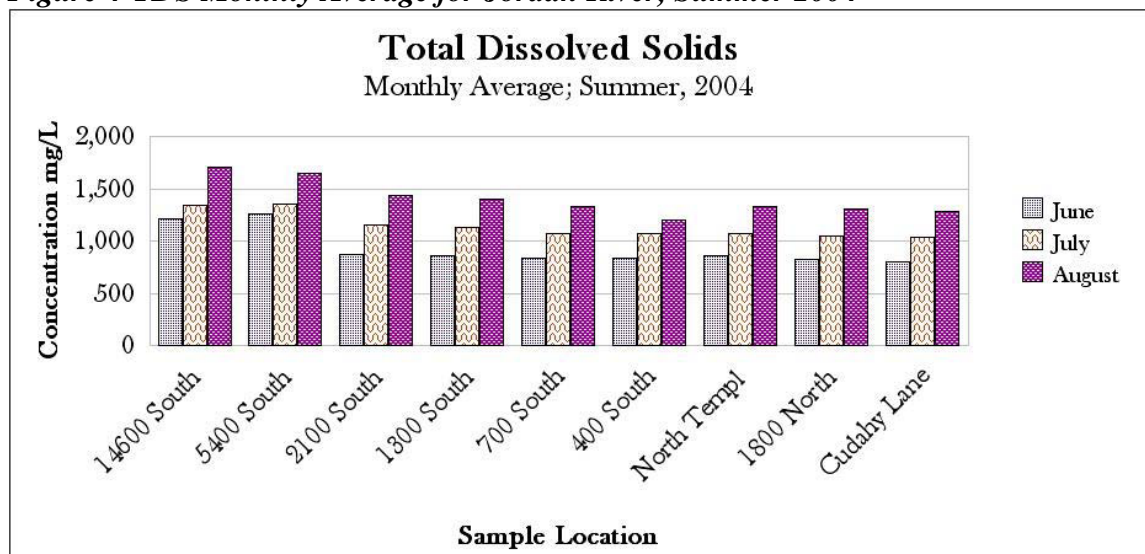
**Figure 4-TDS Monthly Average for Jordan River, Summer 2004**

As with mean summer TDS, 30-day average TDS concentrations were highest at the Jordan Narrows, and gradually decreased as the River progressed downstream. In contrast to patterns observed with temperature, total phosphorus, and TSS data, TDS concentrations were highest in the month of August (varying between 1,208.8 mg/L and 1,708.0 mg/L) and lowest in the month of June (varying between 803.67 mg/L and 1,267.67 mg/L). July TDS concentrations were between August and June concentrations (varying between 1,038.0 mg/L and 1,348.0 mg/L). Notably, 30 day average TDS values exceeded the 1,200 mg/L standard for the Bluffdale and 6400 South sample sites for all three months of this study (Salt Lake County Jordan River Water Quality TMDL Assessment, 2004).

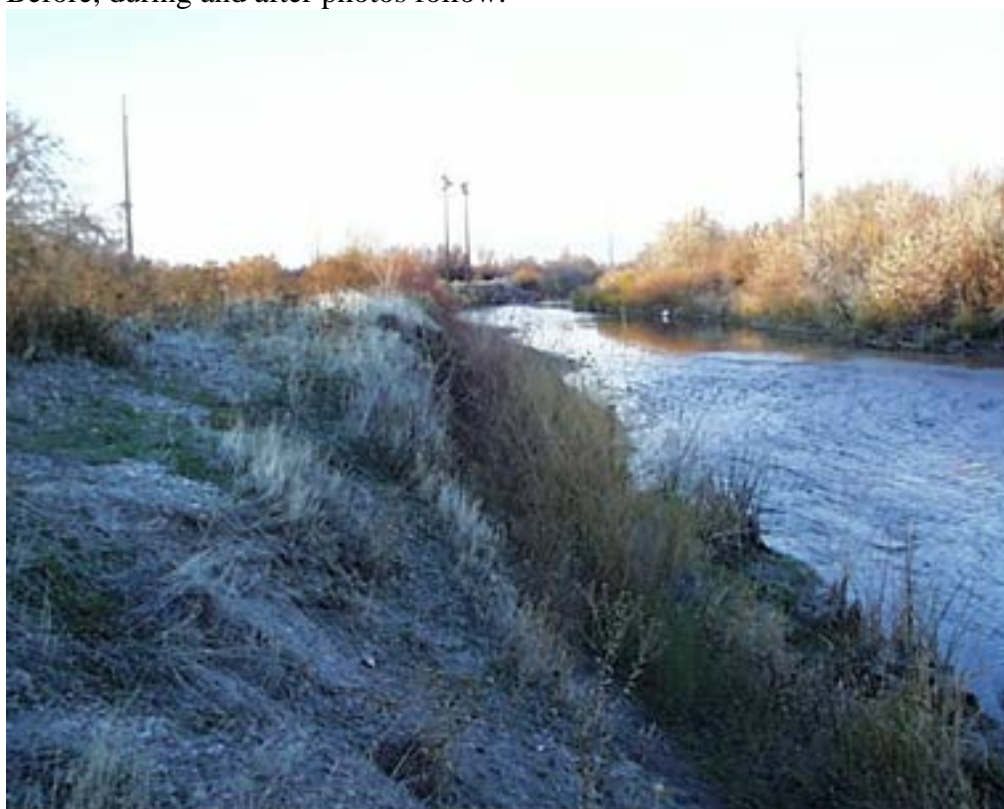
This site had major bank erosion, in one area specifically; a power pole was dangerously undercut. This location was listed as a priority by Salt Lake County, due to these factors. Rocky Mountain Power, who is the land owner, also, felt this would be a worthwhile project for their property and granted an easement for work at no cost.

**Before Construction (November 2001)**

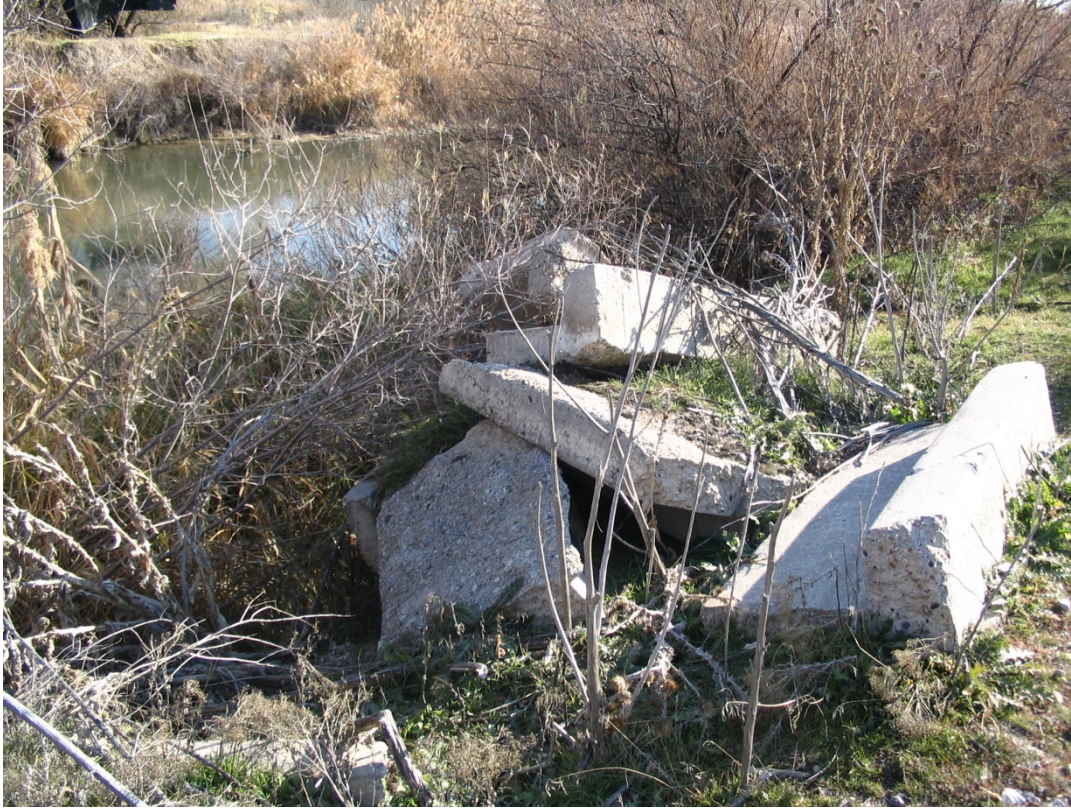
**Before Construction (November 2008)**

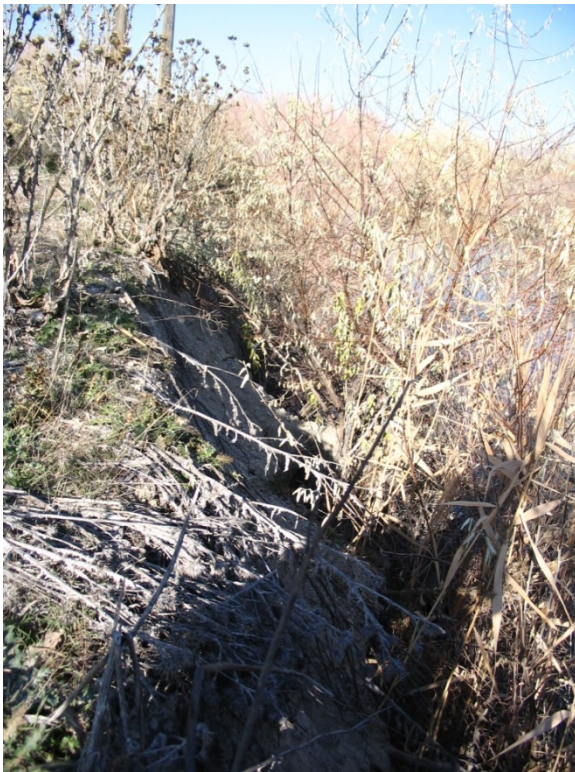
**Before Construction (November 2008)**

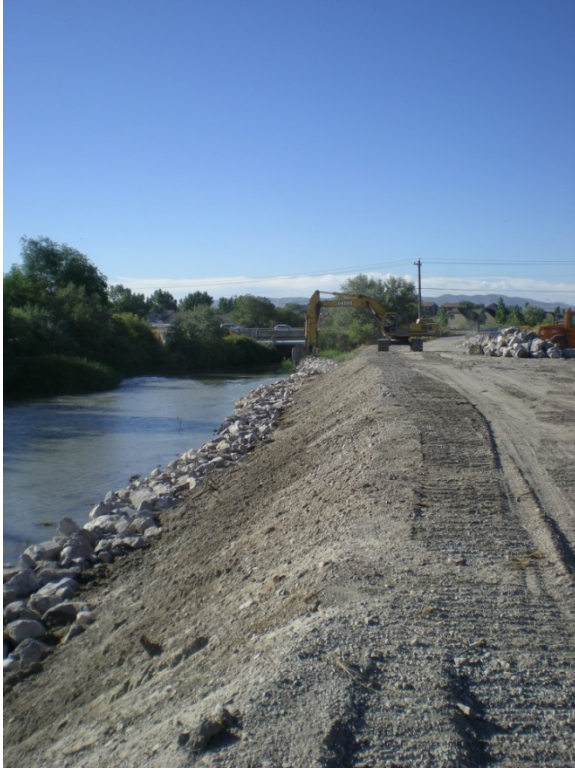
**During Construction (August 2010)**

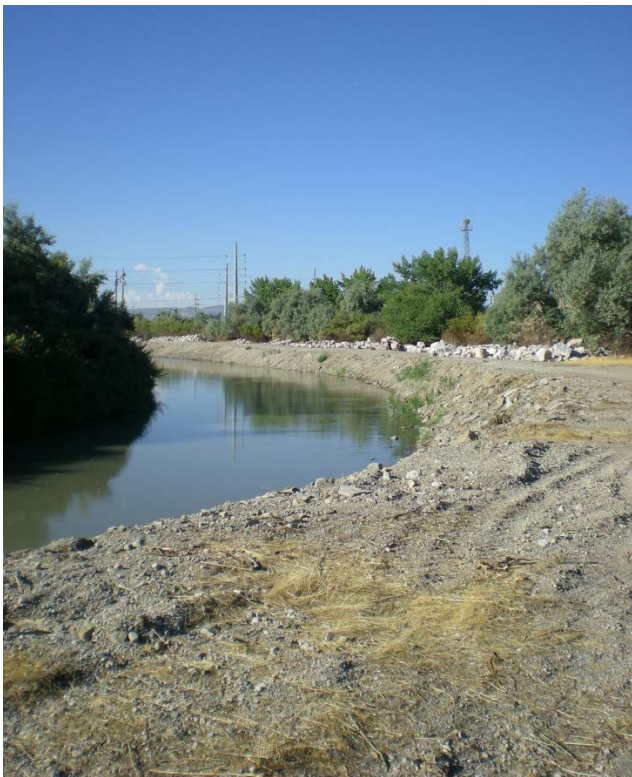
**During Construction (August 2010)**

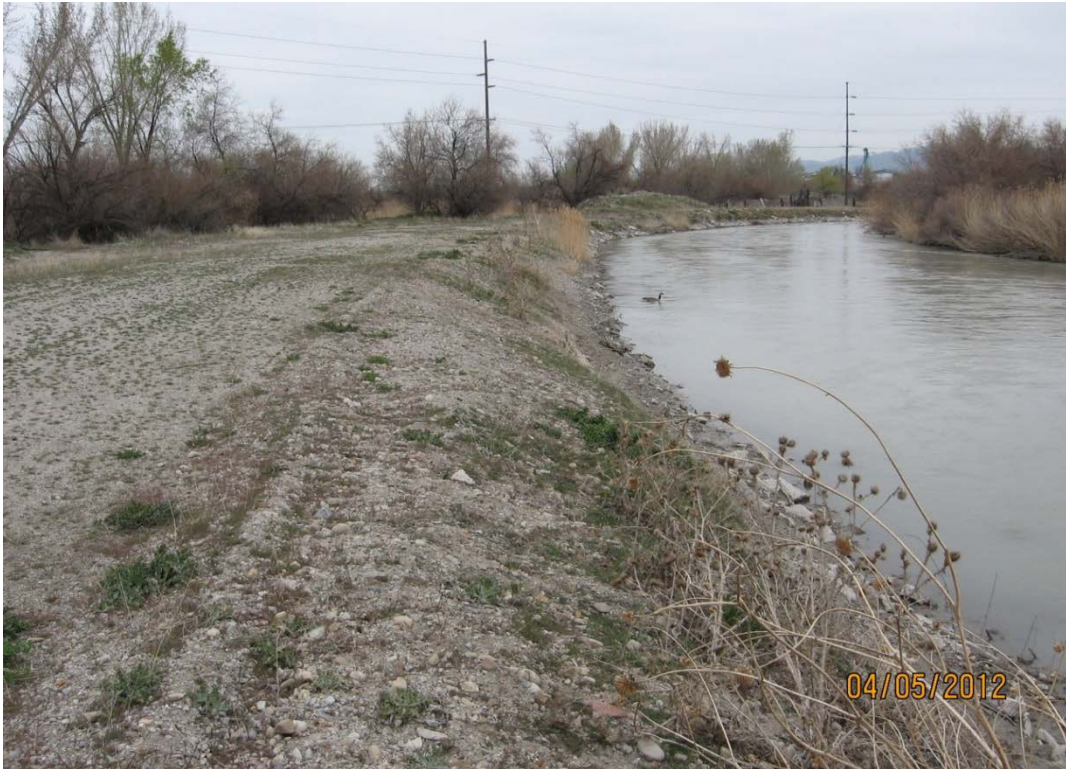
The banks are no longer mass wasting in to the river, due to the toe being installed. The two power lines have also been protected by a riprap revetment.

**After Construction (April 2012) – Note: Water level is above the riprap in this picture.**

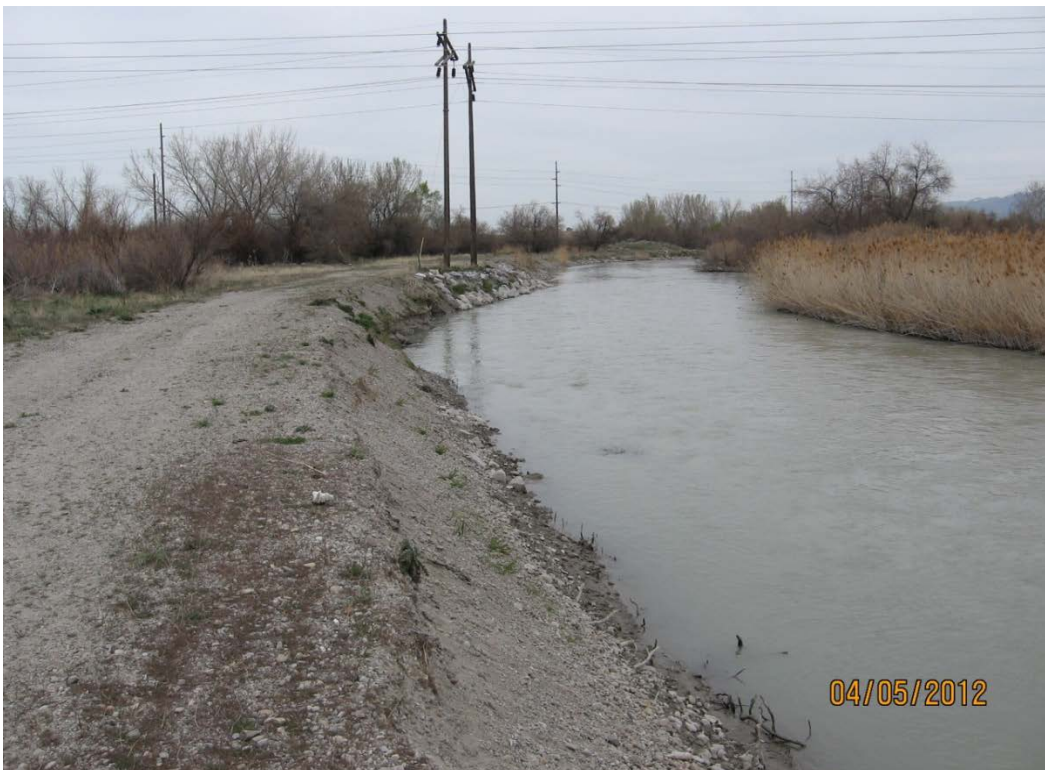
**After Construction (April 2012) – Note: Water level is above the riprap in this picture.**

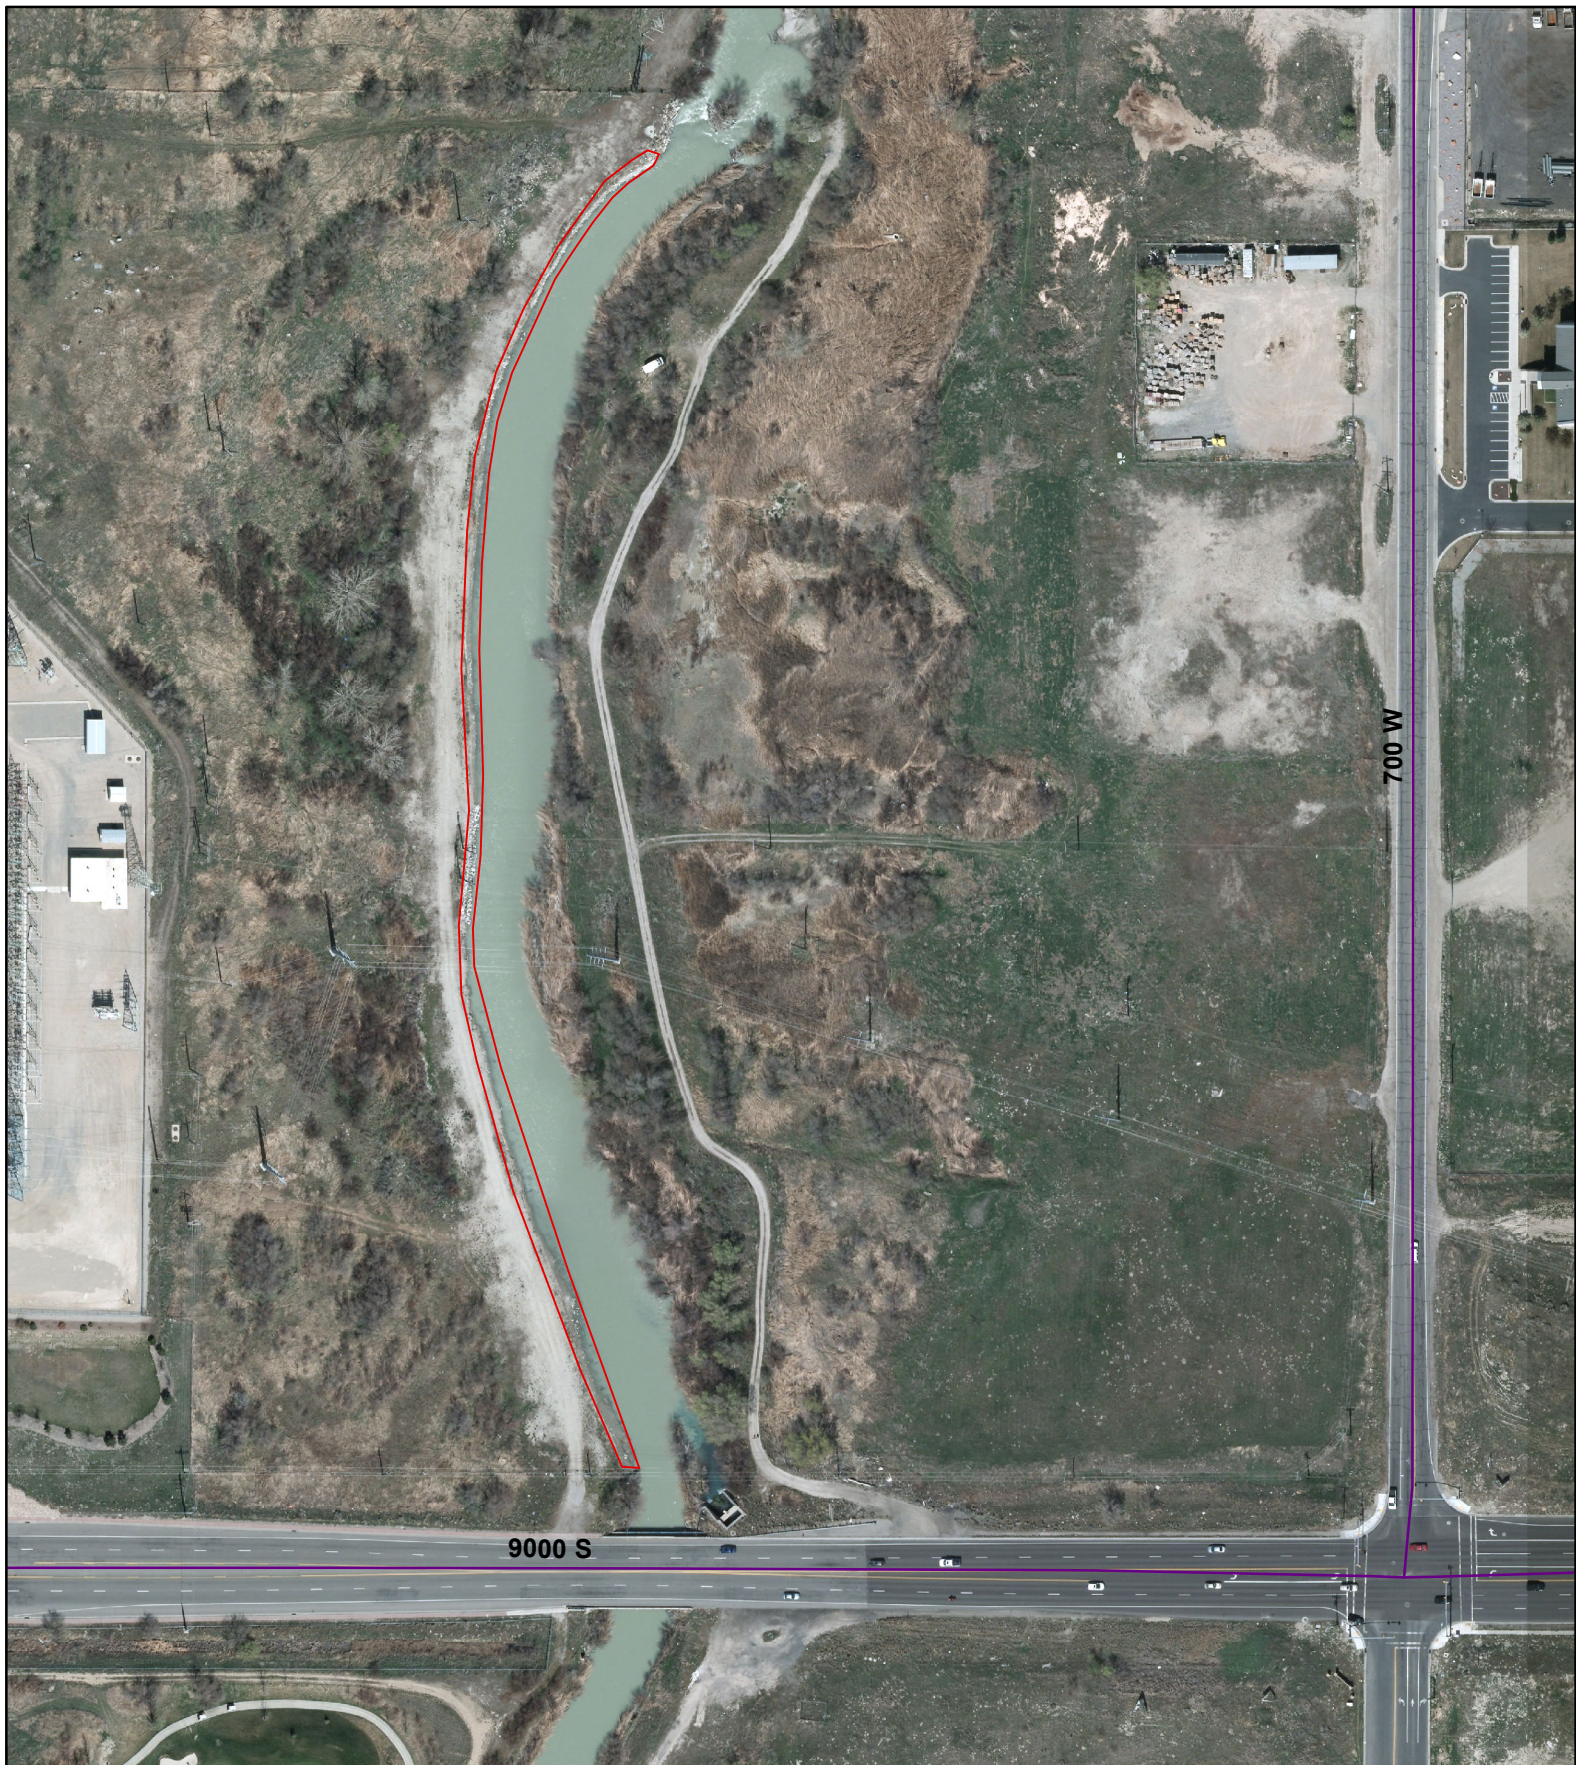
# Jordan River - 9000 South to 8600 South

Project area is outlined in red.  
Approximately 1150 feet of bank had rubble  
and invasive plants removed.  
It was then sloped to a minimum of 2:1  
and a riprap toe was placed.
