Watershed Project Final Report

Fremont River

By Monte Turner UACD Zone Four Planner

January 2012

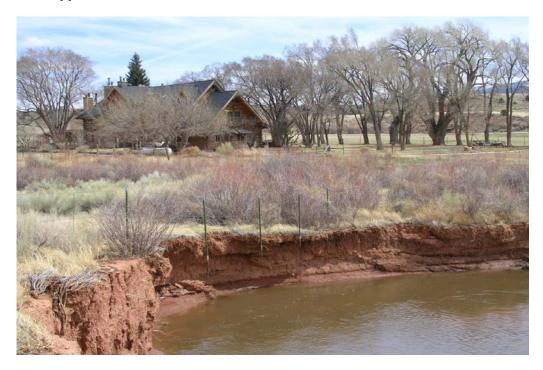
Before: Raw vertical banks, erosion has cut into the bank where a fence was once installed.

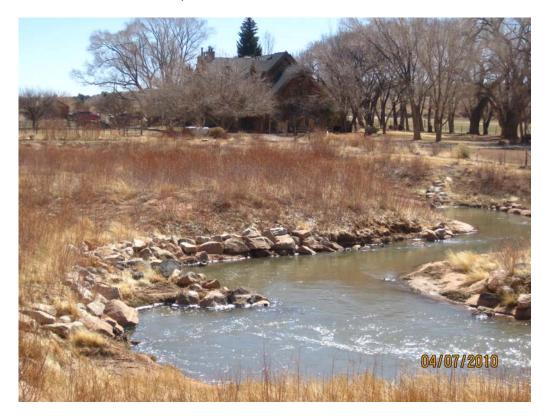
After: Streambank practices included shaping, rock rip rap, rock barbs and willow planting.

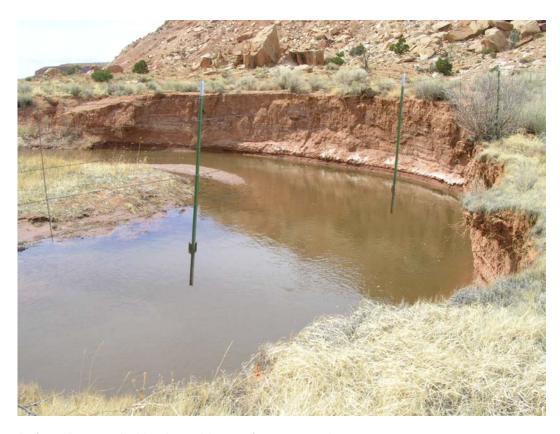
Before: Raw vertical banks, evidence of severe erosion.

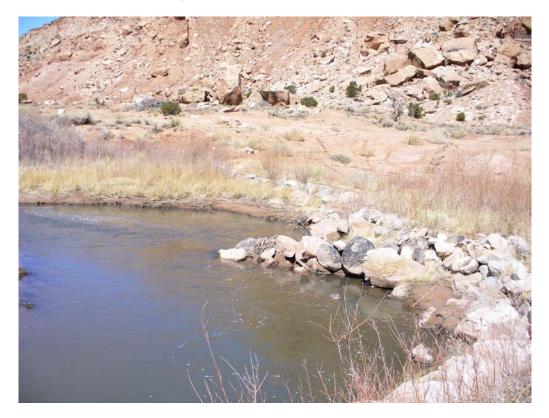
After: Practices included shaping, rock rip rap, rock barbs, and willow planting.

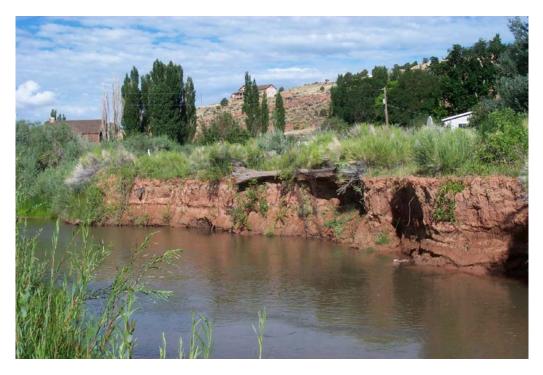
Before: Raw vertical banks with significant erosion.

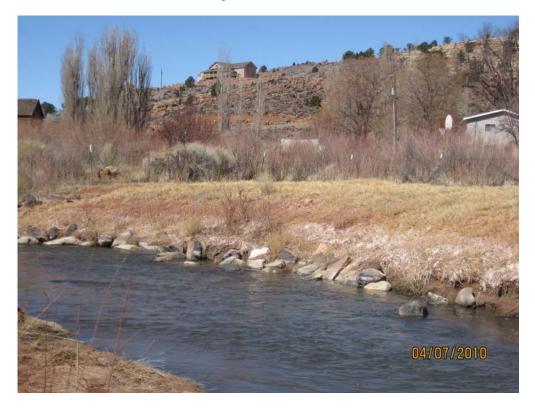
After: Practices installed include shaping, rock rip rap, rock barbs and willow planting.

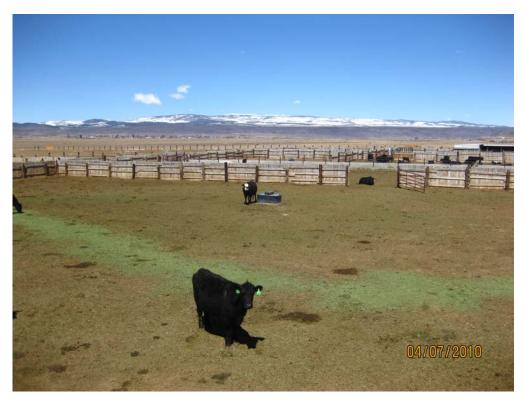
Picture of Jacobs new corrals, 3000 ft away from Fremont River.

The feed lots that were moved were originally located on or within 50 meters of the Fremont River. They have now been moved to a distance of 1000 meters or more from the river, or to where the slope of the feedlot does not allow runoff to reach the river. The operations that have been implemented have been between 50-600 animals. In addition to the feedlots, off site watering structures have been installed instead of watering cattle directly in the river.
