UTAH SUCCESS STORY: MAIN CREEK

PHASE 1 RESTORATION EFFORTS DECREASE TEMPERATURE AND POLLUTANT LOADING IN WALLSBURG WATERSHED

Utah Success Story: Main Creek

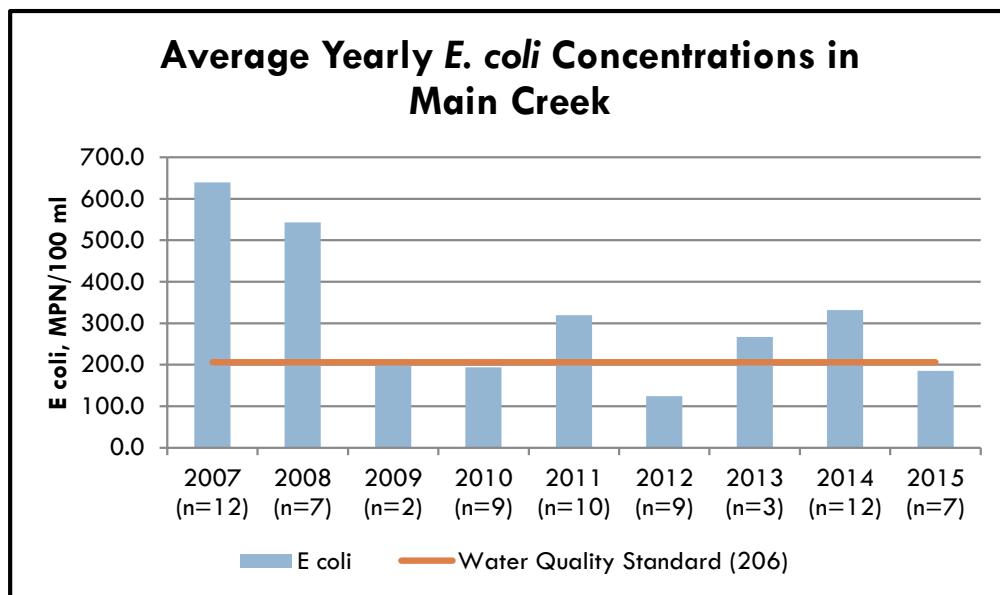
FIGURE 1. AVERAGE ANNUAL E. COLI CONCENTRATION IN MAIN CREEK ABOVE DEER CREEK RESERVOIR.

Though Main Creek comprises only 8% of the inflow into Deer Creek Reservoir, it contributes 17% of the TP load. Further assessments of Main Creek (UT16020203-009) placed it on the 2010 303(d) List for failing to protect its infrequent recreational and cold water fishery uses due to elevated levels of *E. coli* and water temperature respectively. Figure 1 shows that *E. coli* concentration in Main Creek often exceeded the water

quality standard of 206 MPN/100 ml protective for infrequent recreation. For the 2010 303(d) listing, temperature in Main Creek exceeded the 20° C water quality standard set to protect for cold water fisheries 18% of the time between 2004-2008 (Figure 2).

Figure 1 shows a downward trend in *E. coli* concentration in Main Creek as well. When comparing data before and after Phase 1 work, there is a 24% reduction in concentration (Figure 11) though levels still exceed the WQS of 206 MPN/100ml for infrequent contact recreational use. Figure 12 displays a 79% reduction in *E. coli* loading before and after Phase 1 project work. Note that 2014 was a dry water year which could overestimate the percent reduction.

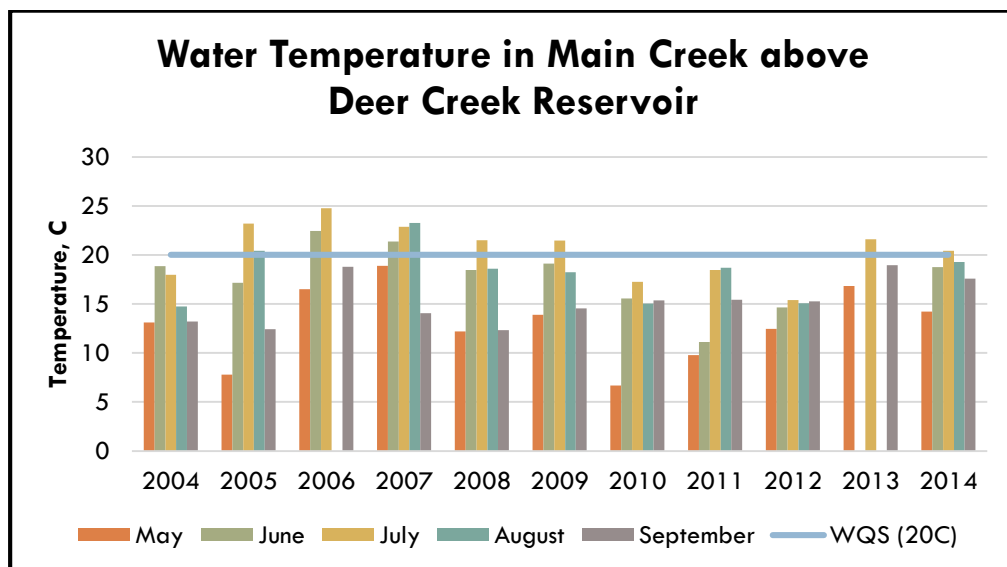
FIGURE 2. WATER TEMPERATURE READINGS IN MAIN CREEK ABOVE DEER CREEK RESERVOIR.

Assessment of 2004-2008 temperature data triggered an impairment listing in 2010 with an 18% exceedance of the water quality standard (WQS) of 20°C required to protect cold water fisheries (Figure 2). Utah's assessment methodology allows for 10% exceedance of the water quality standard. The most recent data assessment (2010 – 2014) indicates only a 4% exceedance. Main Creek is now considered to be fully supporting its cold water fishery designated use and will be delisted in 2016.

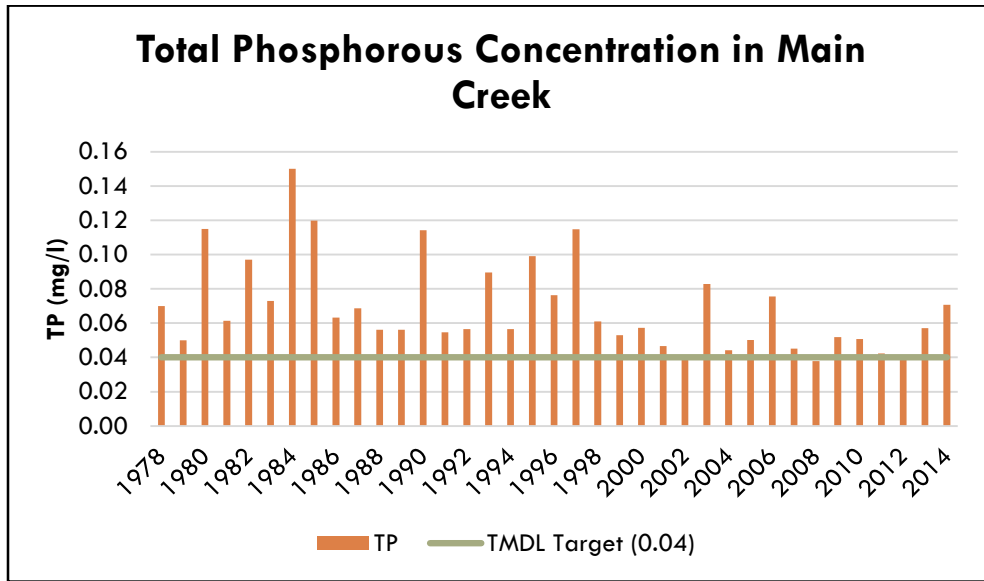
FIGURE 3. AVERAGE ANNUAL TOTAL PHOSPHOROUS CONCENTRATION IN MAIN CREEK ABOVE DEER CREEK RESERVOIR.

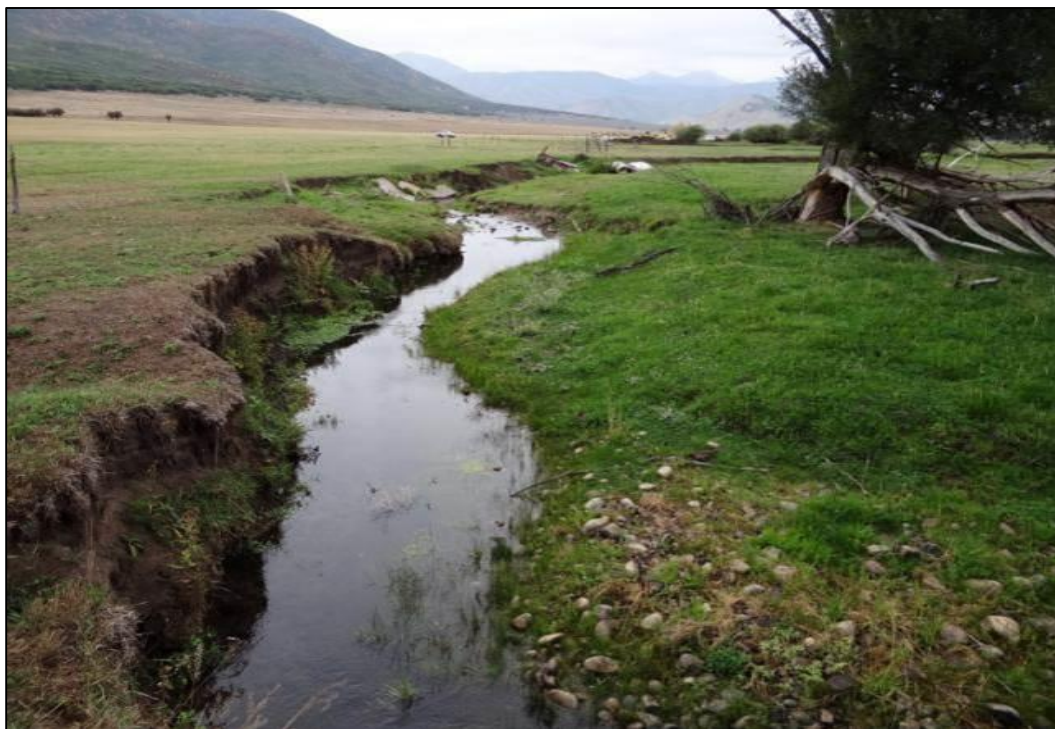
FIGURE 4. MAIN CREEK PRIOR TO PHASE 1 RESTORATION.

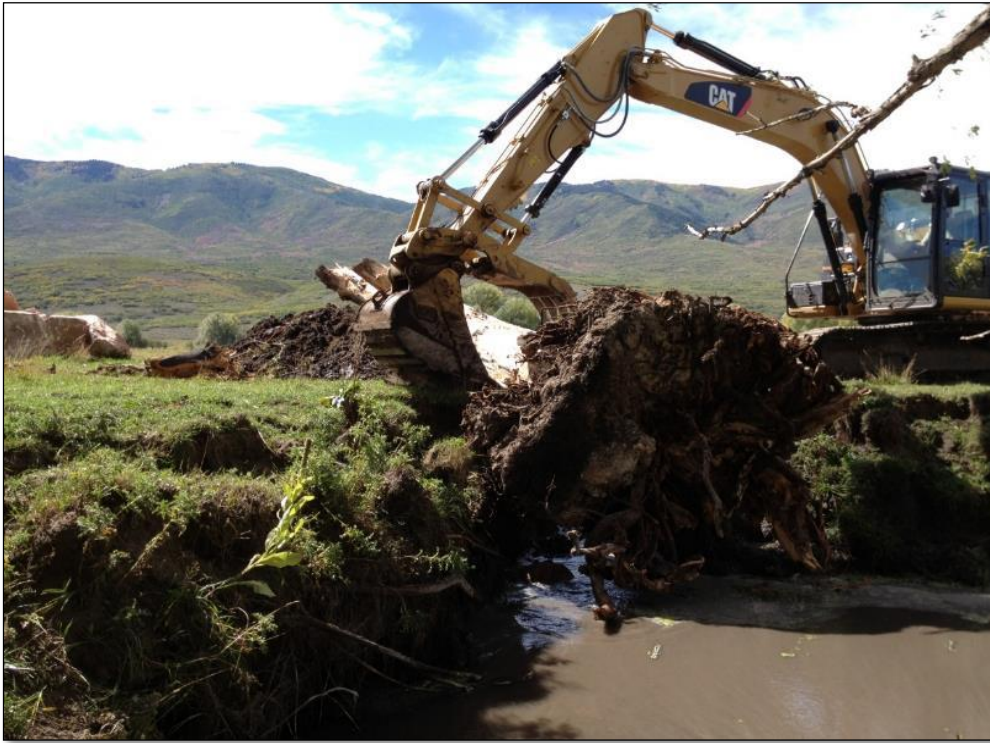
FIGURE 5. UTAH DIVISION OF WILDLIFE RESOURCES' RIPARIAN TEAM SLOPING MAIN CREEK BANKS BACK TO A 3:1 SLOPE.

Phase 1 concluded in December 2014 with 3.22 miles of stream restored. In some sections meanders were reinstalled and banks were pulled back to a 3:1 slope. The disturbed areas were seeded with a wide assortment of

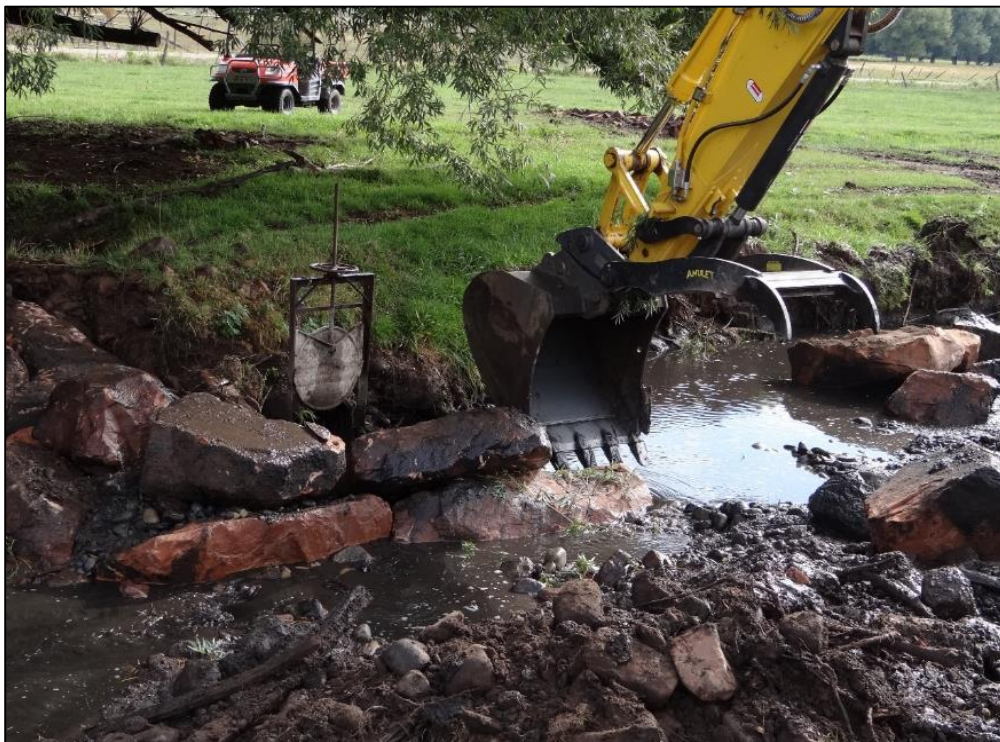
FIGURE 6. CROSS VANE INSTALLATION AND ROCK PLACEMENT ALONG MAIN CREEK.

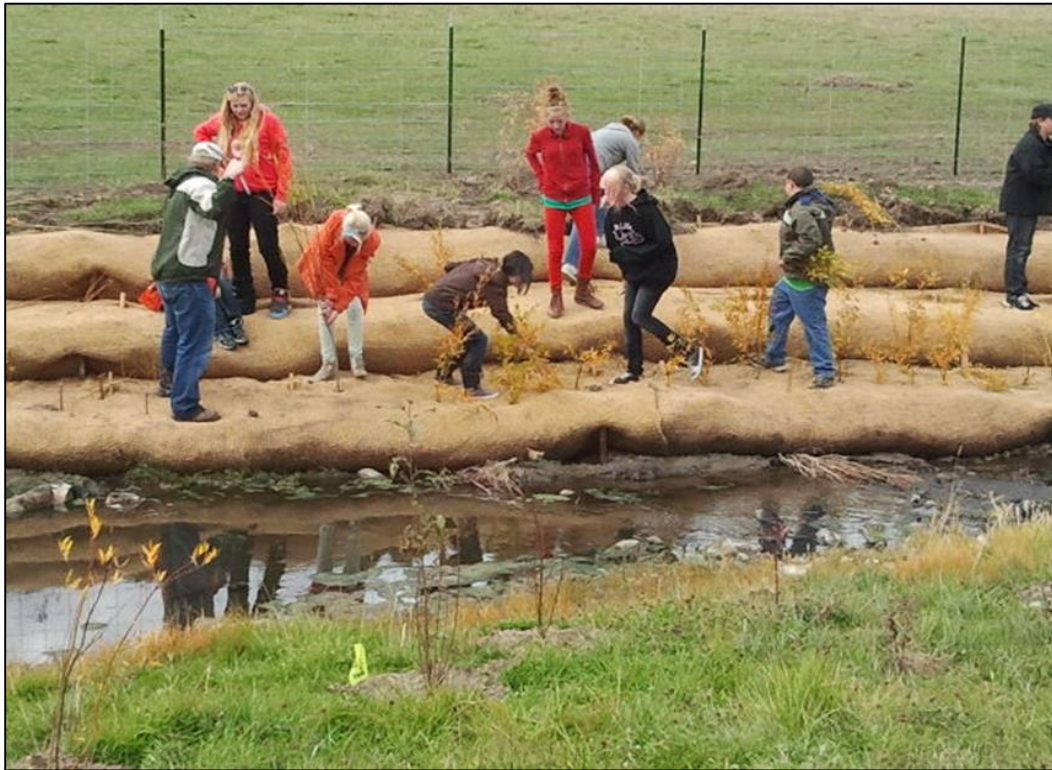
FIGURE 7. VOLUNTEERS PLANTING WILLOW POLE CUTTINGS ALONG MAIN CREEK.

riparian vegetation species. Other sections used soil lifts wrapped with coconut fiber mesh. A seed mixture was spread below the fabric and native vegetation was planted. Over 10,000 willow cuttings were inserted through the coconut fiber. Five miles of exclosure fencing has also been installed reducing unrestricted cattle access. Water gaps and hardened crossings were installed to allow cattle selective water access and movement between pastures.

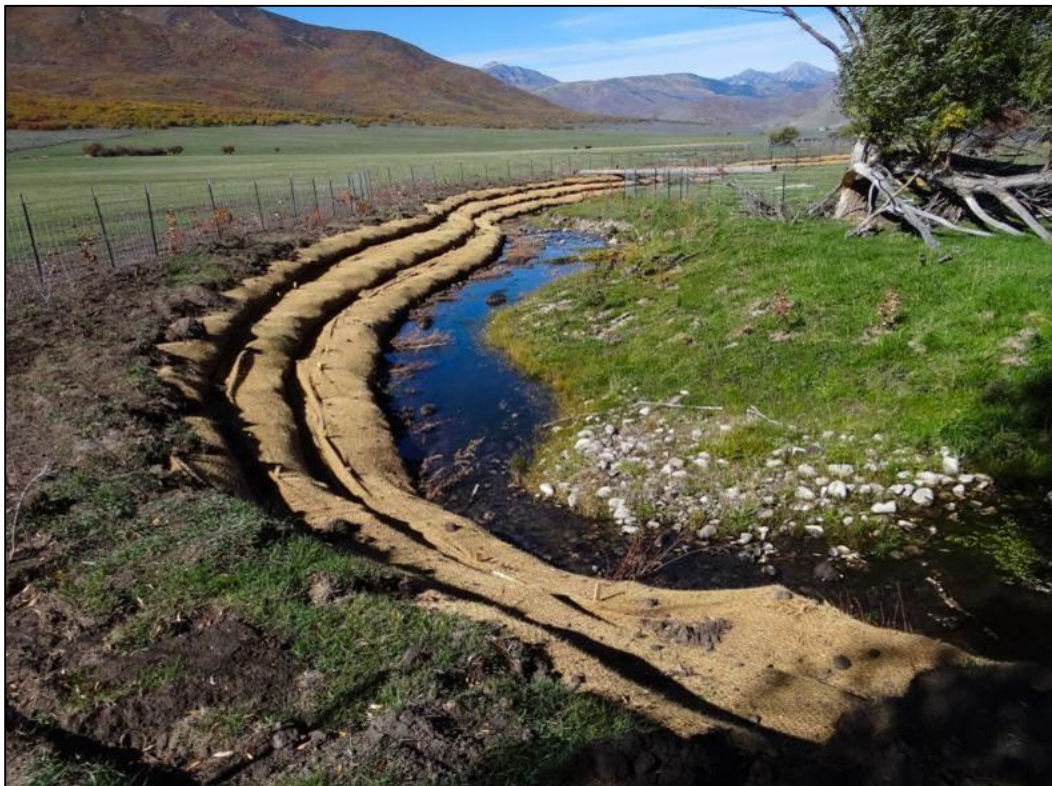
FIGURE 8. MAIN CREEK (SAME REACH FIGURE 4) AFTER PHASE 1 IMPLEMENTATION.

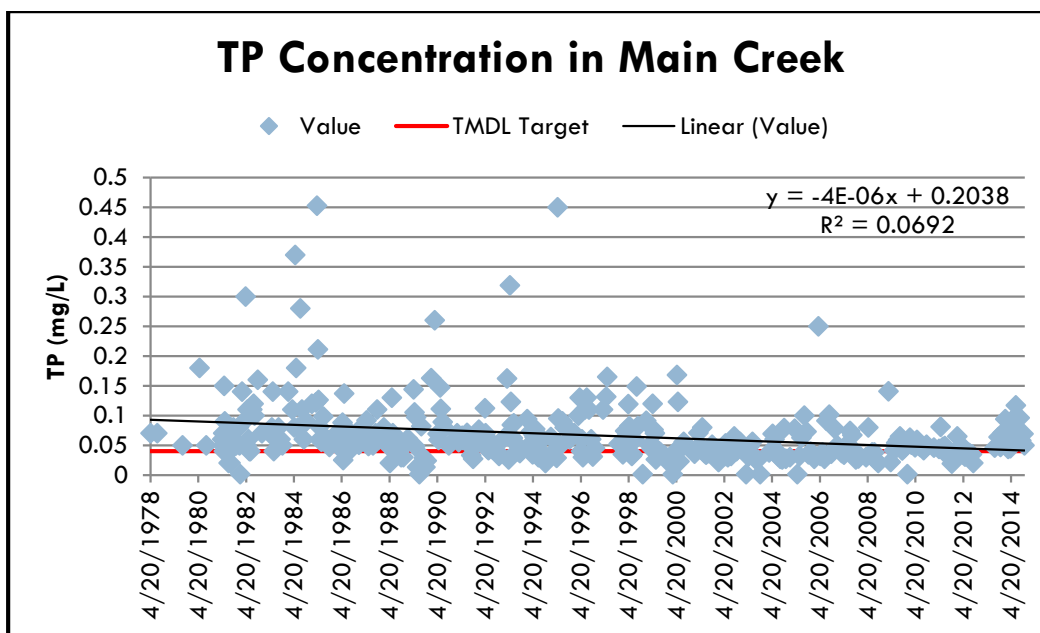
FIGURE 9. GRAPH INDICATES A DOWNWARD TREND IN TP CONCENTRATION OVER TIME THOUGH STILL EXCEEDING THE TMDL TARGET OF 0.04 MG/L.

Trend analysis of TP concentration shows a general decrease over time however concentrations are still above the TMDL target of 0.04 mg/L. Stable concentrations point to natural sources of pollution. There is a positive correlation between flow and concentration indicating that erosion and transport of TP during high flows is a dominant process in the watershed. TP loading has decreased by 63% after Phase 1 restoration.

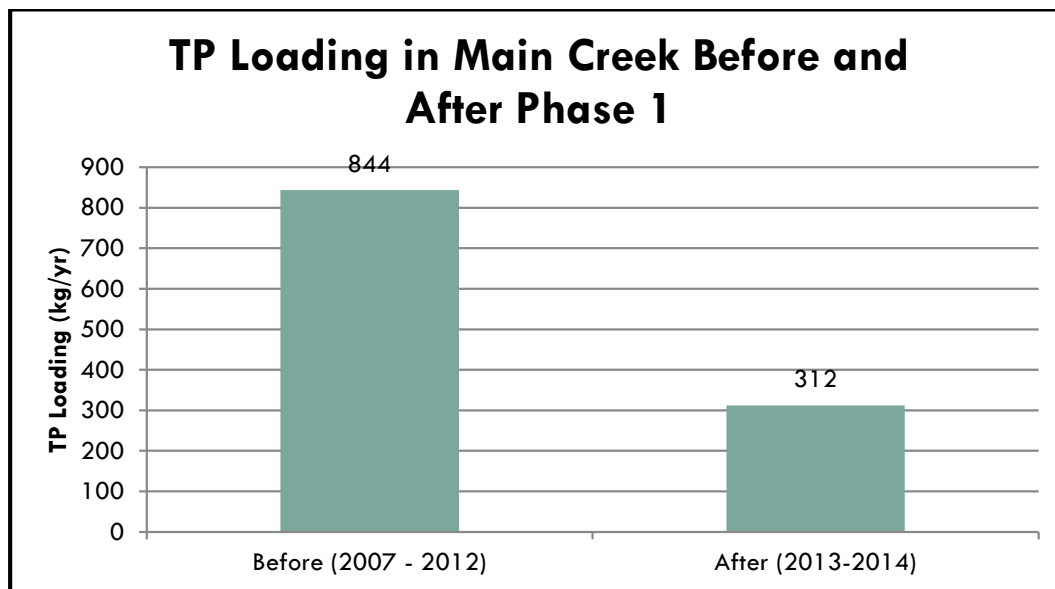
FIGURE 10. BAR GRAPH INDICATES A 63% REDUCTION IN TP LOADING AFTER MAIN CREEK PHASE 1 RESTORATION WAS COMPLETED.

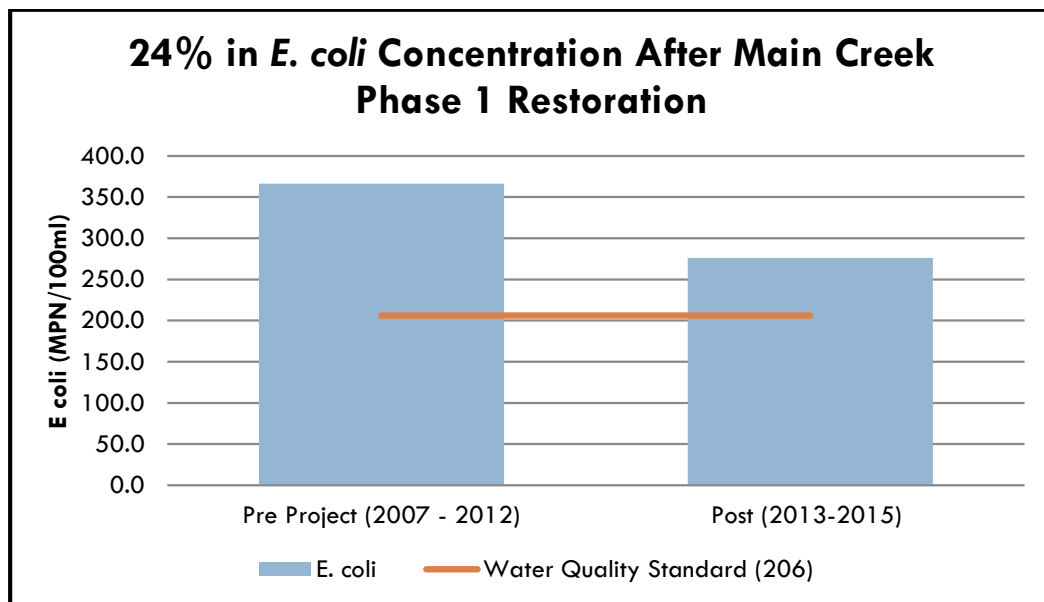
FIGURE 11. BAR GRAPH INDICATES A 24% REDUCTION IN *E. COLI* CONCENTRATION AFTER MAIN CREEK PHASE 1 RESTORATION WAS COMPLETED THOUGH LEVELS STILL EXCEED THE 206 MPN/100ML WQS.

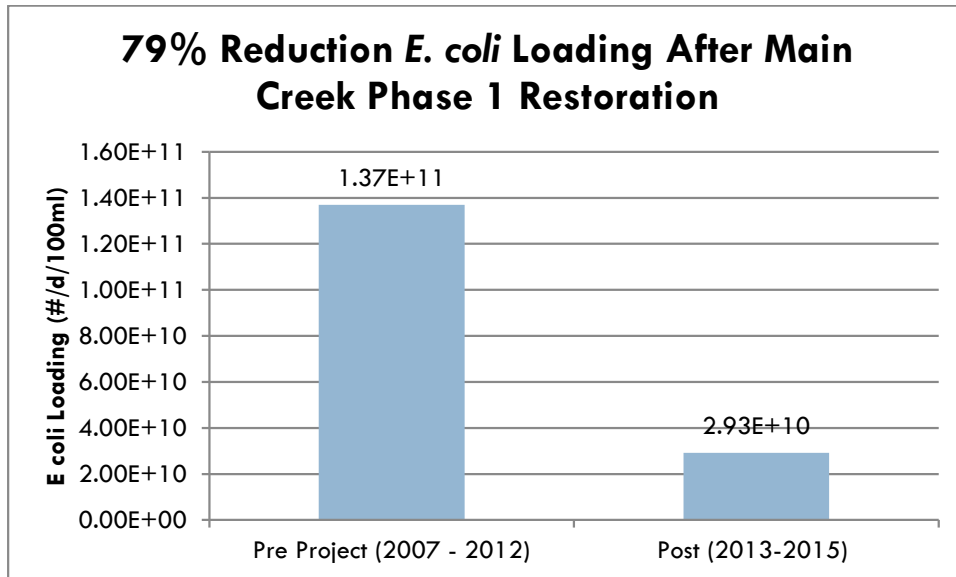
FIGURE 12. BAR GRAPH INDICATES A 79% REDUCTION IN E. COLI LOADING AFTER MAIN CREEK PHASE 1 RESTORATION WAS COMPLETED.
