Section 319 Nonpoint Source Pollution Control Program
Information/Education/Training/Demonstration Project

Final Report

Onion Creek Streambank Stability Demonstration

Michael Johnson (USU Extension), Ann Marie Aubry (BLM)
and Bill Jackson (Grand County Road Dept)

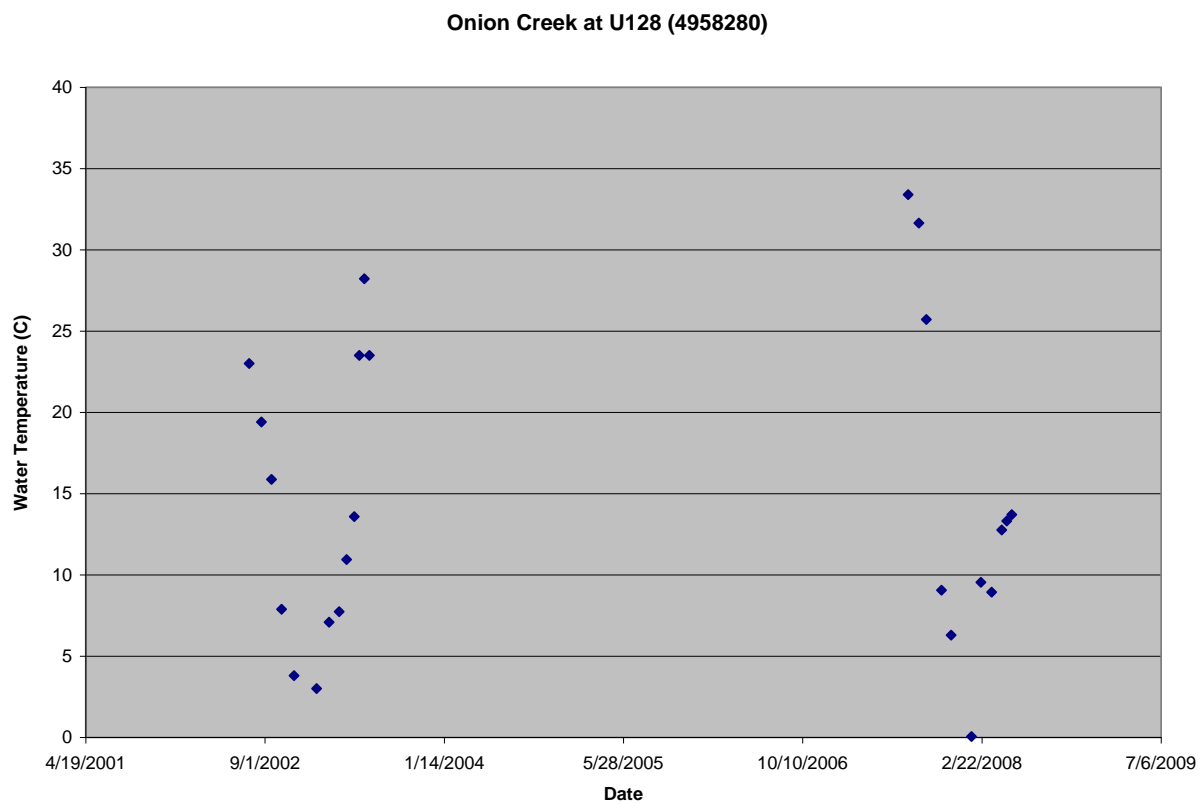
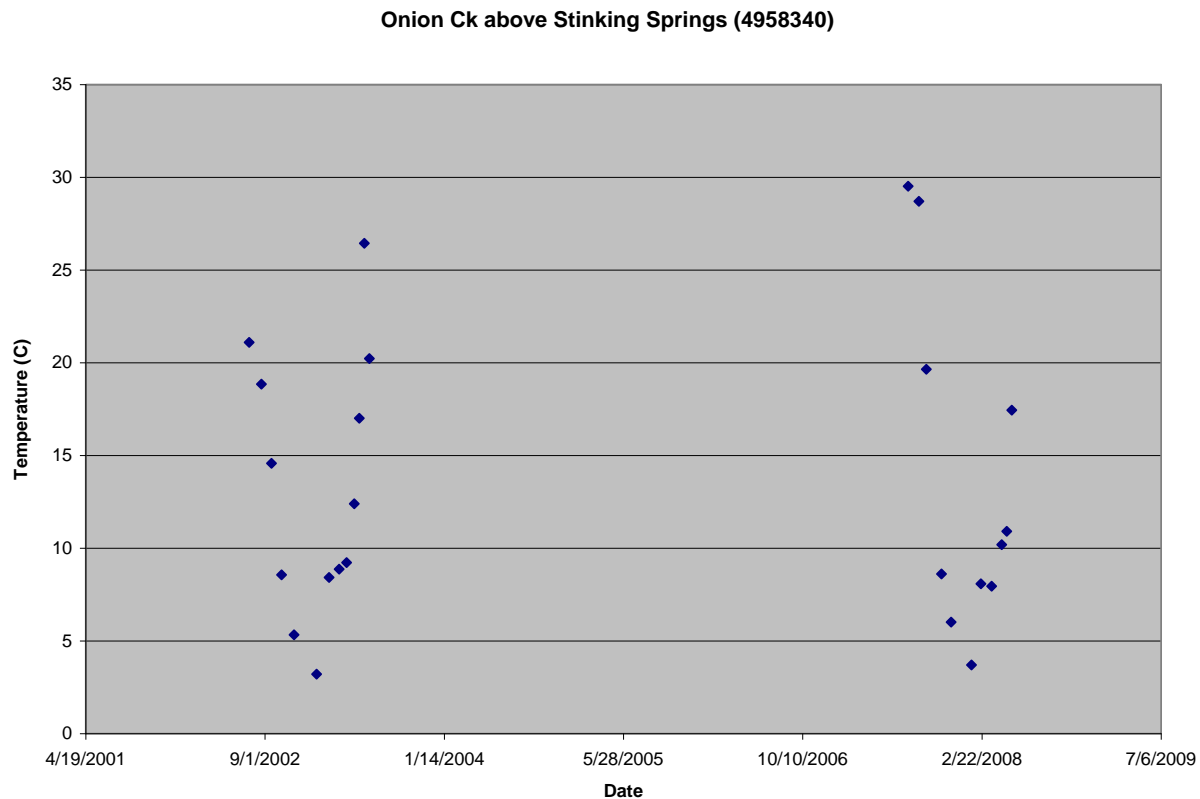
The following charts show the water quality temperature over the period of the TMDL and the implementation. No significant change has occurred to date however many nonpoint source implementation projects require several years to see a change in the water quality monitoring data.

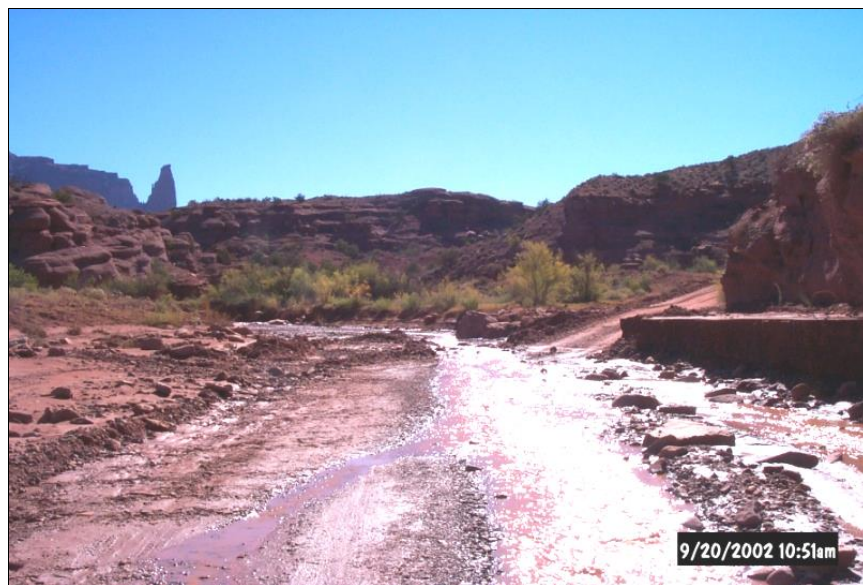
The site farthest downstream is site #1, one of the first sites to be stabilized. The road runs between a low rock wall and the stream channel. Prior to stabilization, this portion of the road washed out every couple of years. To repair the road, material was gathered from the stream channel and floodplain and replaced in the roadbed. This further destabilized the stream channel, continuing the wash outs.

Looking upstream at road wash-out, road on right

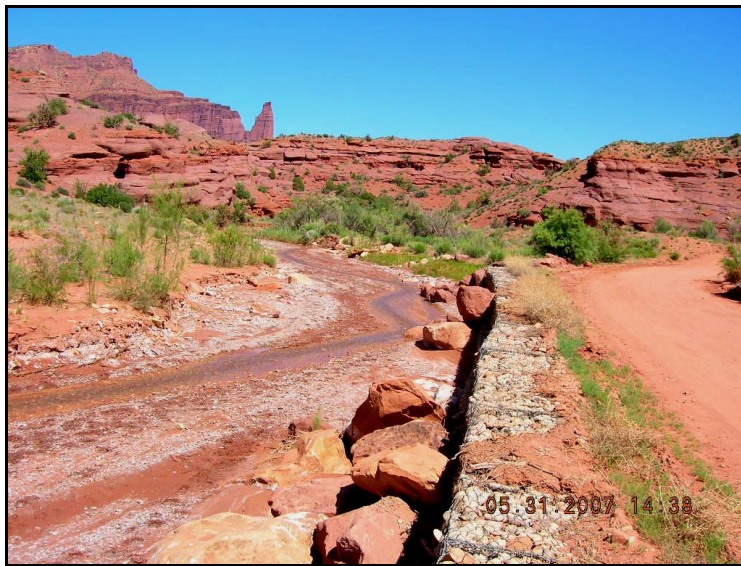
This site was surveyed before stabilization work, while the road was washed out, in 2004. Surveying was done again, shortly after road stabilization was complete, in 2005. Surveying was repeated again in 2007, almost 2 years after road work was done. These surveys are representative of the entire stream segment affected by road washouts at this site.

The stream channel has changed dramatically. The active channel has shifted about 20' to the north, and deepened slightly. The shape of the stream channel has changed from a wider shallow channel (5' wide, 2" deep) to a narrow deeper channel (2' wide, 5" deep). The road has not washed out since stabilization, saving 20,000 cubic feet of sediment from washing downstream every 2 years (on average).

Looking upstream, May 2007

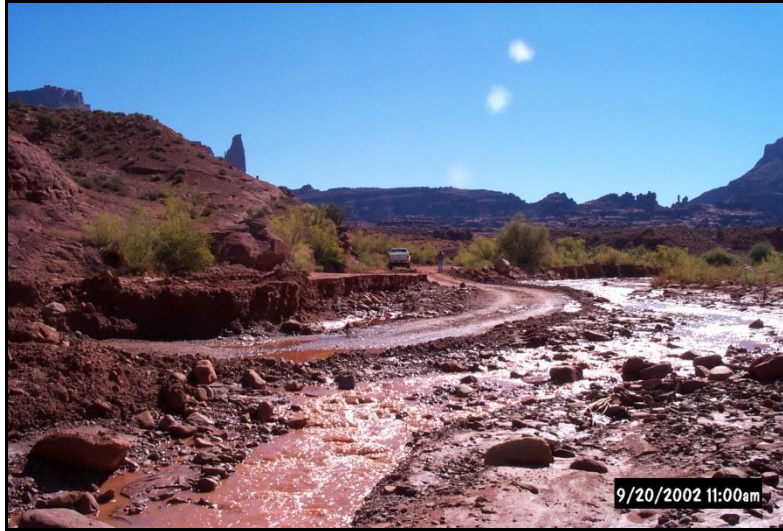
The next site upstream is site #2, one of the first sites to be stabilized. Again, the road runs between a low rock wall and the stream channel. Prior to stabilization, this portion of the road washed out every couple of years. To repair the road, material was gathered from the stream channel and floodplain and replaced in the roadbed. This further destabilized the stream channel, continuing the wash outs.

Looking upstream at site #2 after road wash-out, 2002

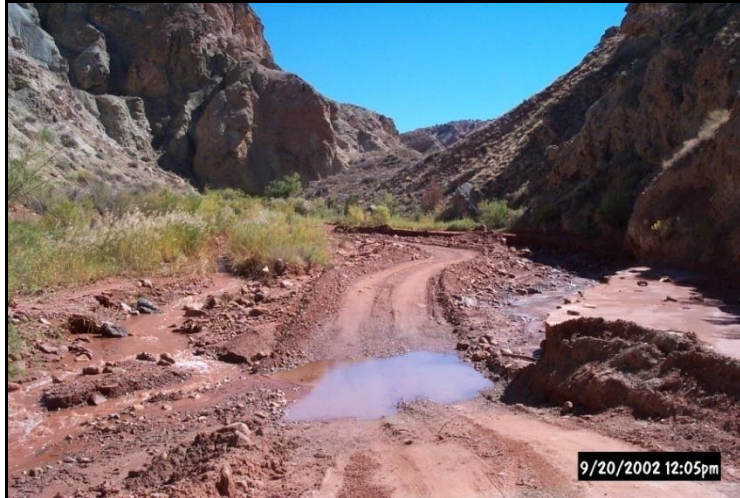
Site #5 is at the Stinking Springs section of Onion Creek. This site was a major problem for years, as the road washed out more frequently than any other site prior to stabilization. The canyon is very narrow here, with no room for natural sinuosity and the road.

Looking upstream, road was on right before flooding
