CLEAN WATER ACT SECTION 319
NONPOINT SOURCE POLLUTION CONTROL PROGRAM
WATERSHED OR DEMONSTRATION PROJECT FINAL
REPORT

PARIA RIVER RESTORATION PROJECT

CANYONLANDS CONSERVATION DISTRICT

OCTOBER 23, 2009

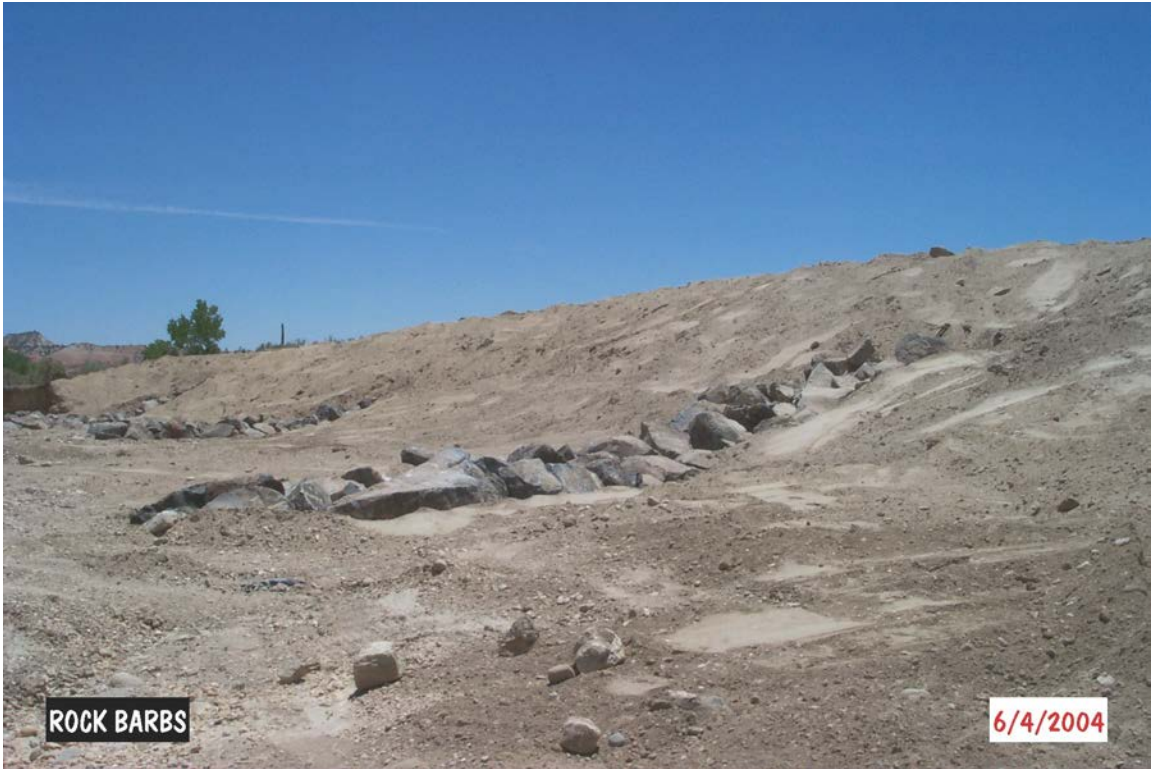
View of rock barbs and sloping on Paria River Restoration Demonstration Project, looking south from Highway 12 at Cannonville Bridge. (June 2004)

The BMPs were successful at meeting their intended purpose. Although this was not demonstrated through water quality sampling, it is apparent with a site visit and with pre and post project photo points. The channel has not moved significantly since 2002 and the town well site has remained intact. The rock barbs have trapped a large amount of sediment and vegetation has naturally filled in the area. (See photos in Section 9 for the before and after conditions.)

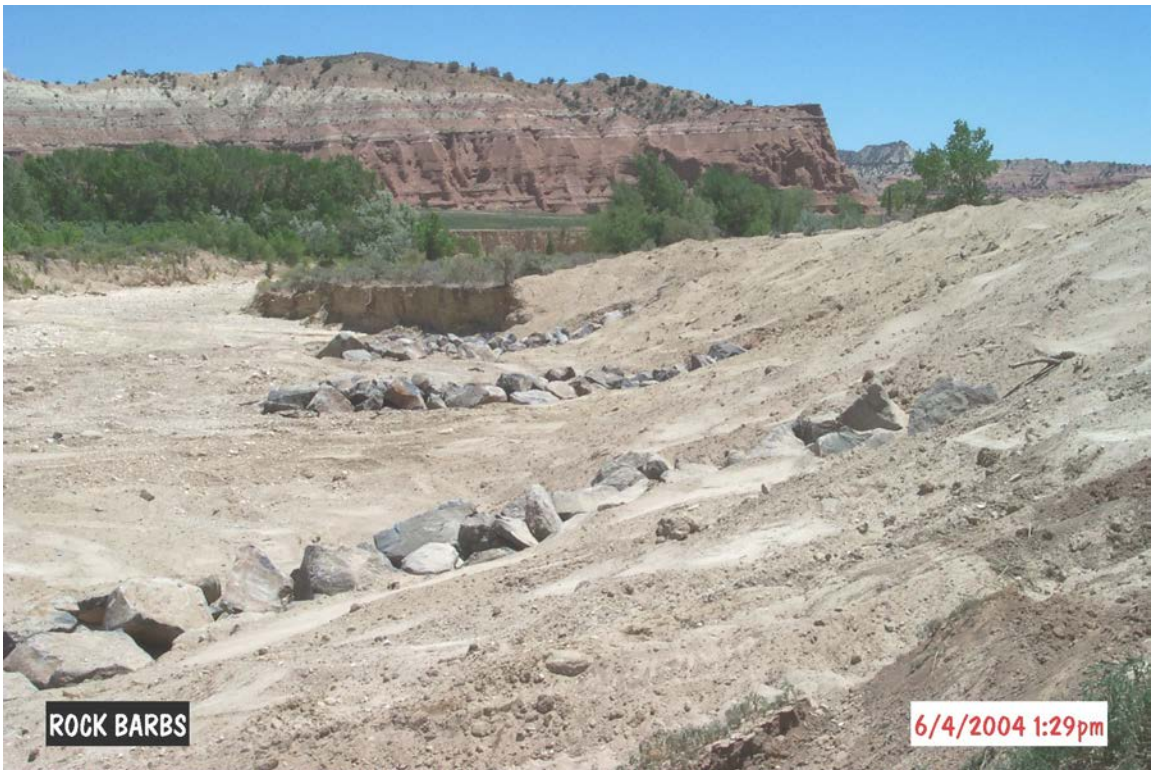
Additional view of sloping and rock barbs on Paria River Restoration Demonstration Project (June 2004)

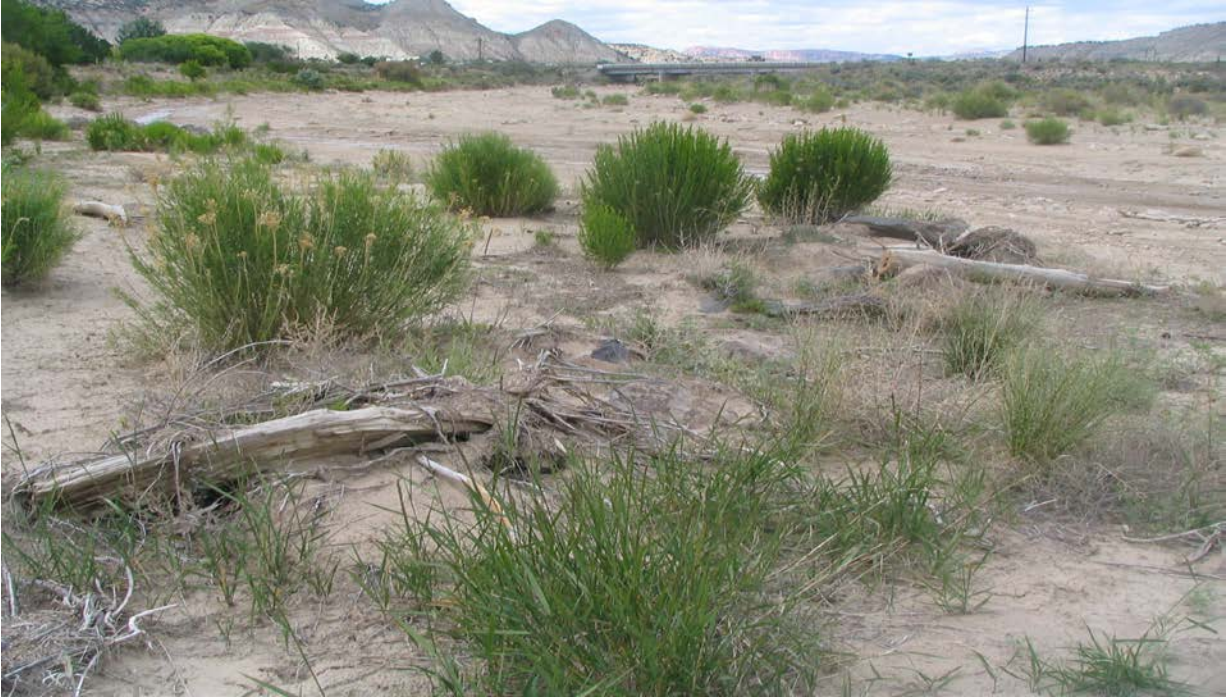
View of rock barbs on Paria River Restoration Demonstration Project, looking north toward Highway 12 at Cannonville Bridge. (June 2009)

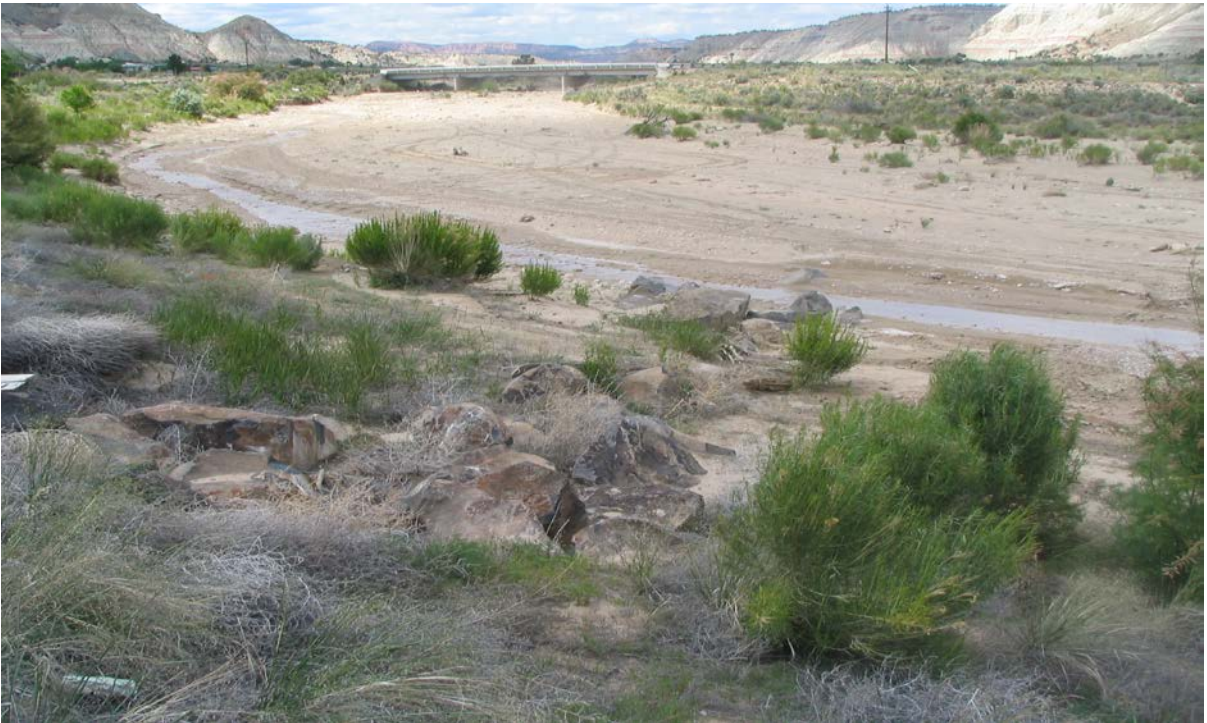
Additional view of rock barbs and sloping on Paria River Restoration Demonstration Project, looking north toward Highway 12 at Cannonville Bridge. (June 2009)
