Section 319 Nonpoint Source Pollution Control Program Watershed Final Report

**Matt Warner and Calder Reservoirs & Pot Creek Water Quality
Improvement Projects FY-08 & 10**

Evan Guymon, Duchesne County Conservation District

December 3, 2013

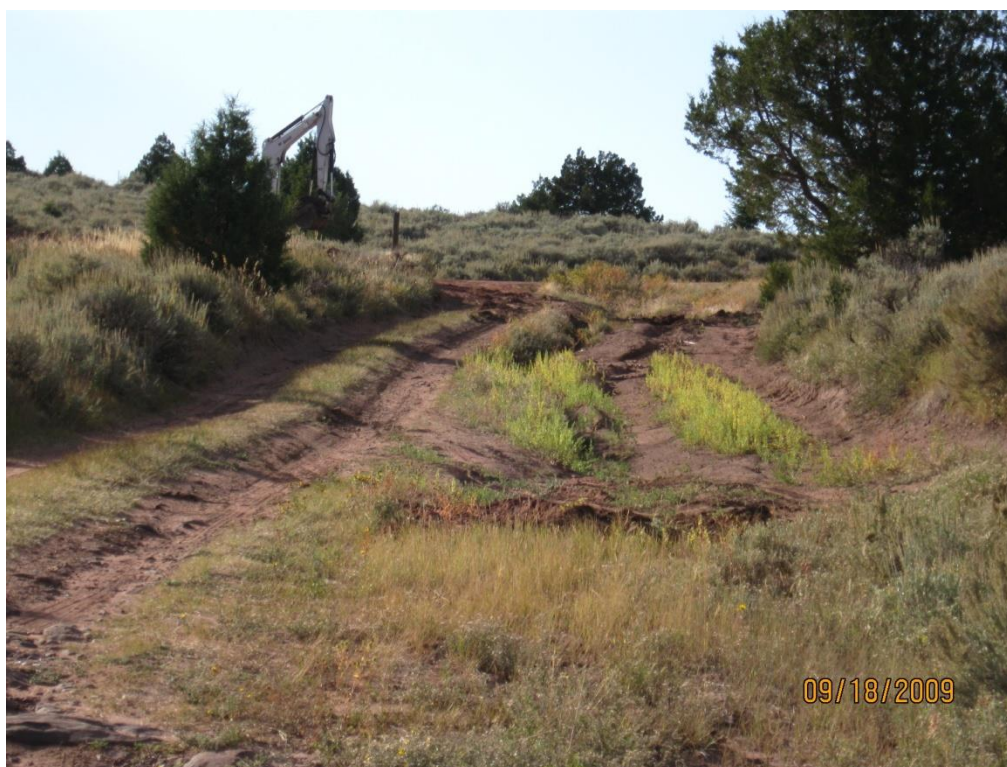
Figure 4. Rill on West Side of Calder Reservoir before restoration work.

- Repaired a 200 yard long rill complex on a 7% grade going into Calder itself.
- Used fill material from sediment basins to resloped gravel parking lot.
- Blocked vehicle access by bouldering ¼ mile of road. Planted rill with native grasses, forbs and wildflowers.
- Capture sediment at the bottom of the rill via straw bales and filter fabric. They will be left in place until vegetation cover has stabilized at 80%.

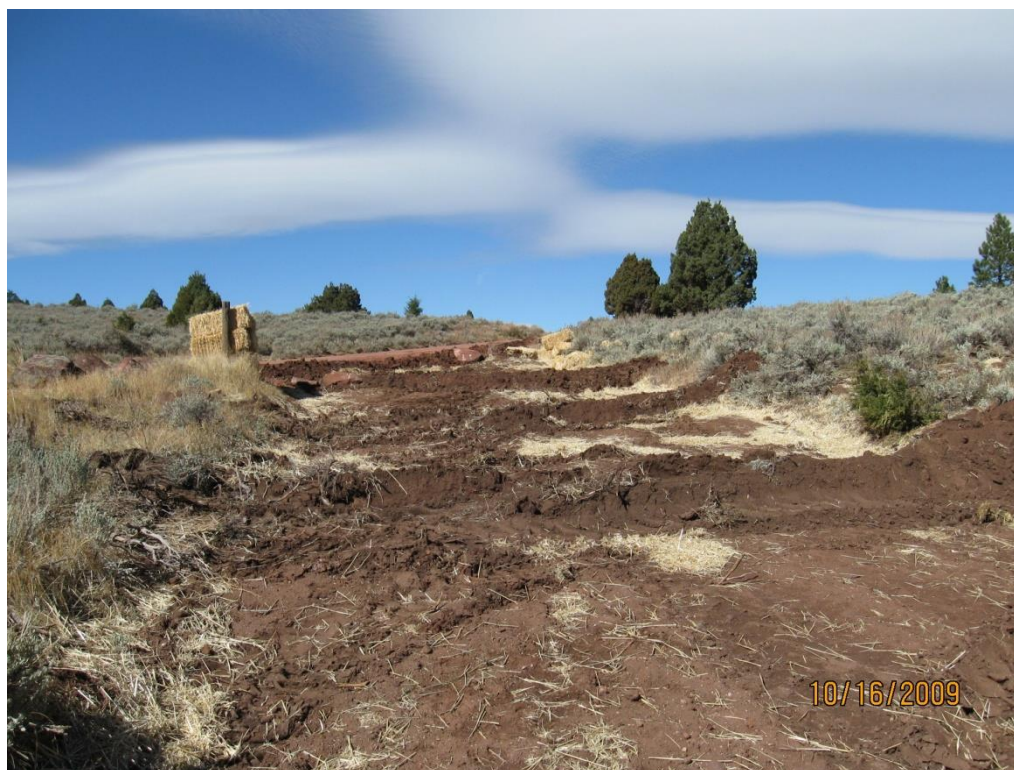
Figure 5. Rill on West Side of Calder Reservoir during restoration work.

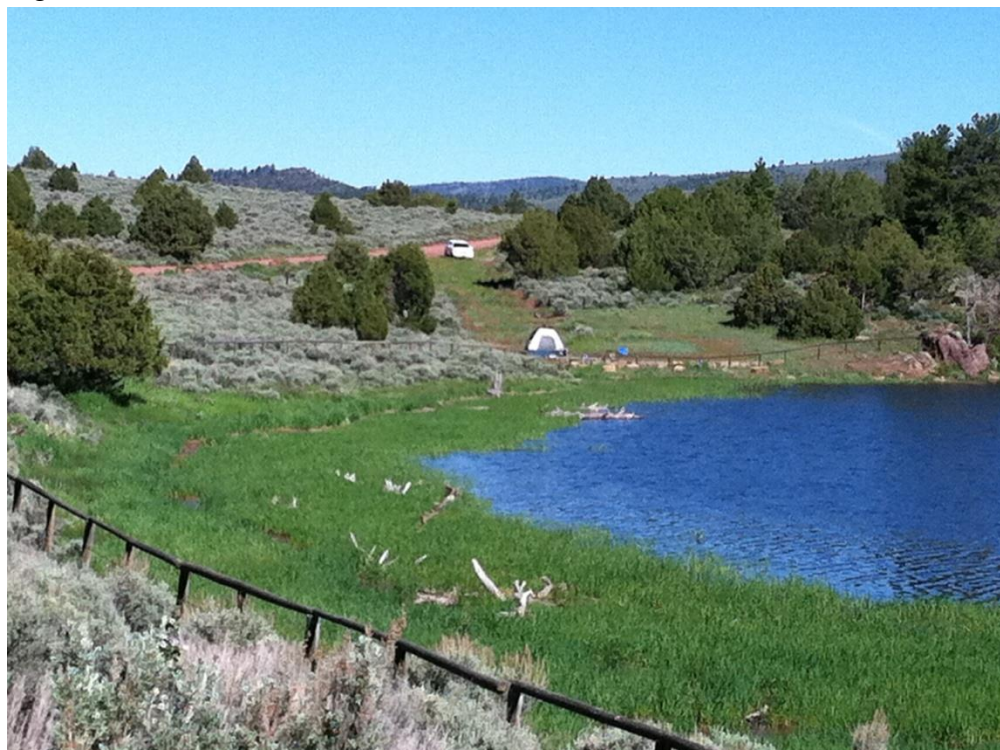
Figure 6. Rill on West Side of Calder Reservoir after restoration work.

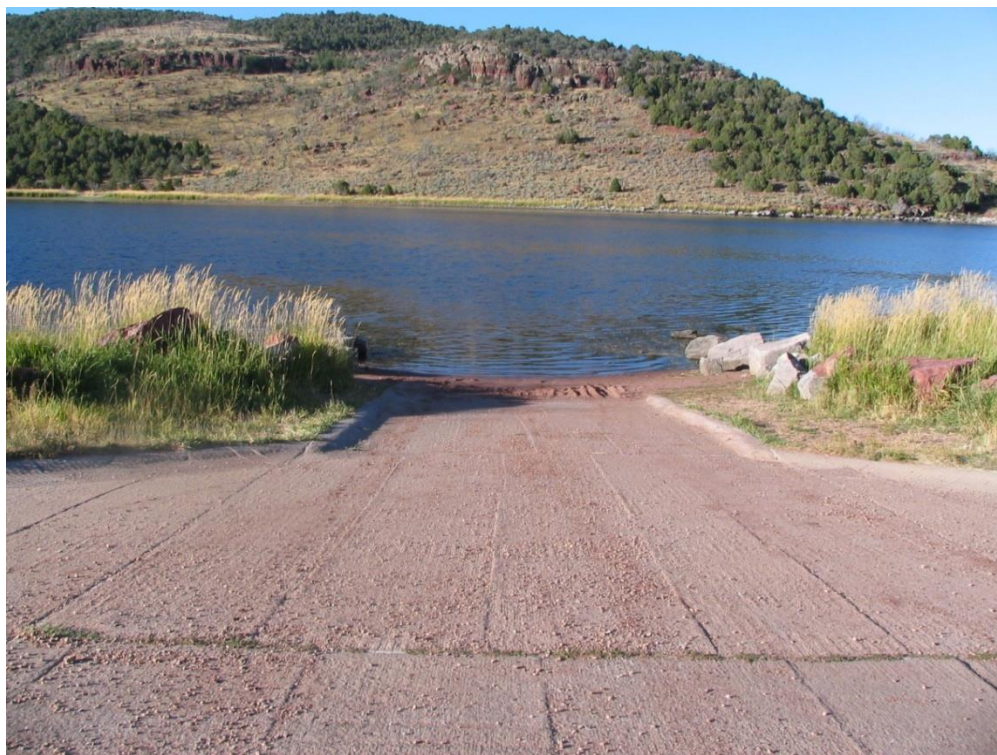
Figure 8. Boat Ramp at Calder Reservoir Before Project.

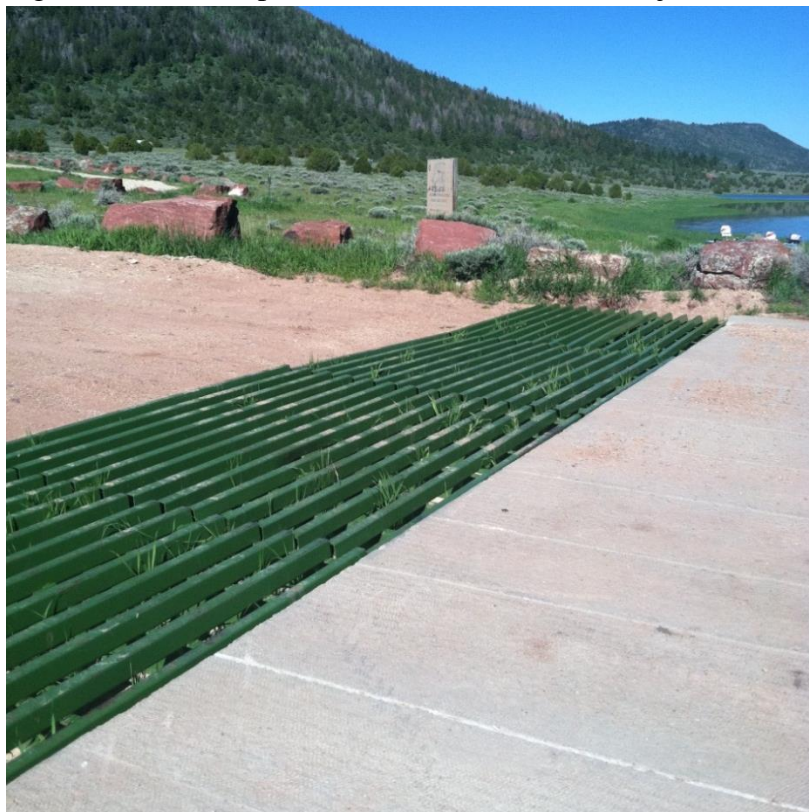
Figure 9. Boat Ramp at Calder Reservoir After Project.

Output: The boat ramp parking area was graveled and leveled. Three cattle guards were installed at the top of the boat ramp. Uintah County DOT is charged with maintaining project.

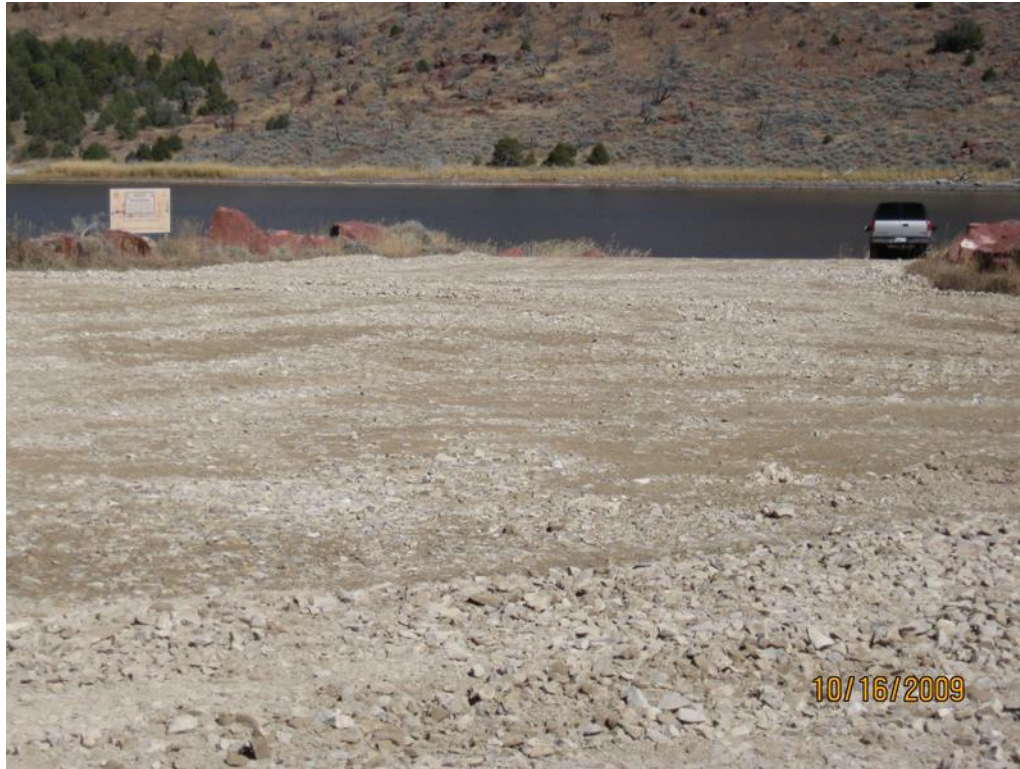
Figure 10. Parking Lot at Calder Reservoir After Project.

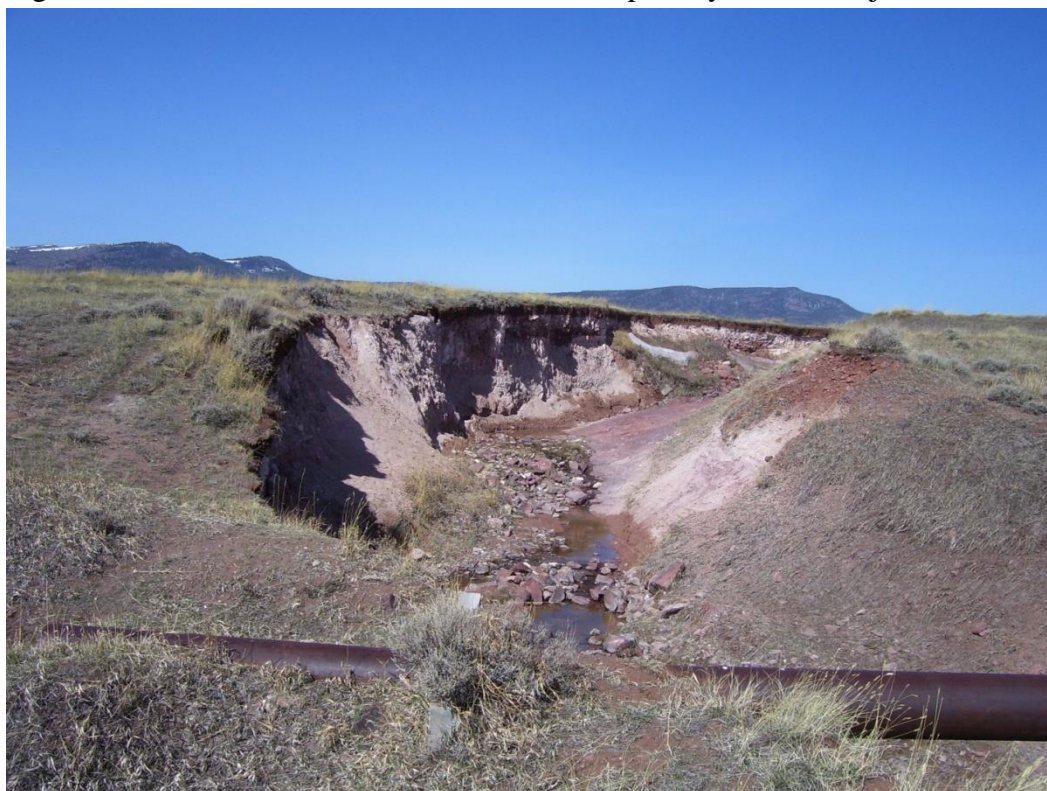
Figure 12. Cutbanks at Matt Warner Reservoir Spillway Before Project.

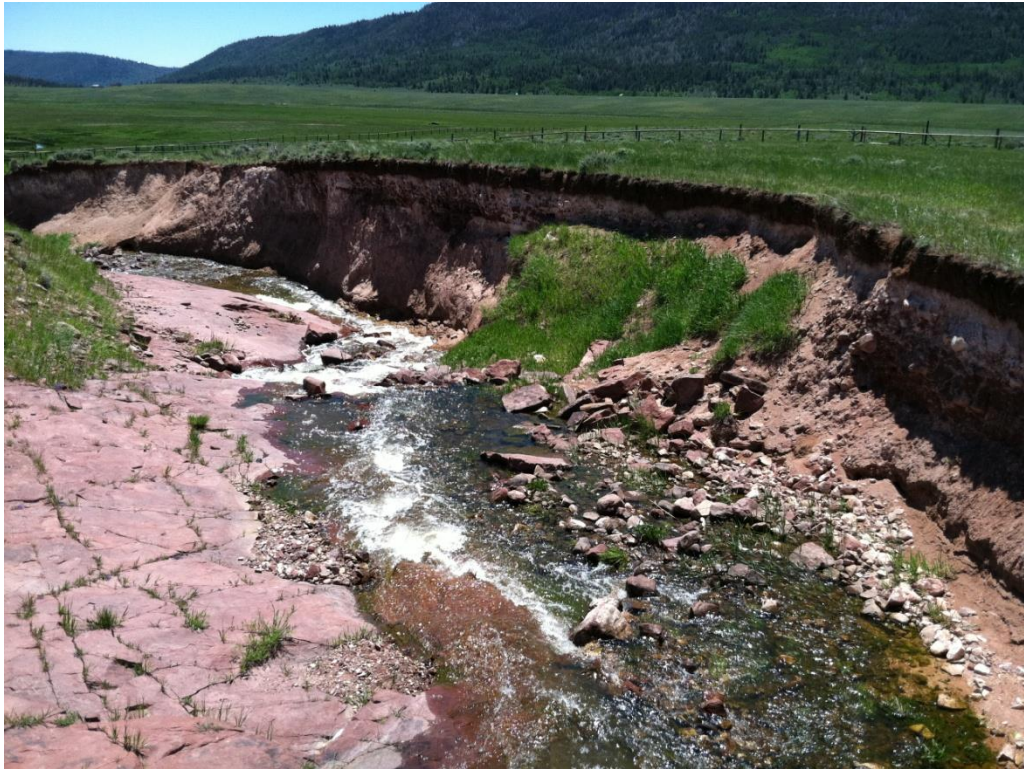
Figure 13. Matt Warner Reservoir Spillway Before Project.

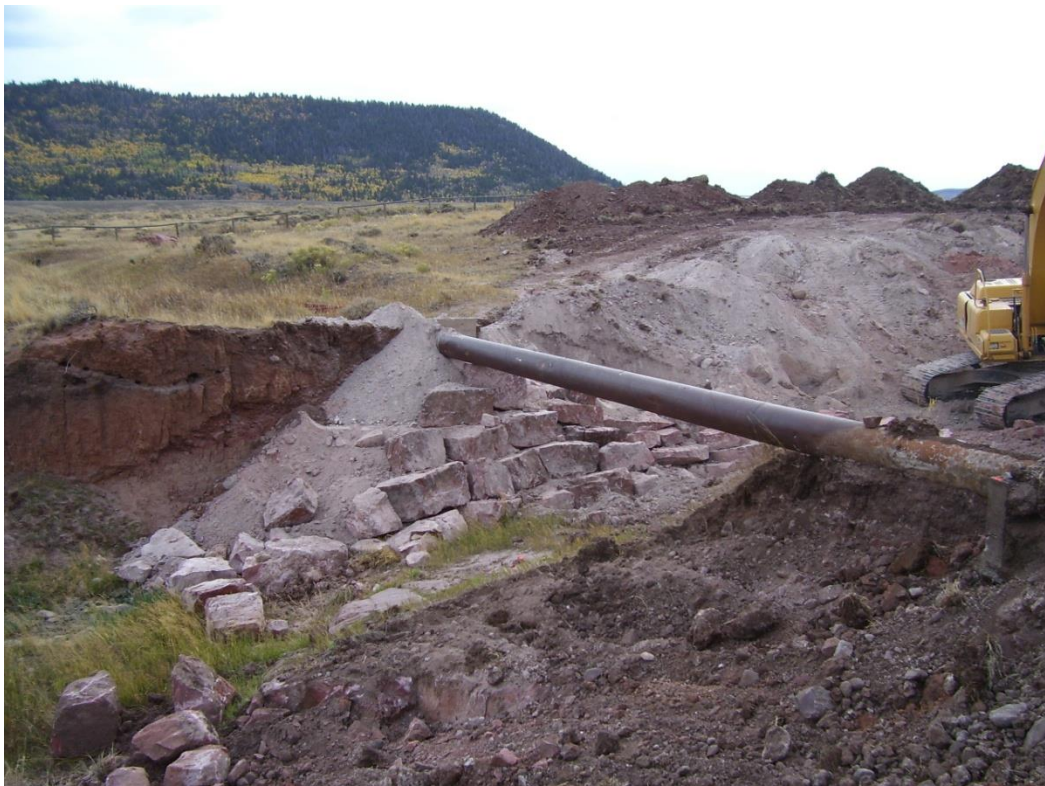
Figure 14. Matt Warner Reservoir Spillway During Project Work.

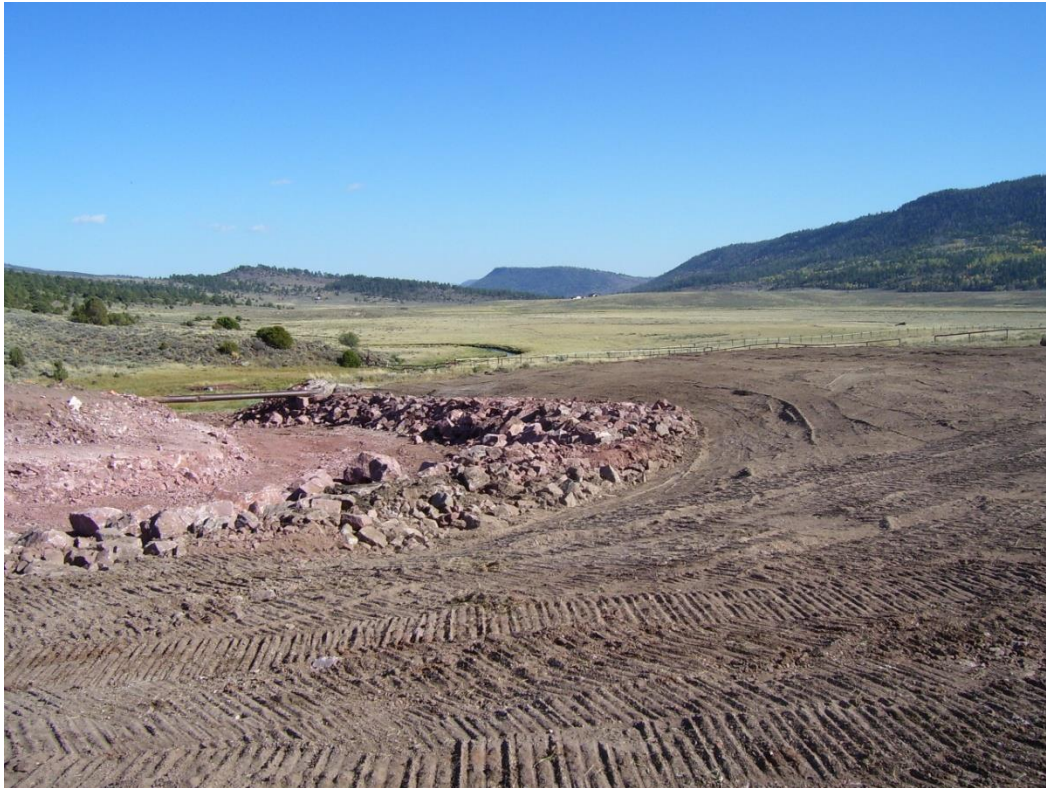
Figure 15. Matt Warner Spillway After Project Work.

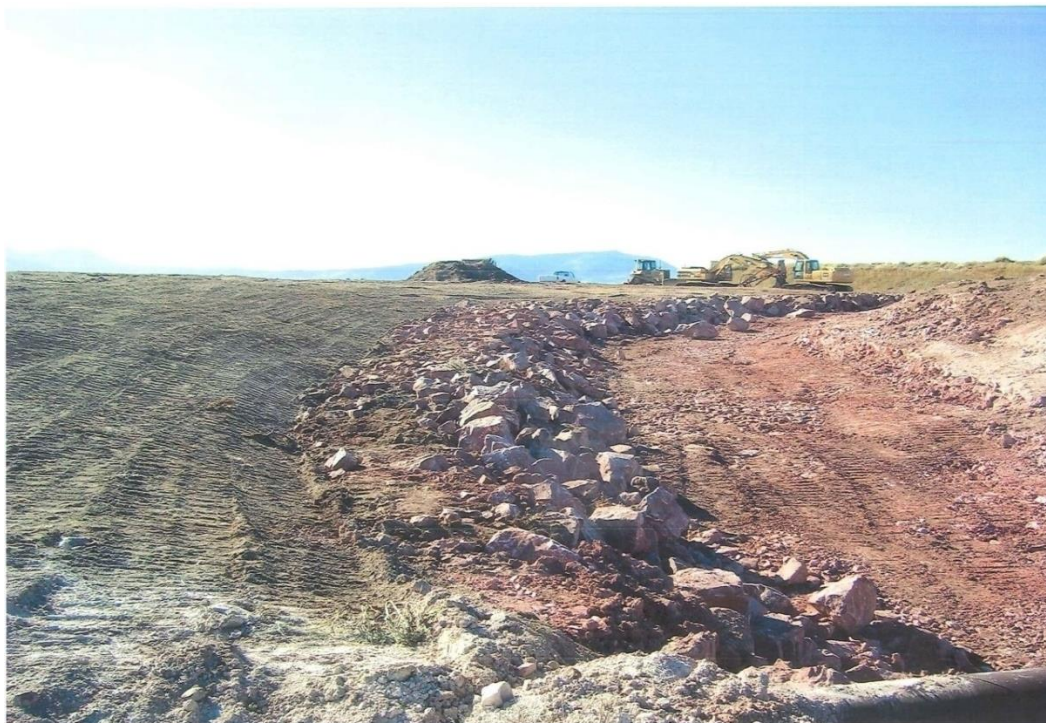
Figure 16. Matt Warner Spillway After Project.

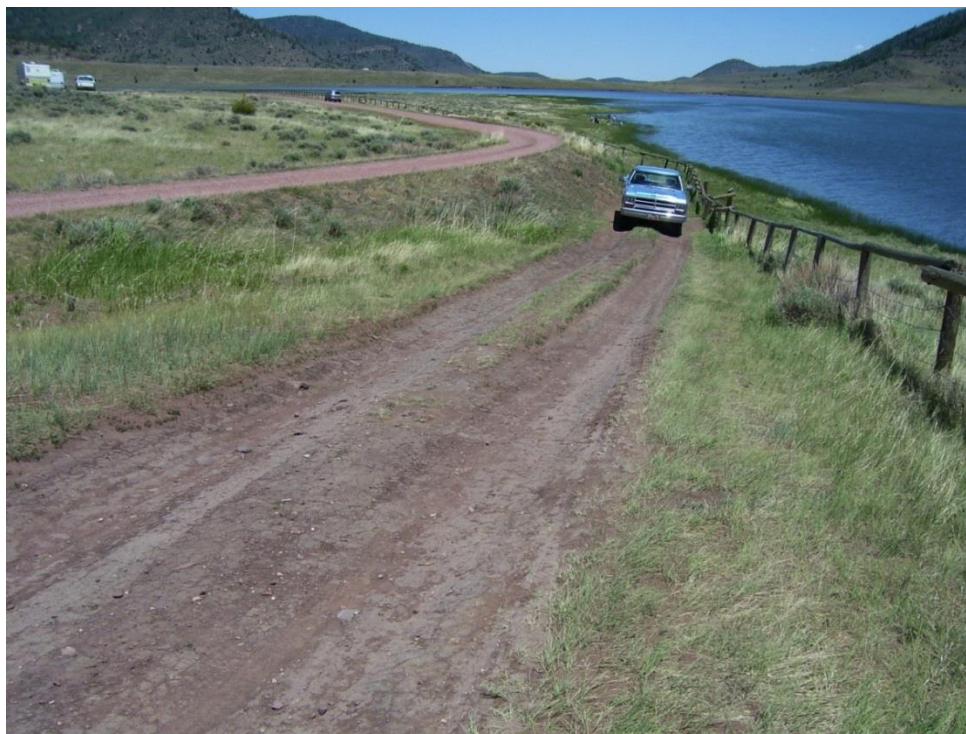
Figure 18. Before vehicle access blocked and detention pond constructed.

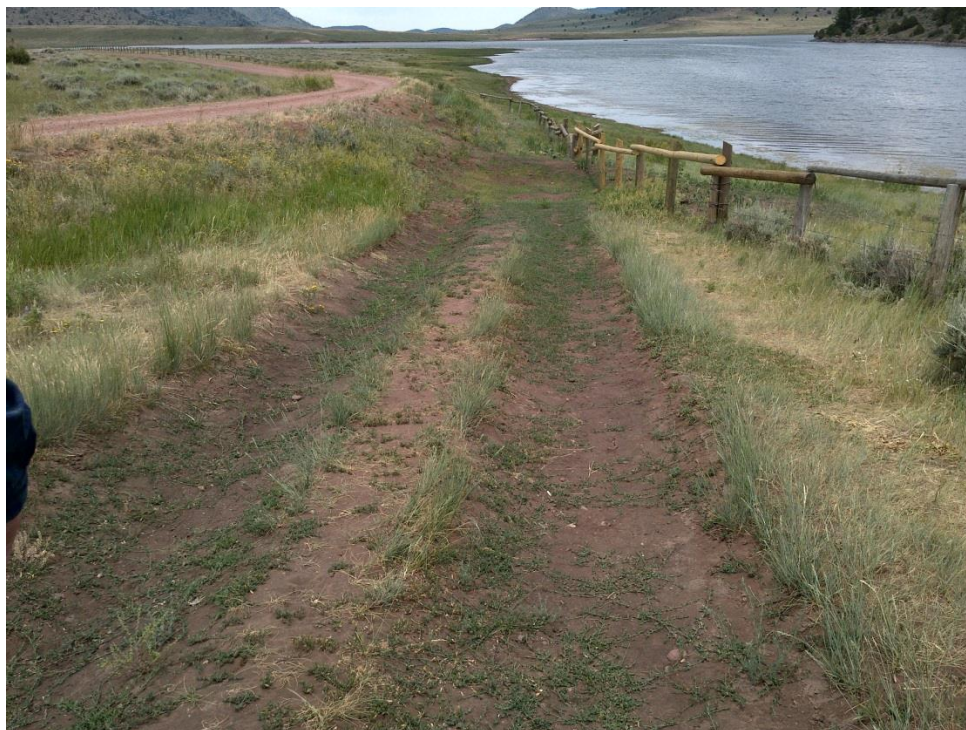
Figure 19. After vehicle access blocked and detention pond constructed.

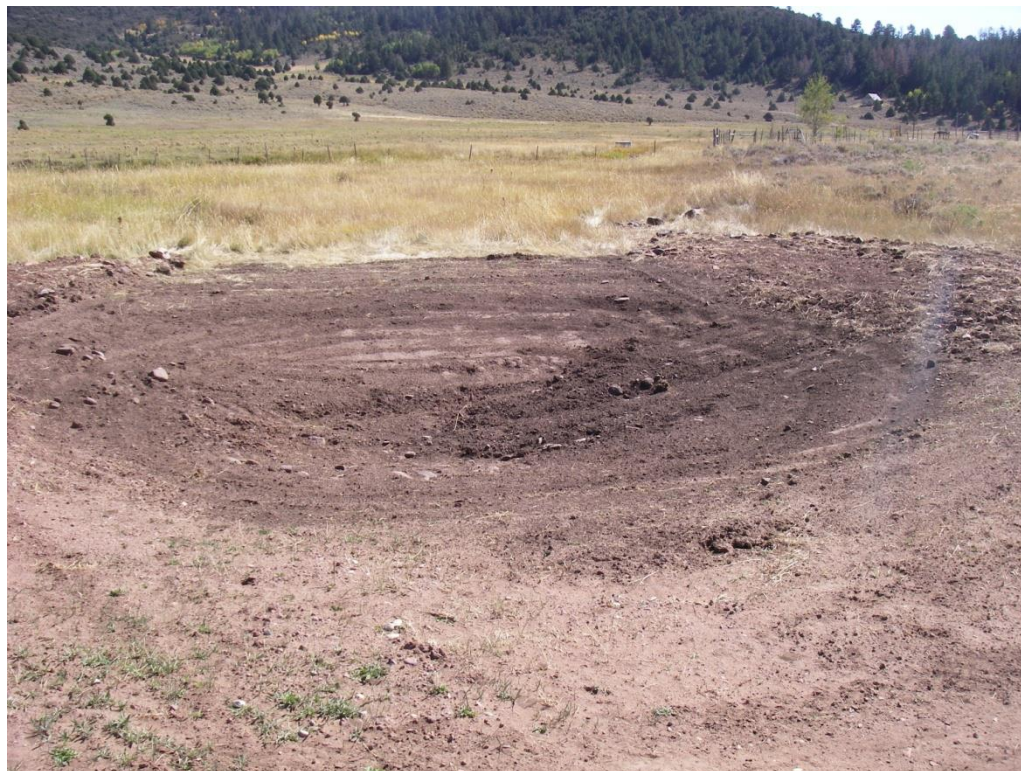
Figure 20. Example of Detention Pond Created Above Calder Reservoir (2010 Grant Project).

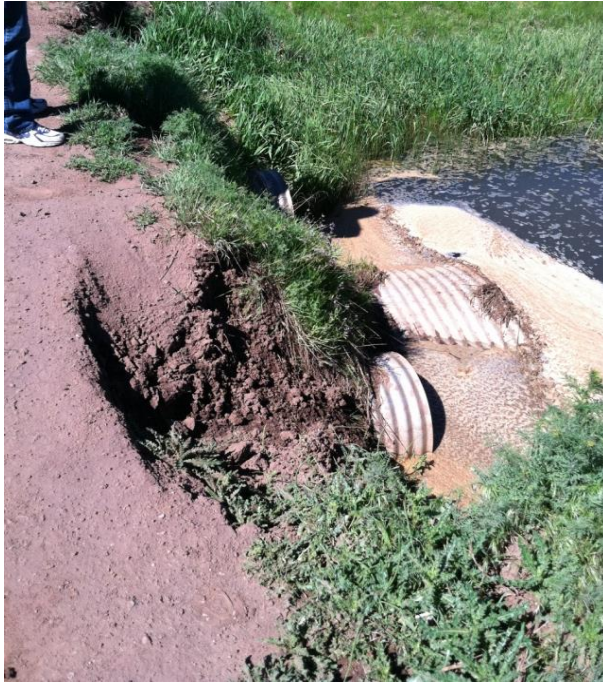
Figure 23. Warren Draw Road Crossing of Pot Creek Before Project.

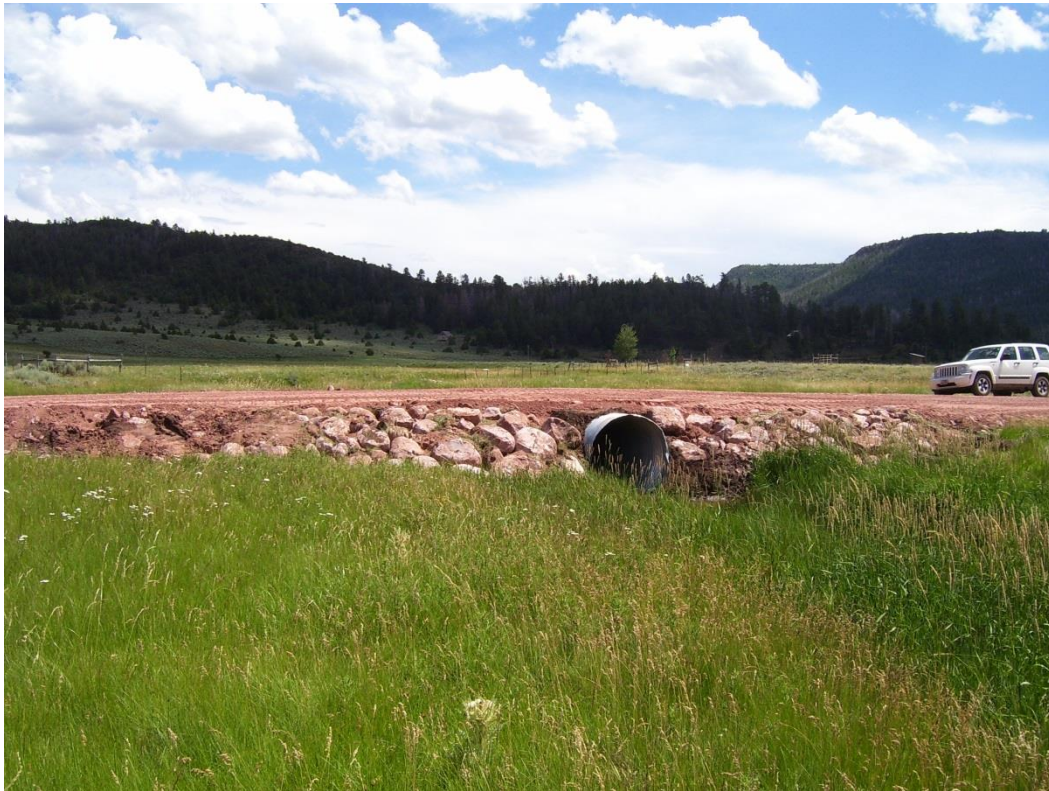
Figure 24. Warren Draw Crossing After Project Work.

- Coordinated with Uintah County DOT to insure the county has secured permission from the Corp of Engineers to install the new culvert
- Replaced exiting culverts with one 60" aluminum culvert
- Armored the banks of both sides of the crossing with rip rap
- Raised the roadbed over the culvert approximately 8" with the high point directly over the culvert.
- Installed several sediment detention ponds on each side of the road crossing
- Graveled road for 150 feet of crossing in both directions

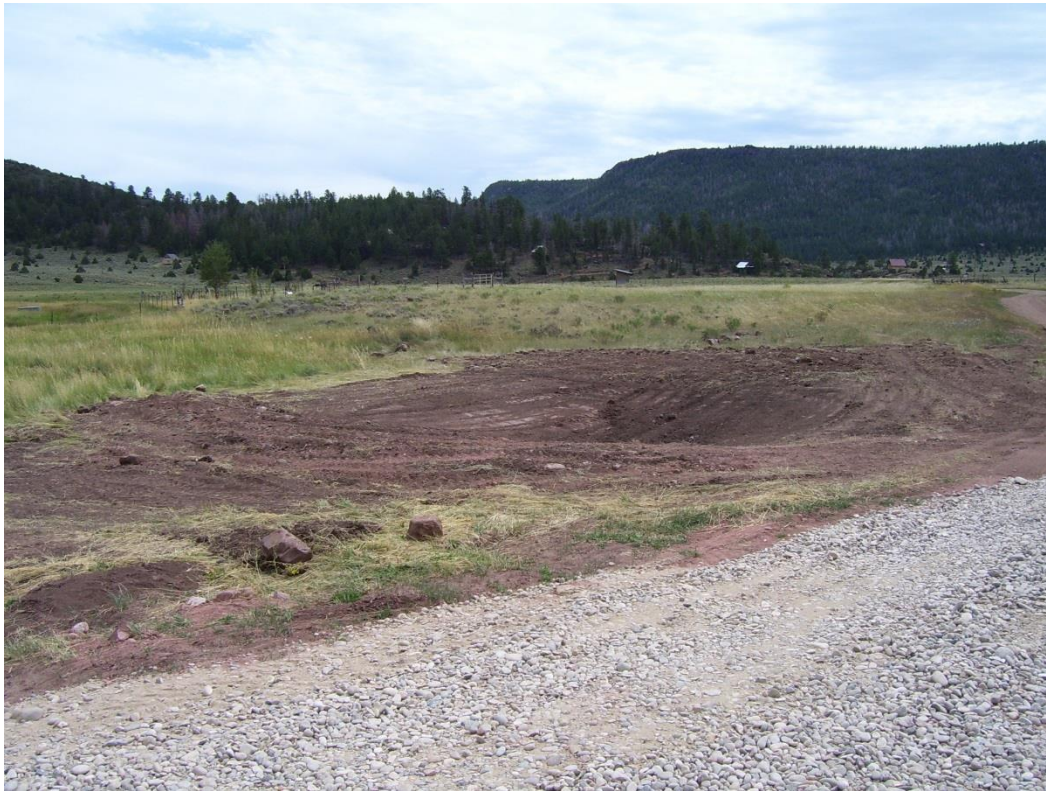
Figure 25. Detention Pond Created Along Warren Draw Crossing.

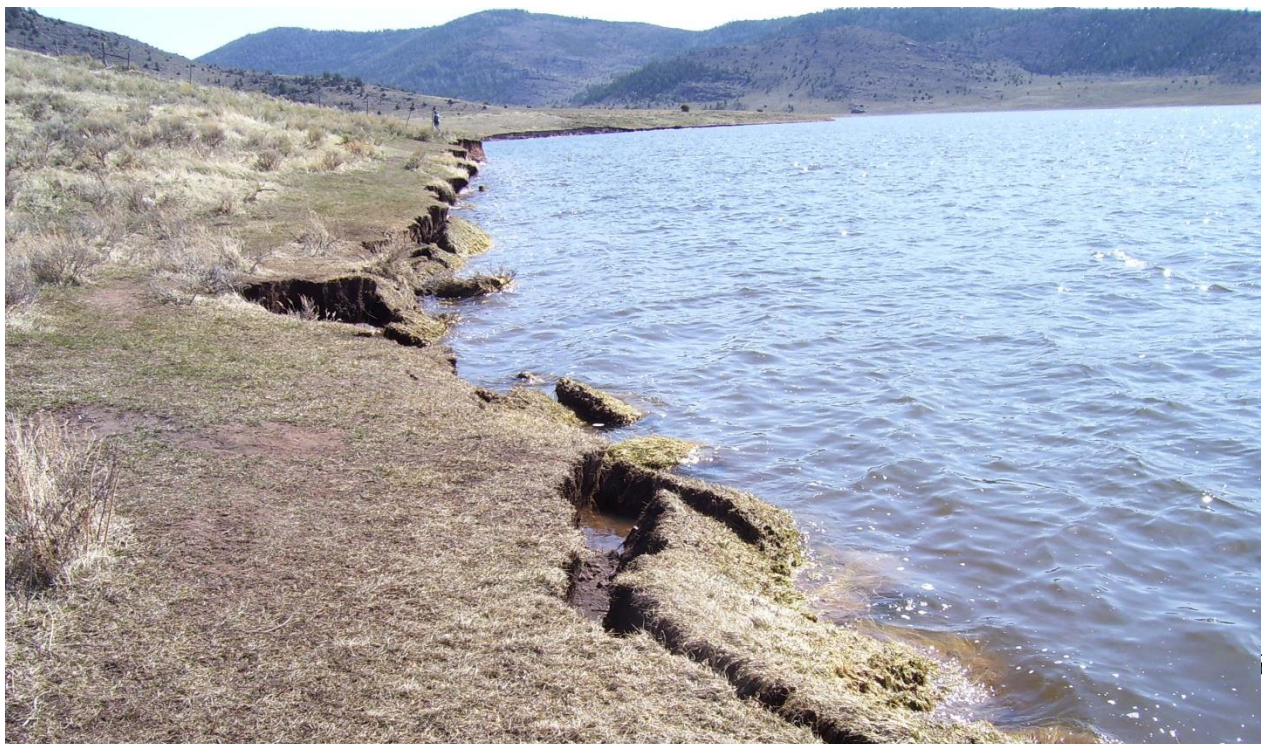
Goal 2: Repair 600 feet of bank damage along the north shoreline of Matt Warner Reservoir (Figures 25-27) caused by wave action from the prevailing southwest wind.

Figure 27. Eroded bank along Matt Warner Reservoir.

- Reshaped eroded bank to 2:1 slope
- Stabilized soil with riprap
- Seeded with native species

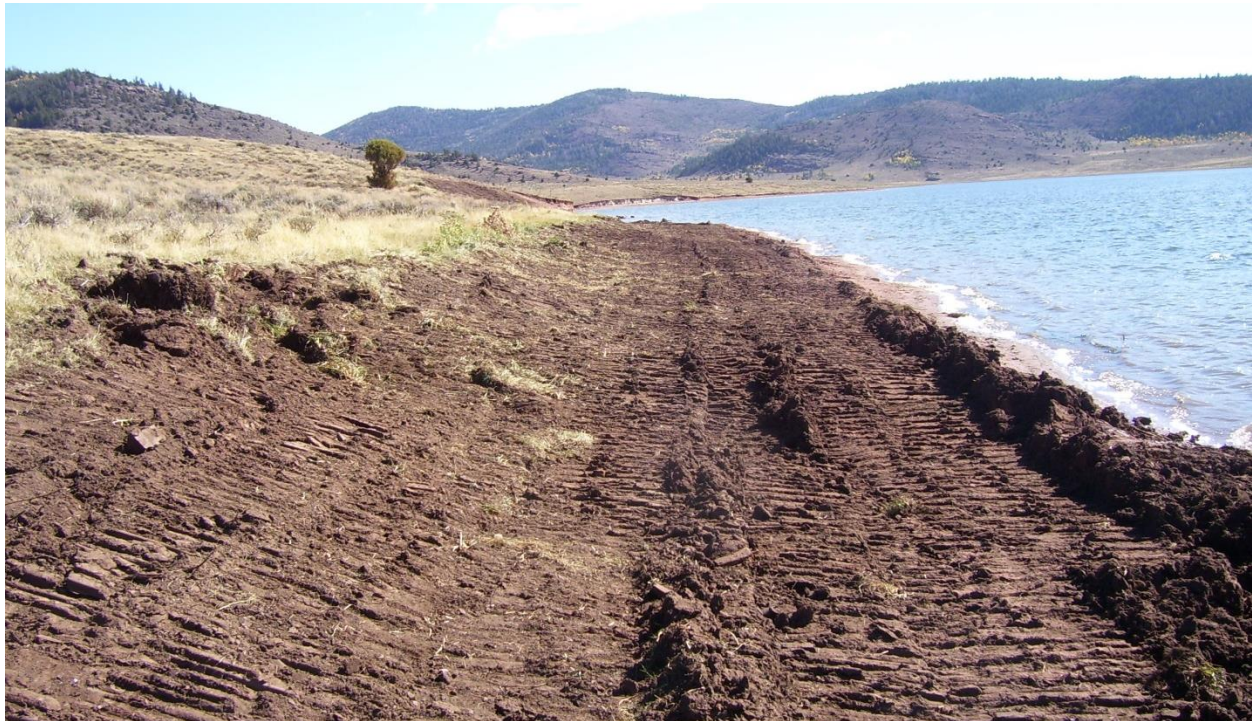
Figure 28. Bank along Matt Warner Reservoir after project.

Output: 600 feet of the bank were reshaped and additional BMPs were installed and 1 acre reseeded.

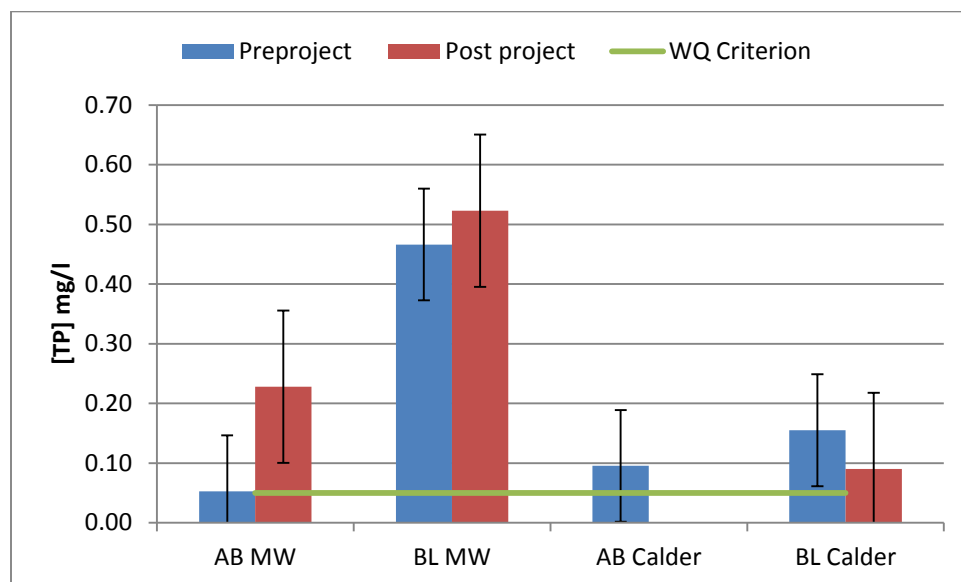
When comparing TP concentration before and after project completion, there was a 0.07 mg/L decrease at the compliance point (Pot Ck below Calder). Note that the after project data was based on one sample taken recently after a precipitation event. More samples are being taken at all four locations to appropriately determine the reduction in TP after project implementation. Figure 1 and Table 2 shows the TP concentration before and after the project. Pot Creek above Calder Reservoir was dry during the post project sampling event thus no data was collected.

Figure 29. Total Phosphorus Concentration (mg/L) in the Pot Creek Watershed Before and After Project Work.
