SECTION 319 NONPOINT SOURCE POLLUTION CONTROL PROGRAM
PROJECT/INFORMATION AND EDUCATION
FINAL REPORT

Scofield Reservoir Project Implementation Plan FY 2004, 2005 and 2006

Price River Conservation District

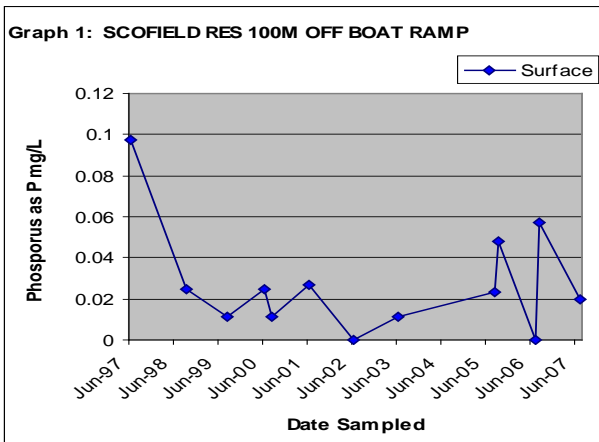
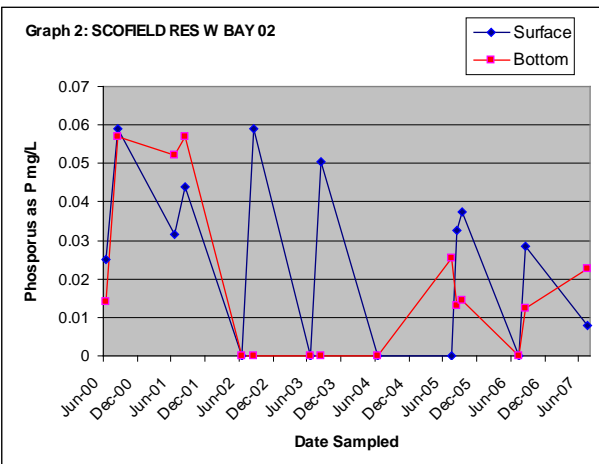
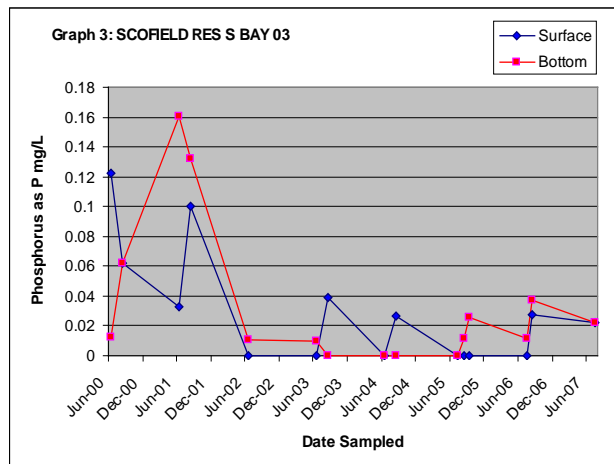
The following graphs (1, 2 and 3) were formulated from the Storet sampling sites included

in the QAPP (593097, 593098, and 593099 respectively). Water Quality samples were collected as subsurface grab samples. Data has been tallied and averaged according to site and date of sampling. In all graphs, recorded phosphorus loads that were lower than .02 mg/l were reported as non detected and for the purpose of these graphical displays have been listed as zero, although a null statistic is unlikely. Due to lower water levels the sample site for the information presented in graph 1 is a surface sample only and did not include a lake bottom sample.

The overall trends show a slight decline in phosphorus over the space of the project, with the highest reported phosphorus decrease in graph 3 of 0.14 mg/l from 2001 to 2007. Although graph 2 depicts a rise in phosphorus toward the end of 2007, the overall phosphorus trend at the sampling site is decreasing. The combined efforts of increasing public awareness and implementation of a grazing improvement plan along the Spur Bay region of the Reservoir may have been a part in the realization of lower phosphorous levels.

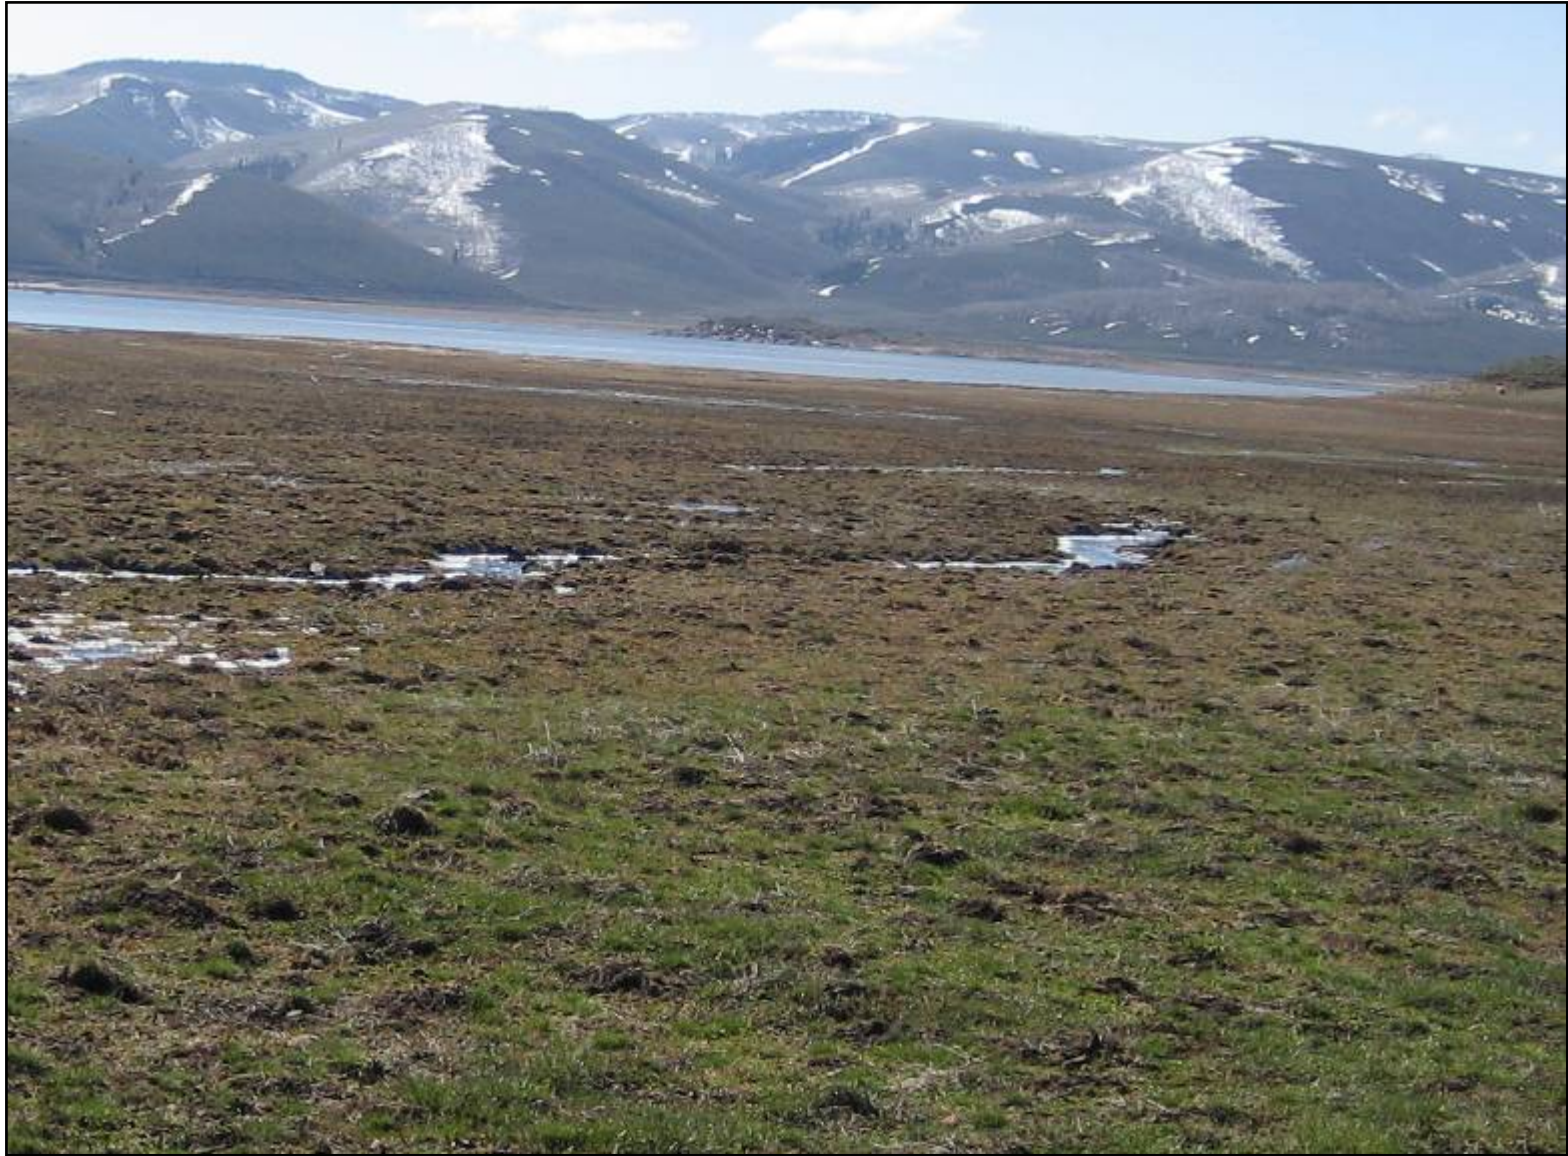
Figure 3: Scofield, Spur Bay before grazing management.

Task 1: Identify and select project cooperators and develop grazing management plans using BMP's. **UPDATE:** Landowners have been identified and mapped. Heavy grazing by cattle in the Spur Bay region of Scofield Reservoir was identified as a cause of nutrient loading and erosion.

Task 2: Implement grazing management plans. **UPDATE:** In cooperation with the local property owner, local rancher and the Watershed Coordinator from the Provo NRCS office, a grazing plan was developed. It was agreed that the cows will be in the area for 2 weeks in the early summer then moved out until another 2 week grazing period in October after the cows are rounded up to come off the mountain. The rancher was very willing to help make improvements at Spur Bay, but still wanted to graze in the area. With this plan, the grass will be able to maintain healthy growth and seed distribution. In just a few months the Spur Bay area had regained vigor. (See Figures 3 and 4) The effects of erosion and nutrient loading had been reduced. Further results will be observed as time progresses. (See Figure 18 for UAFRR estimates of load reductions)

Heavy grazing in the Spur bay region led to higher erosion rates along the banks of Scofield reservoir along with nutrient loading from animal waste. After the implementation of a grazing management plan, grasses have returned to Spur Bay enabling a decrease in erosion and nutrient loading. Although, the Utah Animal Feedlot Runoff Risk Index (See Figure 11) was created for animal feeding operations, a load reduction on a range project basis can be estimated. When Scofield water levels increase nearly 15% of the Spur bay region can be submerged. By limiting upwards of 350 animals that use the bay for grazing, down to 2 weeks in the spring and 2 weeks in the fall; there is an estimated reduction from 3,288 to 548 lbs of loading available nitrogen (2,750 lbs N/year), a reduction from 1,603 to 267 lbs of loading available phosphorus (1,336 lbs P/year) and a reduction from 11,955 to 1,993 lbs of loading available BOD₅ (9,962 lbs BOD₅/year). With the rancher using a grazing management plan, there is a calculated, 83% decrease, in all three nutrients.

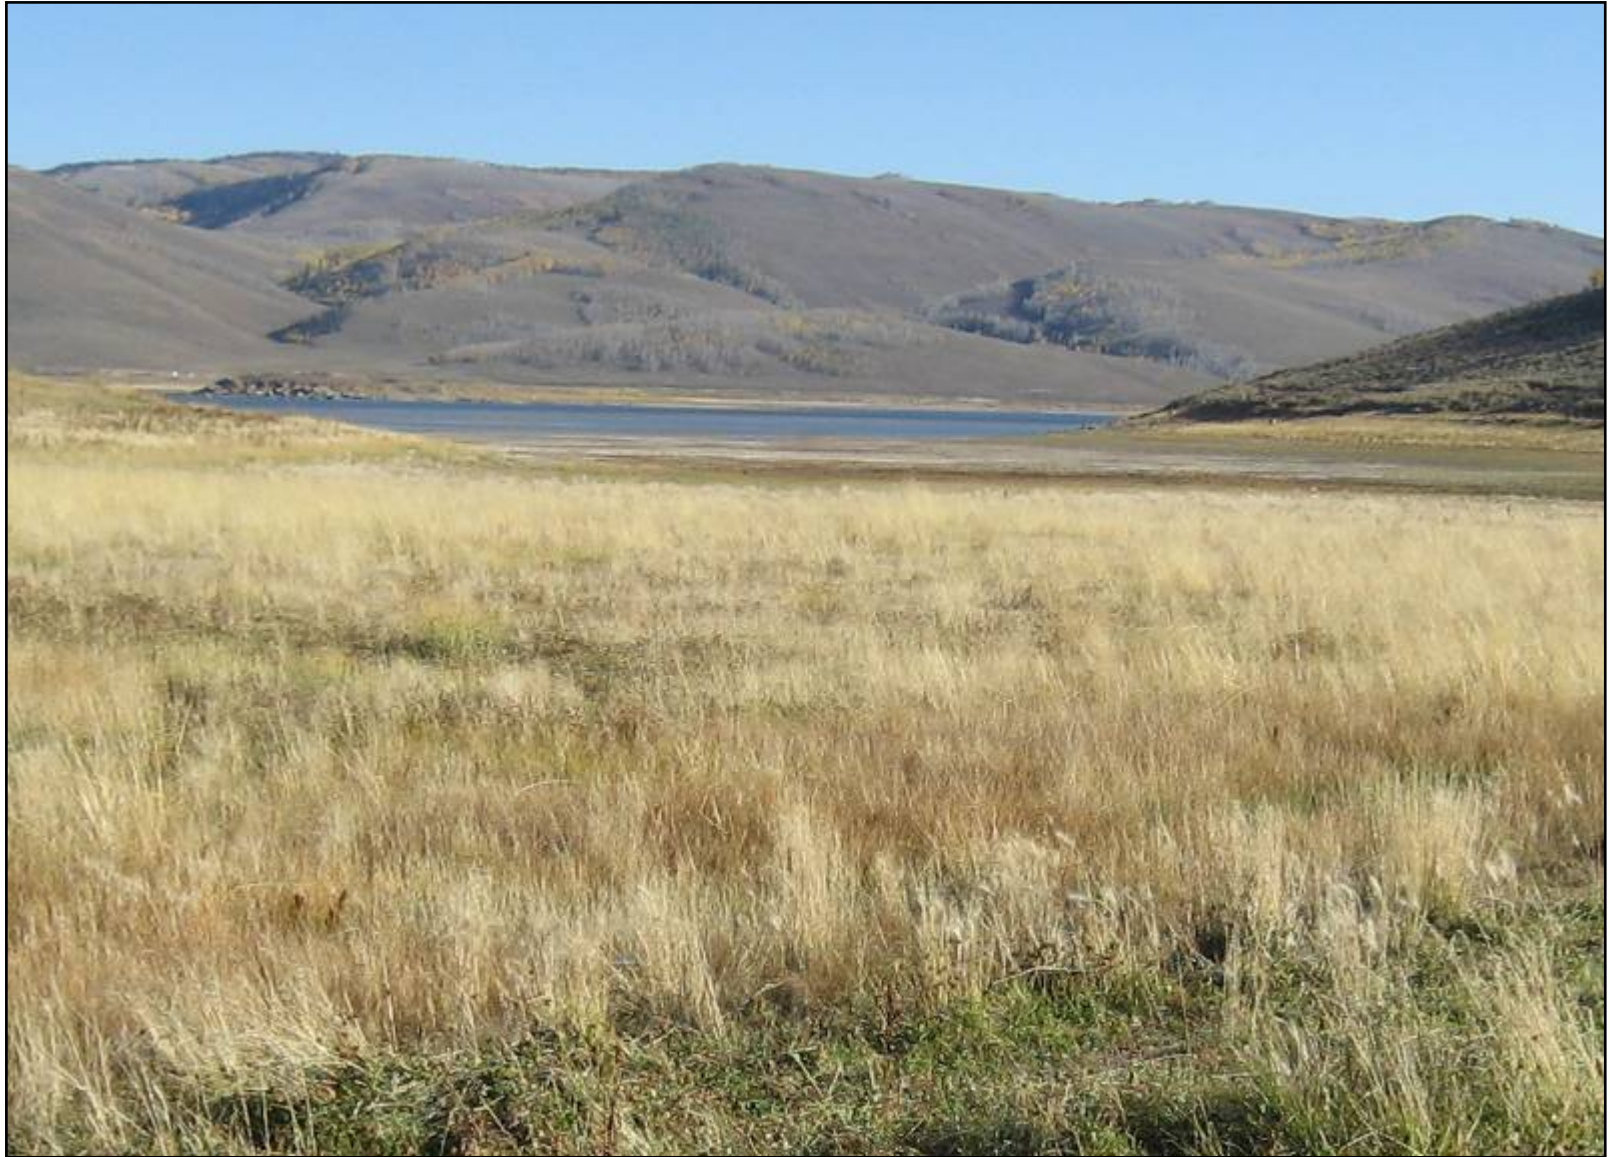
Figure 4: Scofield, Spur Bay after grazing management.

The Grazing Management plan in the Spur Bay area significantly increased the lakeside grasses, reducing raw shorelines and undercutting. The potential for phosphorus reduction is still in the process of being realized.

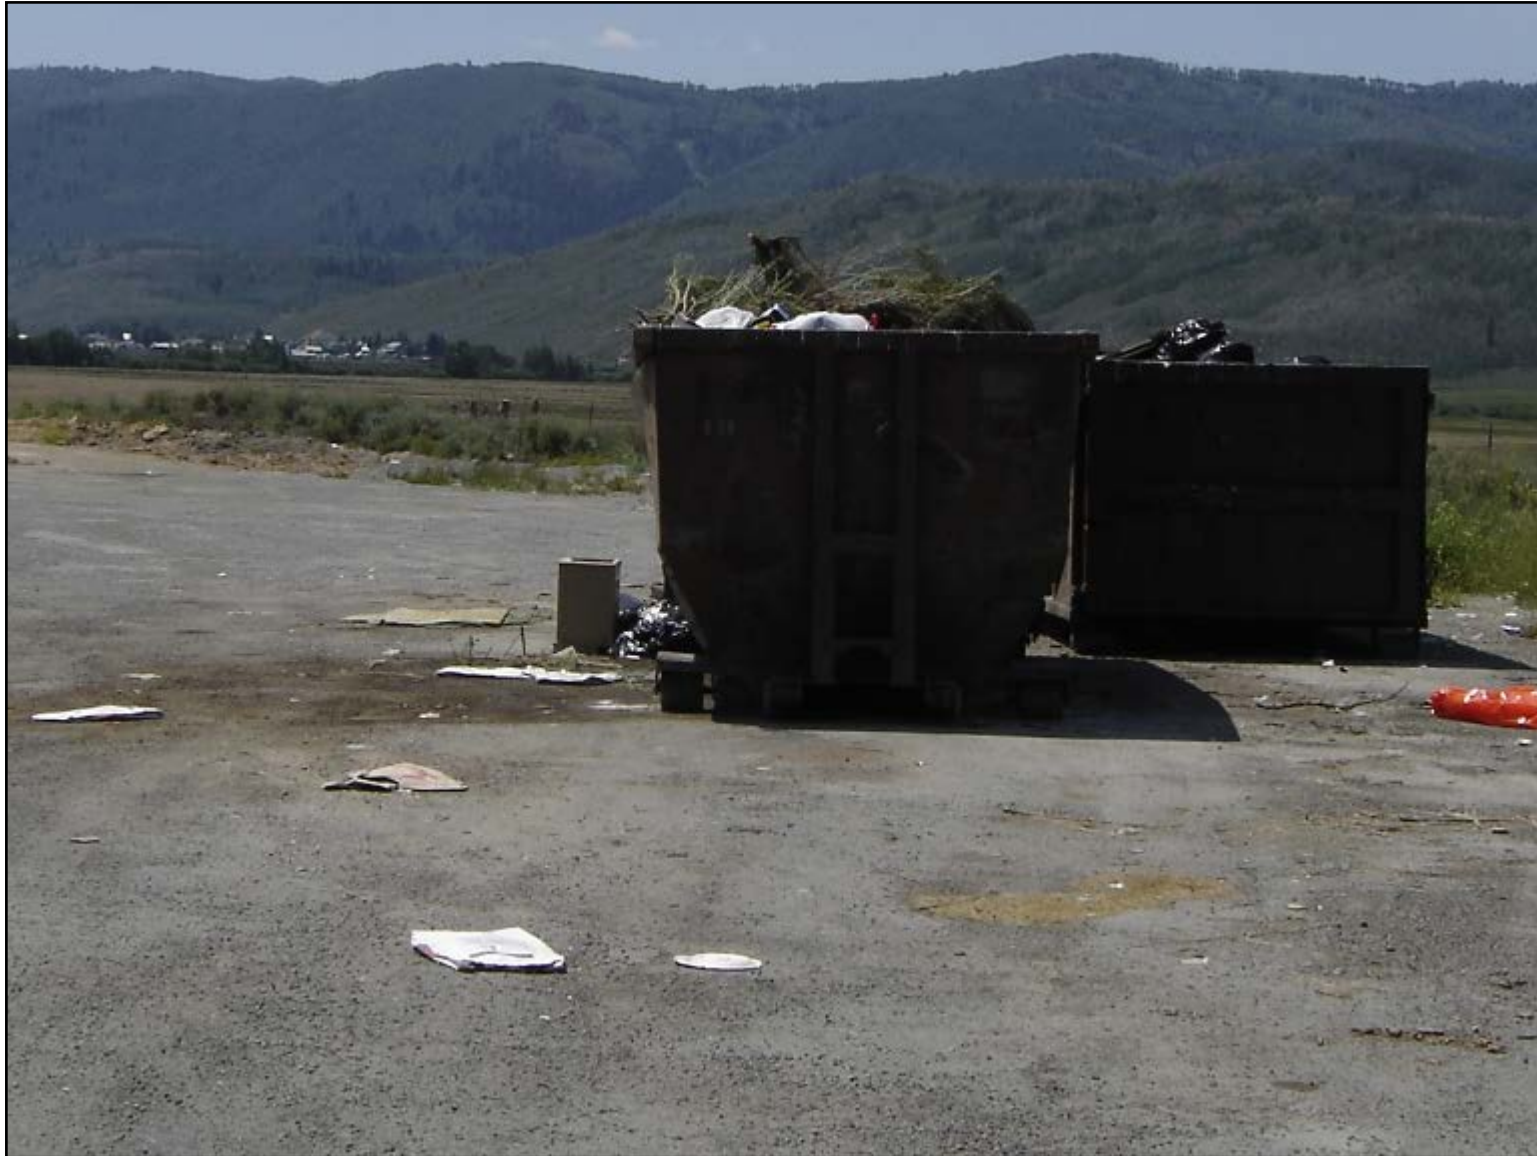
Figure 5: Scofield, dumpster site before project implementation.

Visual surface water improvements came with the implementation of the solid waste transfer station. Before the project was implemented, due to inaccessibility, large quantities of windblown trash and debris would end up polluting the surface waters of the reservoir. The completion of the waste station enables user's better access to the dumpster site, significantly lowering the amounts of trash that ends up in Scofield Reservoir. Several local residents have commented on the surface water enhancements. The project gained momentum and Carbon County secured the funds necessary to install a second solid waste transfer station on the northern end of the reservoir.

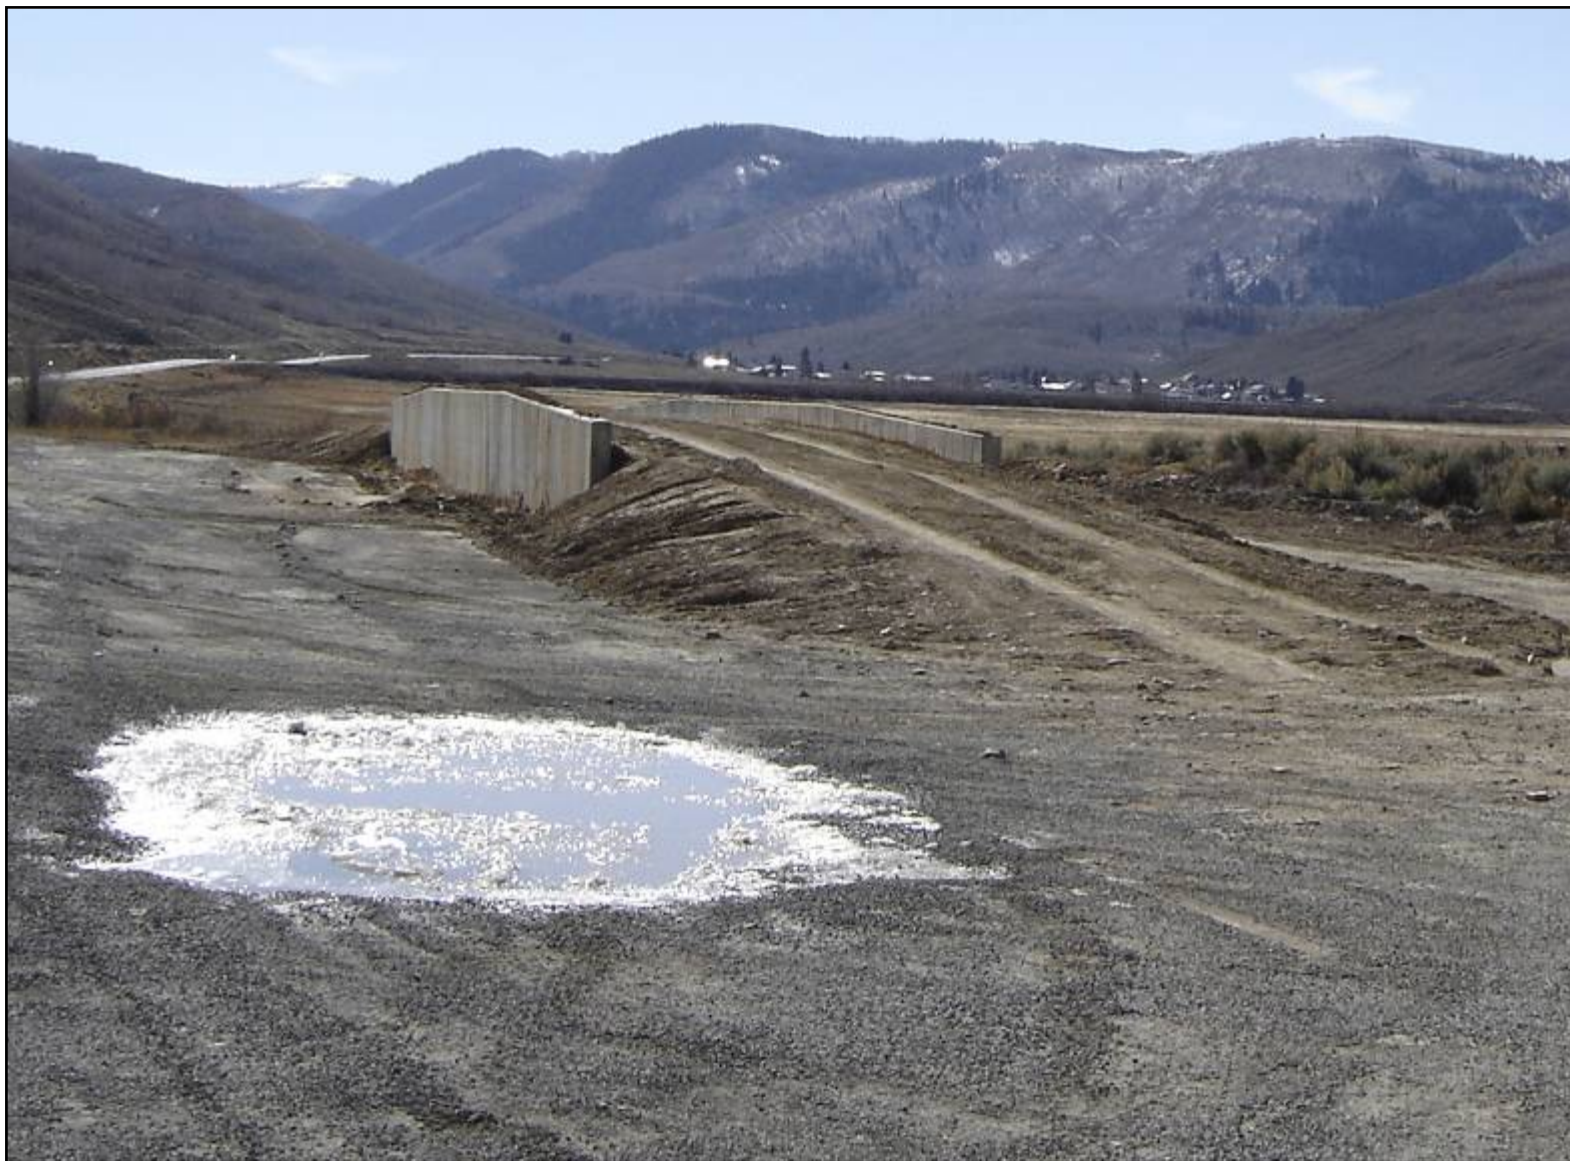
Figure 6: Scofield, dumpster site during project implementation.

Task 6: Construct solid waste transfer station, consisting of a drive through ramp with roll off dumpsters on either side surrounded by a perimeter fence to contain fugitive trash. UPDATE: In November 2005, excavation on the dumpster site began. Cement ramps were later installed to allow users better access to the dumpster sites. Backfill was completed on the 29th of May 2006, signaling task completion. A significant reduction in windblown trash and debris free to pollute the reservoir has been realized. (See Figures 5, 6, and 7) UPDATE: In October 2010 Carbon County began work on an additional solid waste holding facility on the north end of Scofield near Madsen Bay State Park. (See Figures 16 and 17) Two feet of slanted chain link fencing was placed along the top edge of the cement structure to decrease the amount of trash that can blow out of the holding facility. The Project was completed in December 2010 further decreasing the amount of windblown garbage that can enter the Reservoir.

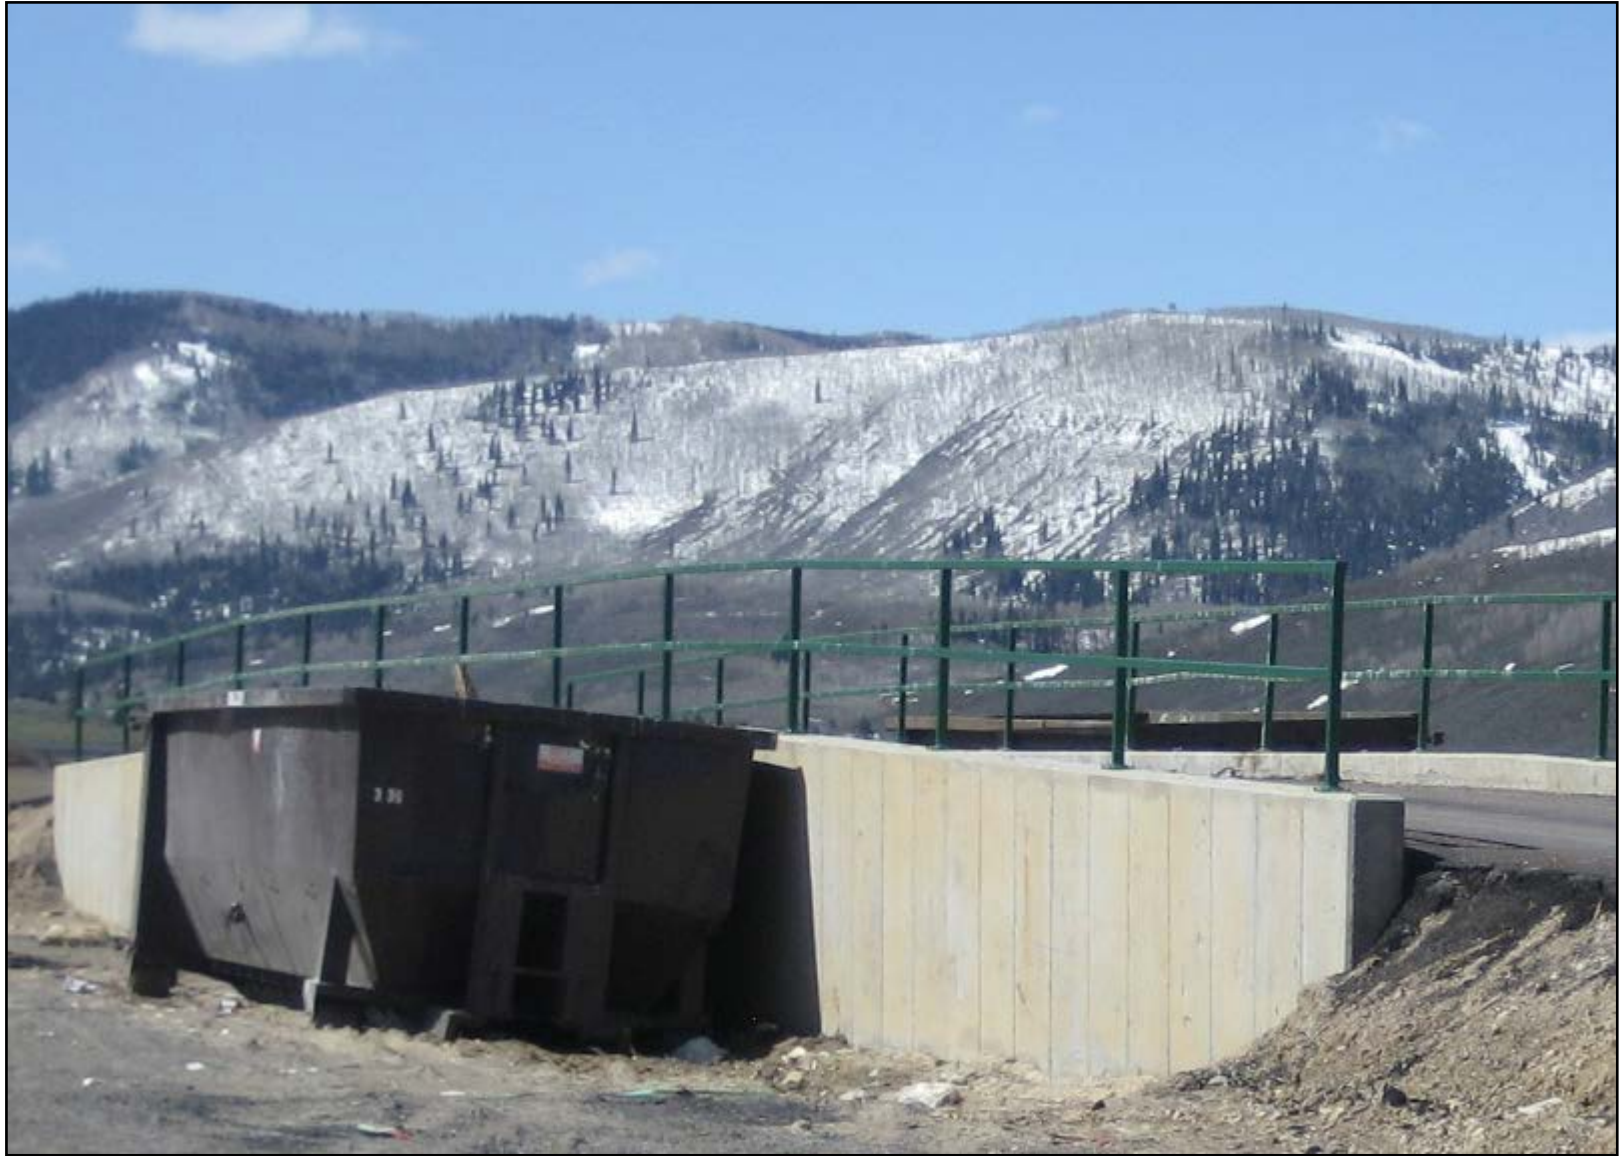
Figure 7: Scofield, solid waste transfer station complete.

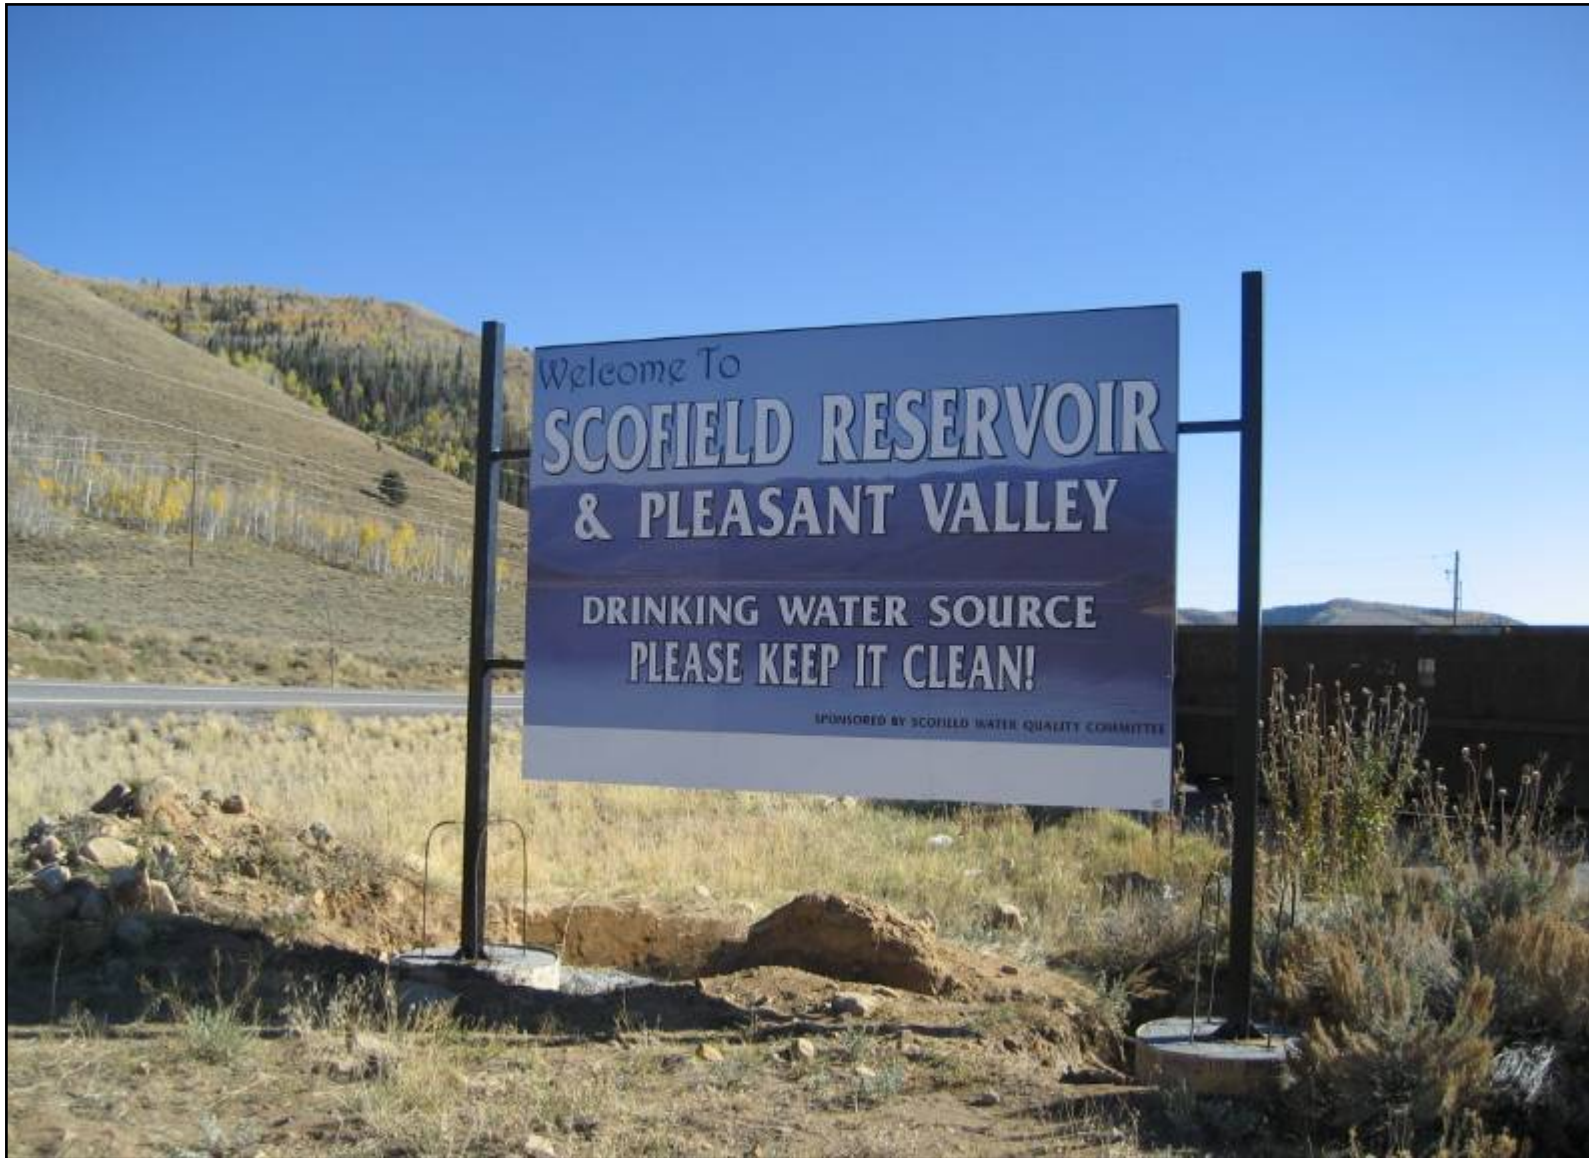
Figure 8: Scofield Sign

Task 7: Place informational signage at key locations where visitors to the watershed can obtain information on the location of facilities, propitiated activities and participating partners in the water quality improvement effort. UPDATE: The Scofield Watershed Council determined that it would be best to add one large, informational sign at the northeast shore along Hwy 96. Hwy 96 is a high traffic area along the main road to the reservoir close to the primary boat ramp. The final sign design was approved by the Scofield Watershed Council, and installation was performed by the Carbon County Planning and Zone Coordinator, Dave Lavanger. Gravel around the base of the sign will be installed at a later date by the Carbon County Road Department. The sign states:

"Welcome to Scofield Reservoir & Pleasant Valley. Drinking Water Source. Please Keep it Clean!" (See Figure 8)

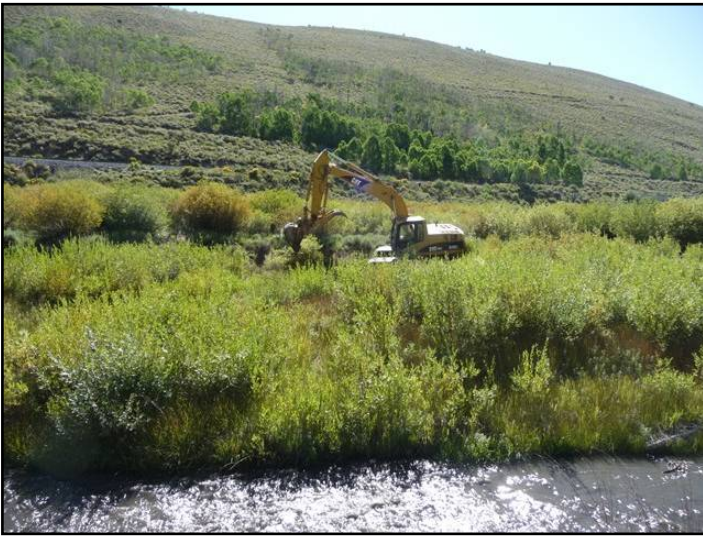
Figure 10: Mud Creek, willow wads.

Task 3: Identify and select project cooperators and develop stream bank and riparian improvement plan using BMP's and bioengineering principles. **UPDATE:** Two sites were identified that require riparian improvement, Mud Creek outside of Scofield town and Upper Fish Creek. Mud Creek is the priority site due to heavy grazing and high stream bank erosion. Carbon County Recreation and Transportation Special Service District purchased property on Mud Creek south of Scofield town. No grazing has been allowed for three years. Previous stream restoration work allowed regeneration of bank vegetation and riparian regrowth. Grazing Management is being considered with adjacent landowner to help control noxious weeds and keep vegetation productive. UDWR hired a consultant to evaluate additional work on the Mud Creek property and active cut banks were categorized in three tiers according to treatment need. Type 3 cut banks were treated to a 3:1 slope with willow clumps, sod mats and log vanes. 1.3 river miles were treated. Construction was completed September 2010. DWQ did UCASE sampling during the summer, pre-project, and plan to continue monitoring for the next 5 years post project. Results not yet received. (See Figures 10-15)

A Riparian improvement plan was developed for Mud Creek south of Scofield Reservoir; high risk areas with erosion potentials were noted. In September 2010 a 1.3 mile stretch of Mud Creek was restored and active cut banks were treated to a 3:1 slope with willow clumps, sod mats and log vanes.

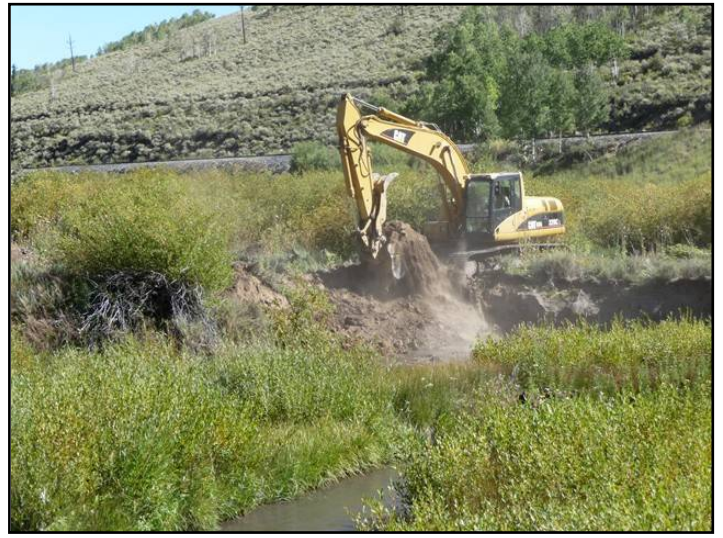
Figure 11: Mud Creek, 3:1 bank slope alteration.

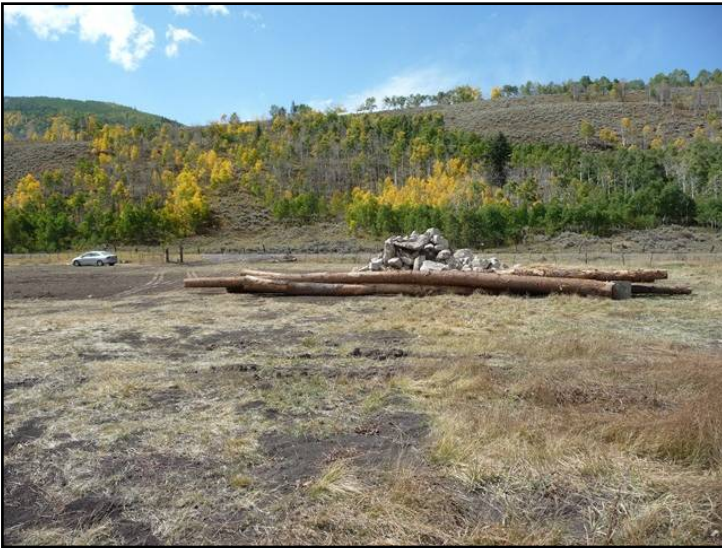
Figure 12: Mud Creek, materials.

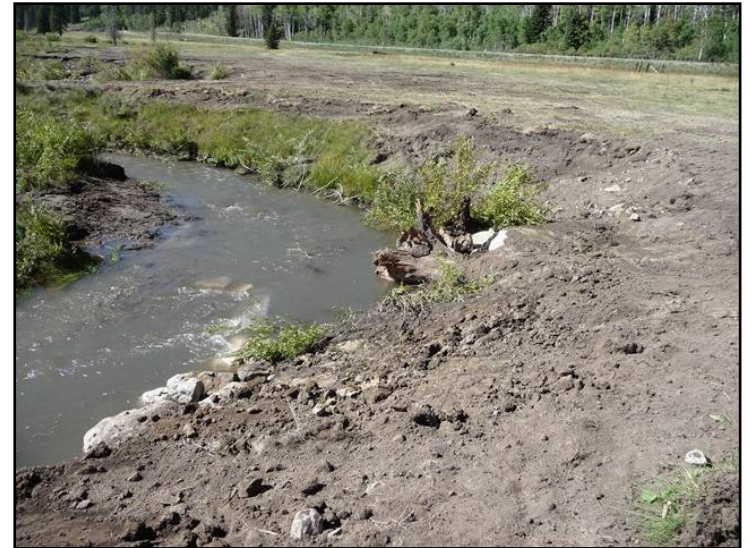
Figure 13: Mud Creek, rock erosion protection.

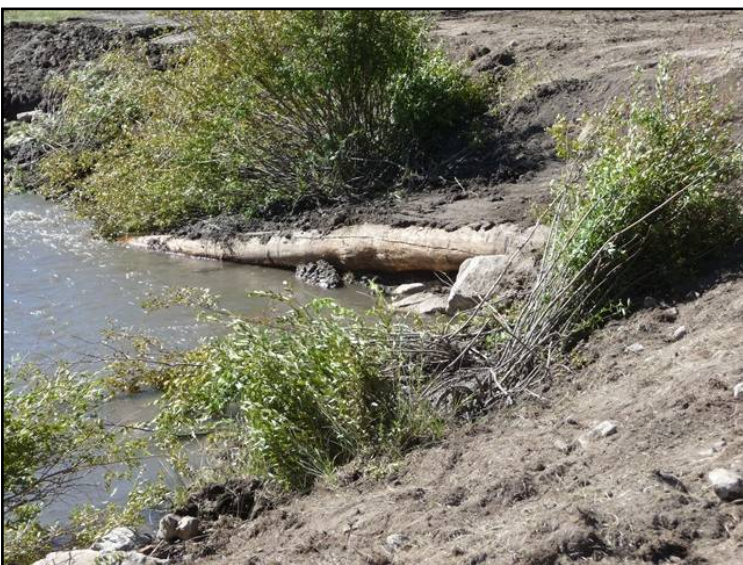
Figure 14: Mud Creek, log vane.

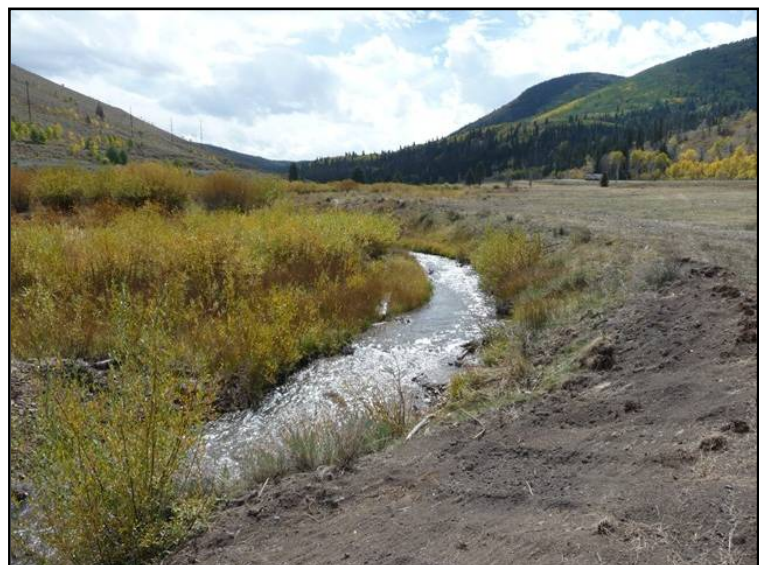
Figure 15: Mud Creek, project completion.

The property purchased by Carbon County Recreation and Transportation Special Service District on Mud Creek south of Scofield Town has had significant stream bank recovery. The areas targeted for high erosion potential were treated. Banks were pulled to a 3:1 ratio and Willows are beginning to return to the riparian zone, with fewer exposed raw banks. Willow clumps, sod mats and log vanes, and rock J hooks were added to increase vitality and speed recovery. 1.3 river miles were treated. Compared to adjacent properties the visual impact is notable. Unfortunately, the UCASE data for the project will be accumulated over the next five years and is not available for inclusion into this report.

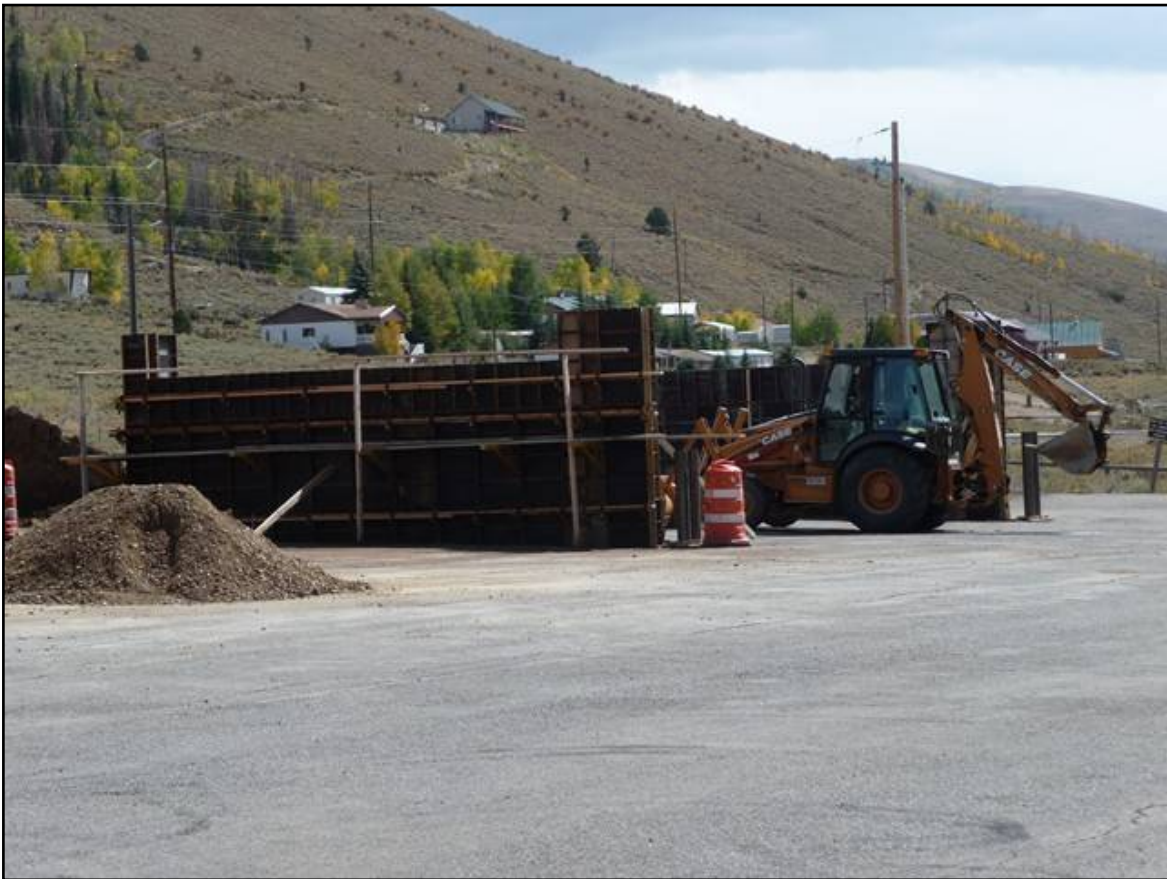
Figure 16: Scofield Madsen Bay, county waste transfer station during implementation.

One waste transfer facility was created at the south end of the reservoir near Scofield town. A second waste facility was created by Carbon County at the north end near the entry for Madsen Bay State Park.

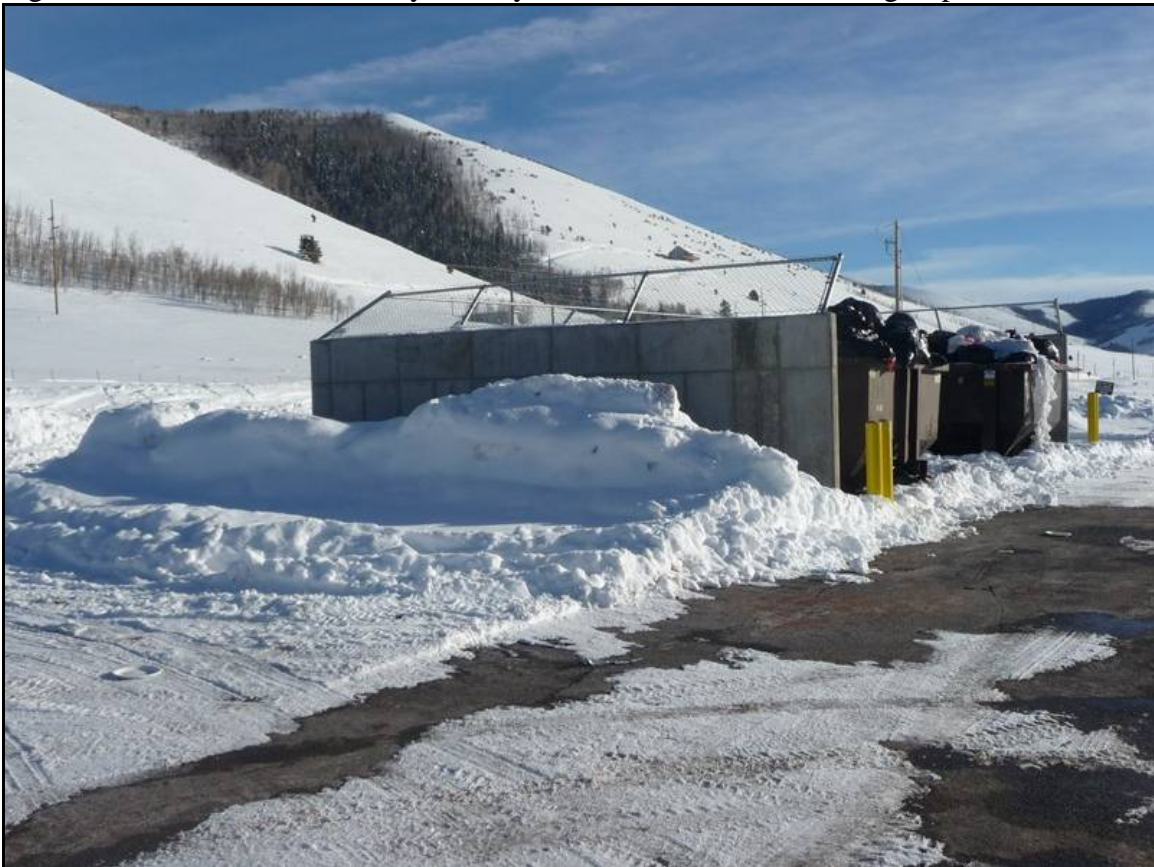
Figure 17: Scofield Madsen Bay, county waste transfer station complete.
