UTAH SUCCESS STORY: STRAWBERRY RIVER

RESTORATION EFFORTS DECREASE PHOSPHOROUS
LOADING IN UPPER STRAWBERRY WATERSHED

Restoration efforts in the Upper Strawberry River have led to a 91% decrease in total phosphorous loading protecting Strawberry Reservoir's cold water fishery.

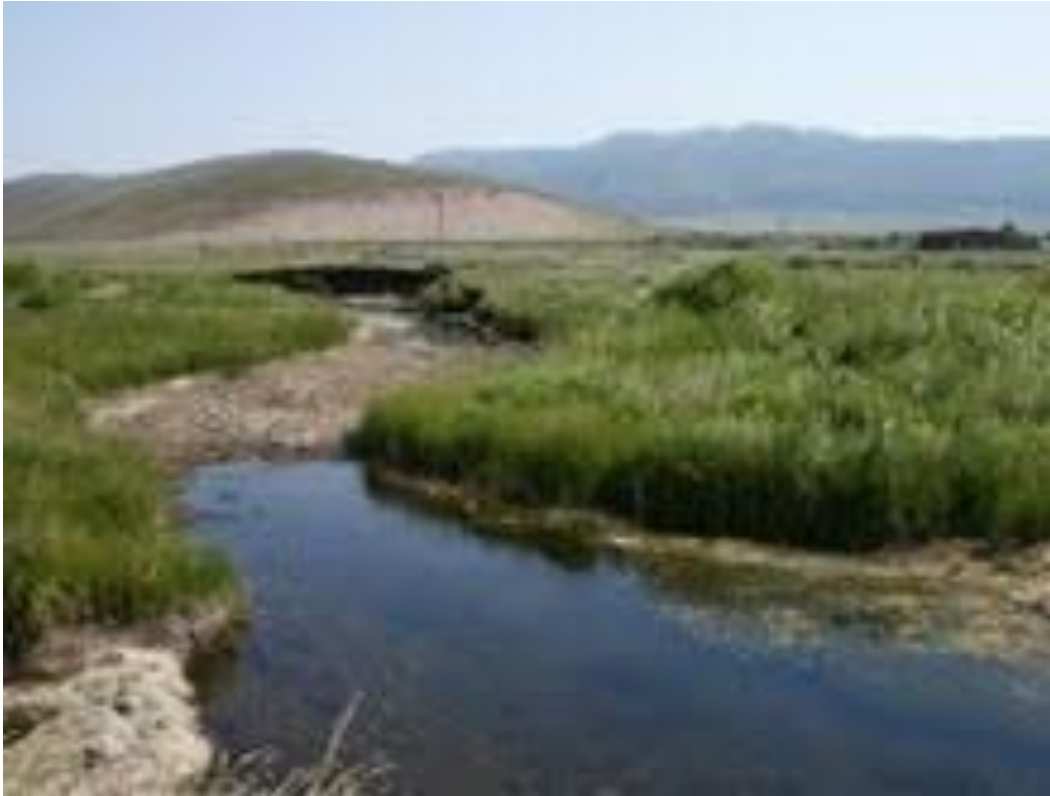
FIGURE 1. FIGURE 1. STRAWBERRY RIVER PRIOR TO RESTORATION IN 2001 HAS RAW BANKS AND NO WOODY VEGETATION.

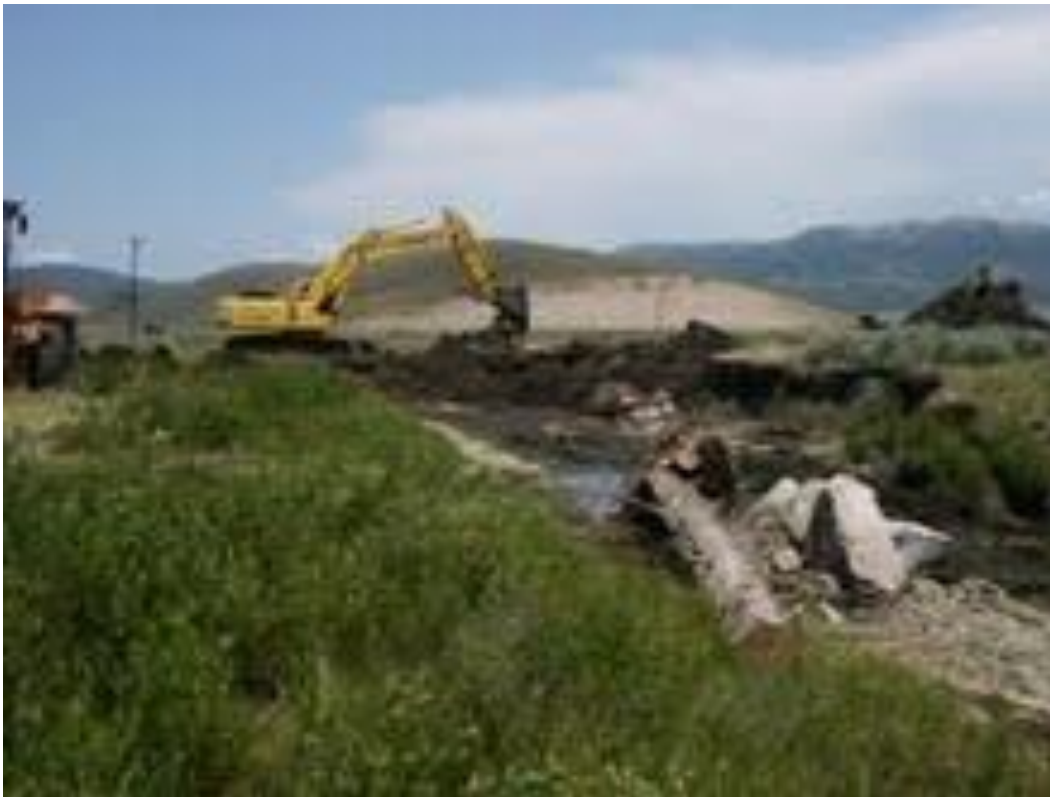
FIGURE 2. FIGURE 2. STRAWBERRY RIVER (SAME REACH) DURING RESTORATION ACTIVITIES IN 2002 INCLUDED INSTALLING STREAMBANK STABILIZING STRUCTURES.

Strawberry River restoration efforts include stabilizing 13 miles of streambank with approximately 33,630 feet erosion fabric and 452 structures, creating 22 oxbow pond habitats, and improving channel alignment. Meanders were installed in straightened reaches pulling banks back to a 3:1 slope. Invasive woody species were removed and native vegetation (7,900 container stock, 19,000 cuttings, and 250 clumps) was planted connecting the river with the floodplain. Grazing pressure was decreased by installing 3 miles of exclosure fencing to prevent unrestricted cattle access in the headwaters.

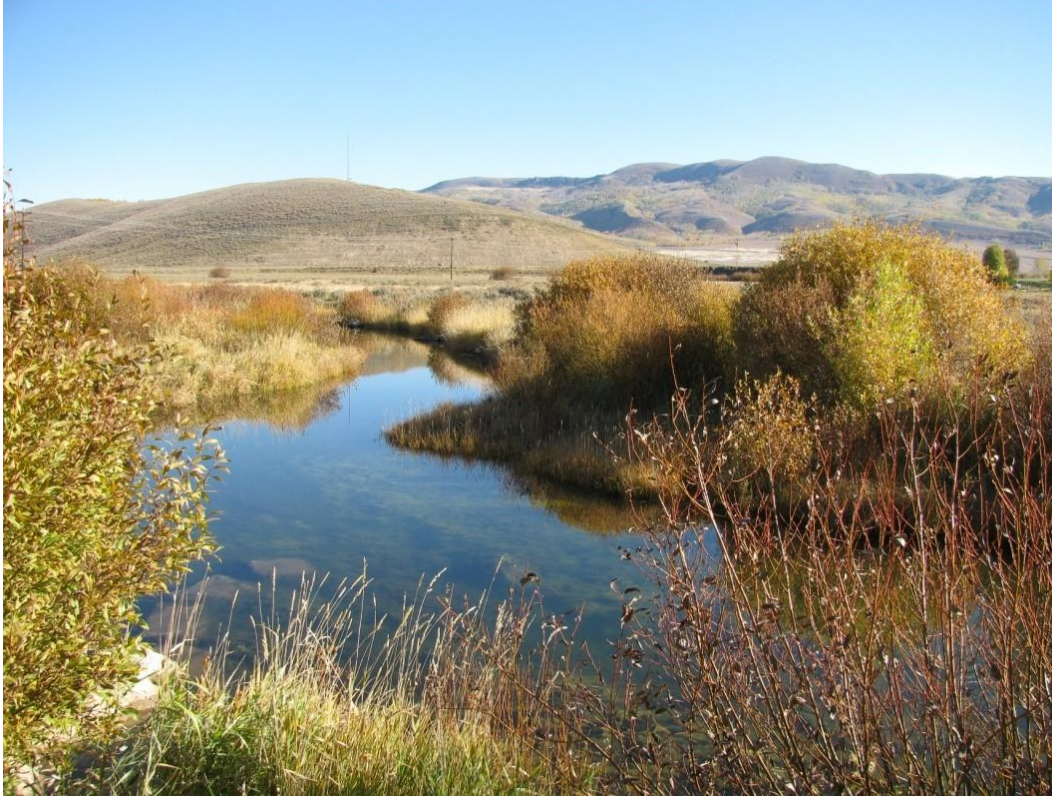
FIGURE 3. STRAWBERRY RIVER (SAME REACH) HAS STABILIZED 11 YEARS (2013) AFTER RESTORATION ACTIVITIES STARTED.

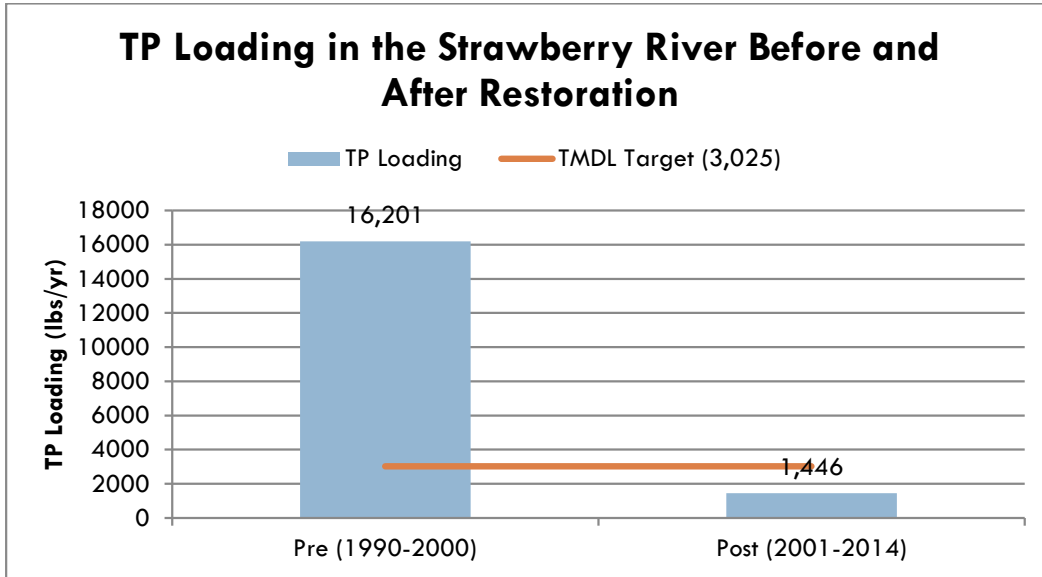
FIGURE 4. TP LOADING REDUCED BY 91% AFTER STRAWBERRY RIVER RESTORATION.

As a result of the watershed scale restoration work that has taken place, TP loading from the Strawberry River has decreased 91% since 2001.

Since 2001, the average TP load is 1,446 lbs/yr which is below the TMDL allocation for the Strawberry River of 3,025 lbs/year. Trend analysis of TP concentration over time shows no significant decrease however concentrations are below the TMDL target of 0.05 mg/L. Stable concentrations point to natural sources of pollution. There is a positive correlation between flow and concentration indicating that erosion and transport of TP during high flows is a dominant process in the watershed.

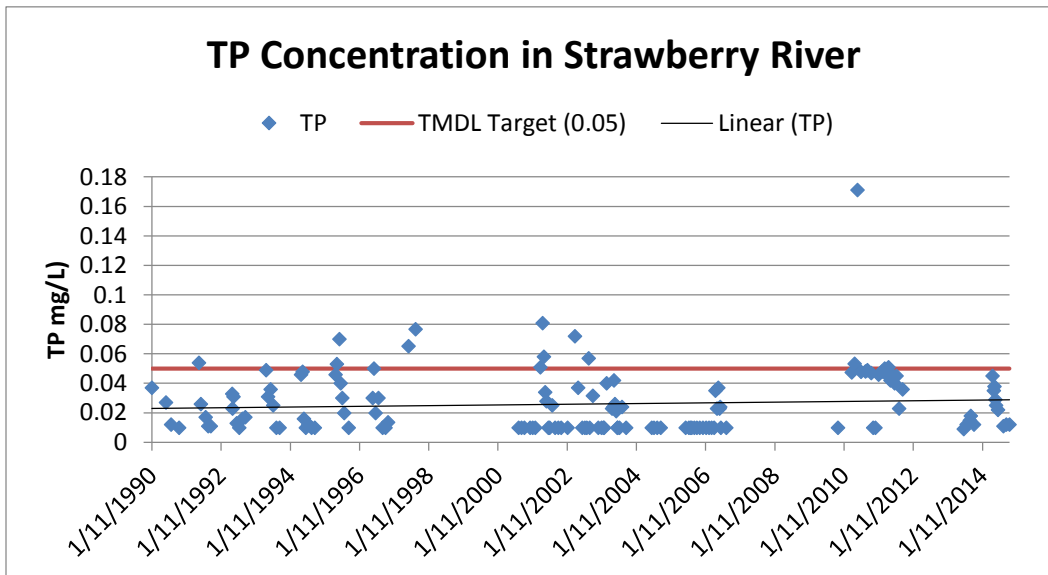
FIGURE 5. TP CONCENTRATION HAS REMAINED STABLE OVER TIME.

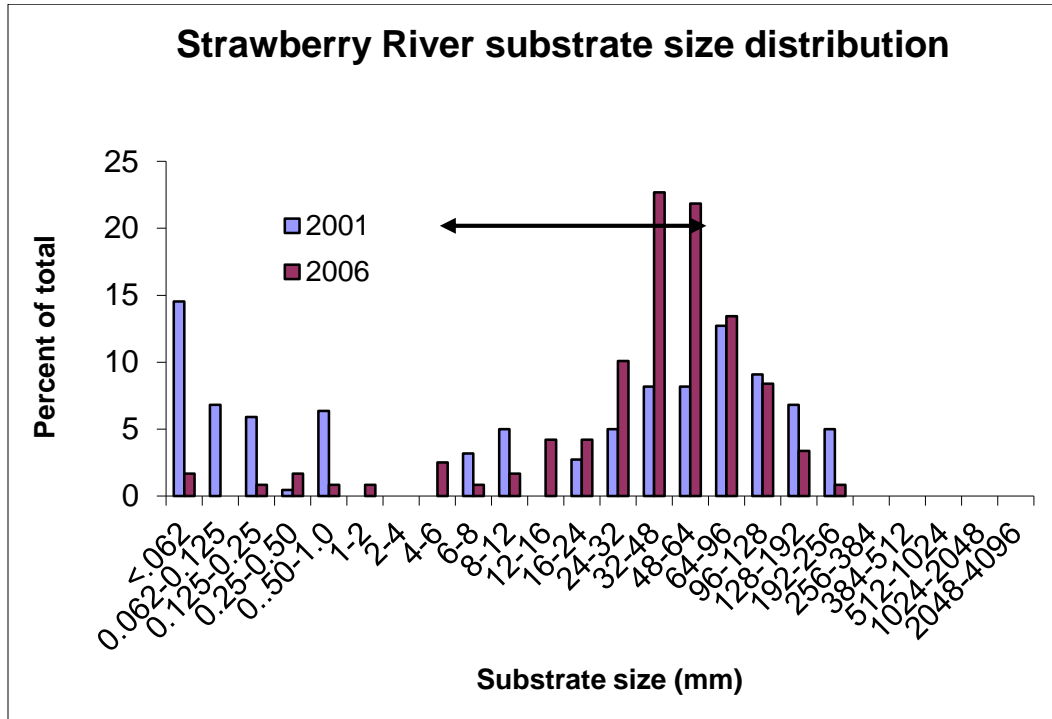
FIGURE 6. RIFFLE PEBBLE SIZE INCREASES AFTER 2003 RESTORATION PHASE. BLACK BAR INDICATES THE OPTIMAL SIZE OF SUBSTRATES FOR CTBL SPAWNING HABITAT.

UDWR has monitored the physical aspects of the Strawberry River restoration project including streambed composition which influences erosion rates, sediment supply, hydraulics, and spawning habitat. Pebble counts are one way to quantify differences in substrate composition. Riffle pebbles have increased in size after restoration efforts in 2002 indicating banks are stabilizing and fines (< 1 mm) have decreased. Cutthroat Trout (CTBL) prefer spawning gravels to be between 20 – 90 mm with the absence of fines.

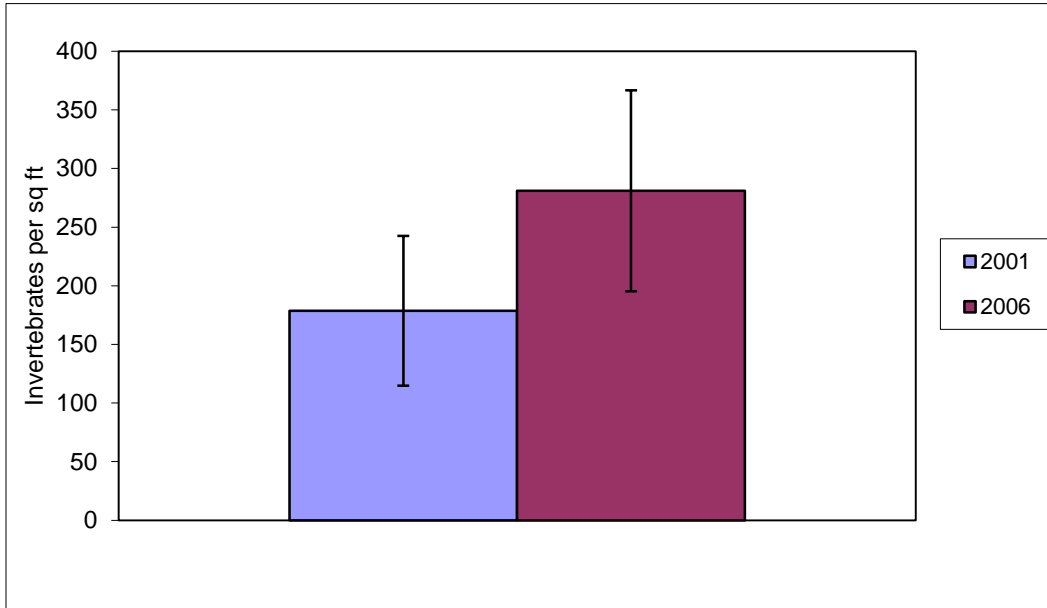
FIGURE 7. INVERTEBRATE POPULATIONS INCREASE AFTER THE 2002 RESTORATION PHASE.

The benthic macroinvertebrate populations were also measured before and after the earlier restoration phases. Strawberry River restoration enhanced the streambed with more cobble substrate resulting in increased density of invertebrates (Figure 7) though not statistically significantly. Macroinvertebrate communities will be surveyed in the last restoration phases in 2017.

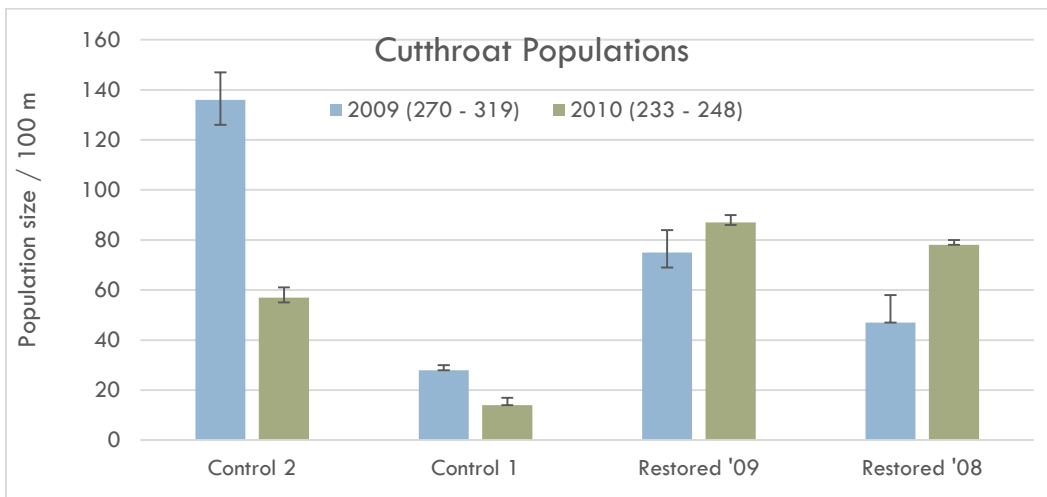
FIGURE 8. CUTTHROAT TROUT POPULATIONS' RESPONSE TO RESTORATION EFFORTS ON STRAWBERRY RIVER.

UDWR and USU are continuing to monitor the fishery population in response to restoration efforts. Fishery populations are a valuable tool for assessing the success of the work. Though post restoration data collection has not been completed for this final phase of restoration, data has been analyzed for previous phases which are directly located downstream of the final phase. Figure 6 shows that cutthroat trout (CTBL) are abandoning non-restored reaches and preferentially inhabiting restored sections. CTBL were collected from two untreated reaches (control), 2008 and 2009 restored reaches. Numbers in parenthesis represent the estimated population range for all 4 study reaches in 2009 and 2010 fishery survey. Fishery populations will be surveyed again in fall 2015.
