**CLEAN WATER ACT
SECTION 319 NONPOINT SOURCE POLLUTION PROGRAM
DEMONSTRATION PROJECT
FINAL REPORT**

**THISTLE CREEK 319 DEMONSTRATION
UTAH COUNTY, UTAH**

**By
Ray Loveless
Resource Coordinator
Utah Association of Conservation Districts**

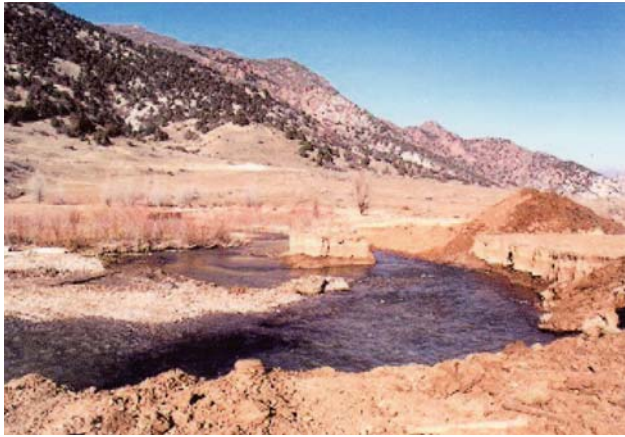
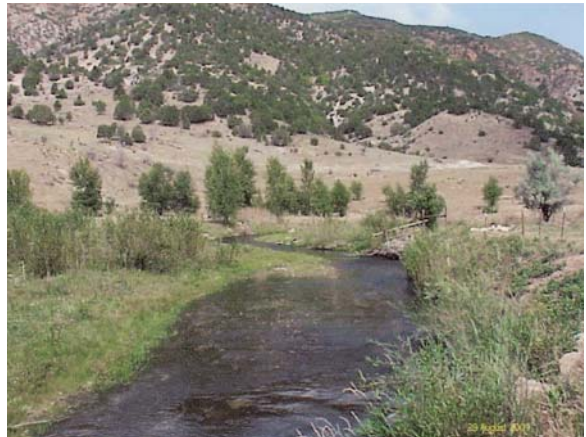
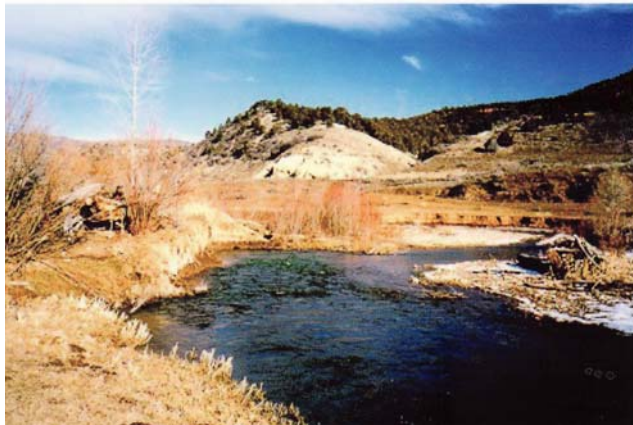
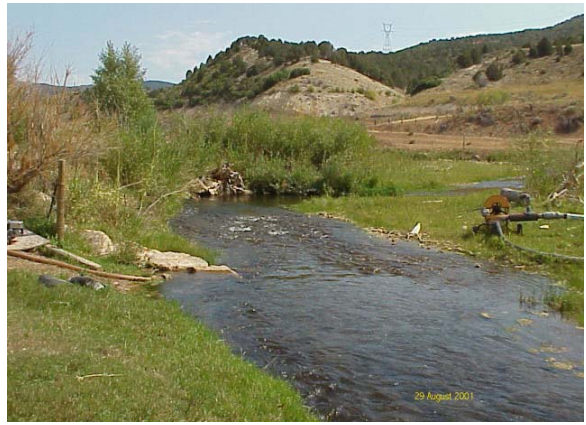
In 1998 and 1999, stream restoration techniques were applied. The restoration focused on techniques to enhance the natural function of the stream. Several rock and log vanes were placed at critical locations to protect stream banks and allow riparian vegetation to re-establish. Vertical banks were sloped to allow vegetative cover to establish. Willow clumps were transplanted to positions along the newly sloped stream banks. Root wads and logs were also used to protect stream banks and provide cover for trout. In addition, livestock were excluded from the riparian area by fencing. The landowner agreed to allow public access to the property for fishing. Structures were built along the fence to allow easy access through and over the fence.

Pretreatment photographs are shown on the left, and photographs taken after about 2.5 years are shown on the right.

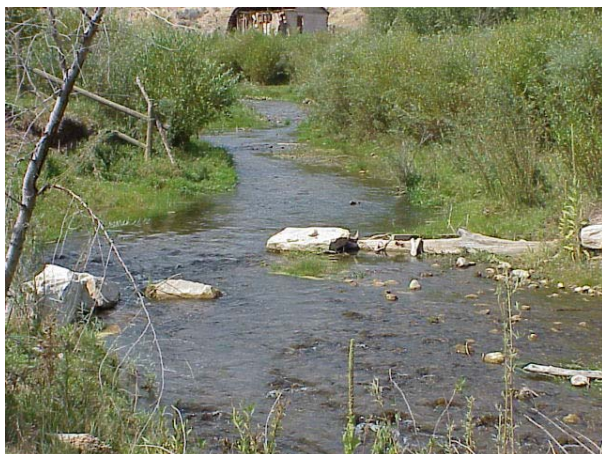
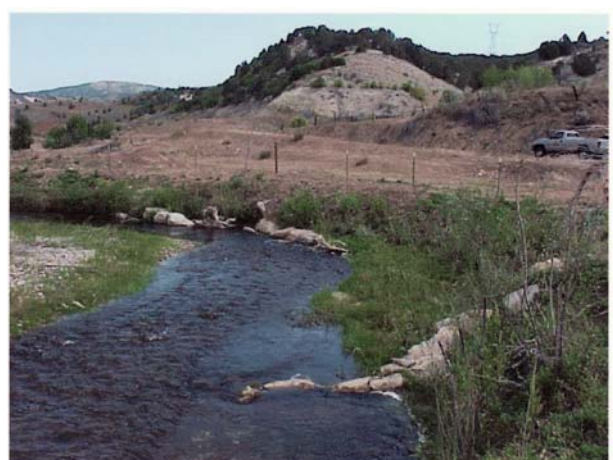
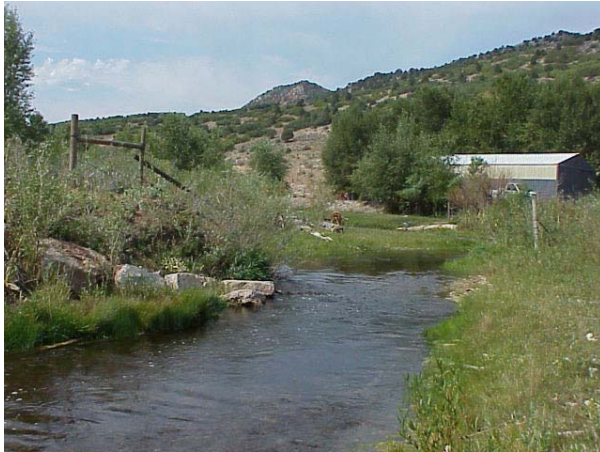
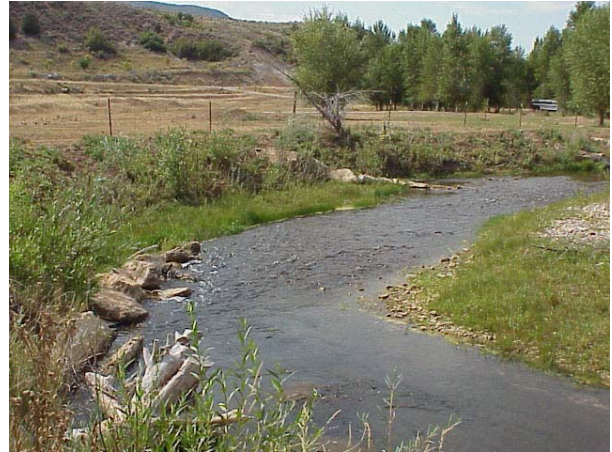
Photographs above are taken about 2.5 years after the project and illustrate rock vanes deflecting flow away from the toe of the bank, barbs that move the flow toward the center of the channel, and re-established vegetation.

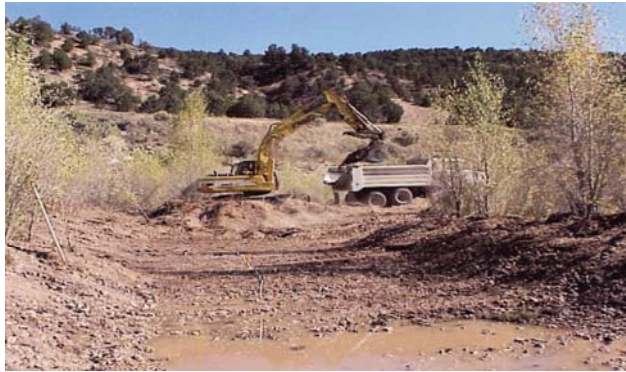
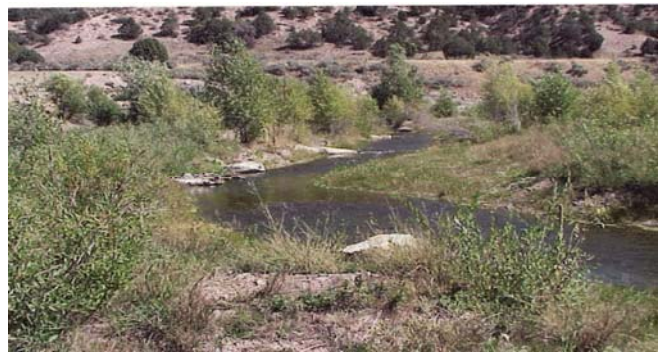
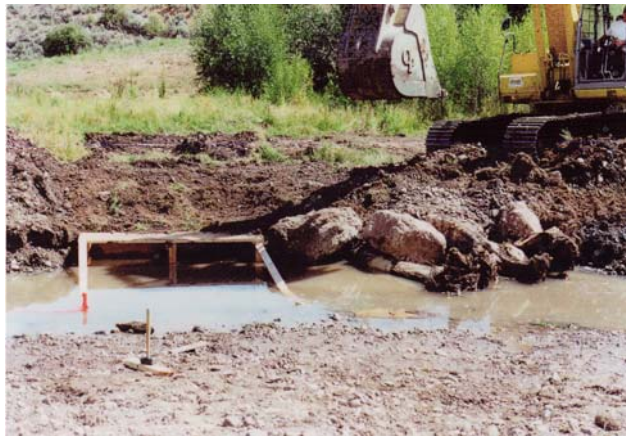
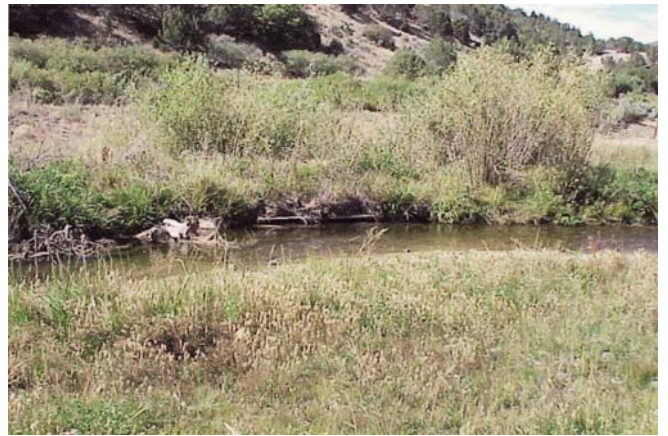
In 1999 and 2000, stream restoration techniques were applied. The restoration focused on techniques to enhance the natural function of the stream. Several rock and log vanes were placed at critical locations to protect stream banks and allow riparian vegetation to re-establish. Vertical banks were sloped to allow vegetative cover to establish. Willow clumps were transplanted to positions along the newly sloped stream banks. Root wads and logs were also used to protect stream banks and provide cover for trout. In addition, livestock were excluded from the riparian area by fencing. The landowner agreed to allow public access to the property for fishing. Structures were built along the fence to allow easy access through and over the fence.

Pictures of the Hall project during construction are shown on the left (new channel reconstruction, and fish structure next to a rock barb), and photographs on the right show the same place after about 2.5 years.

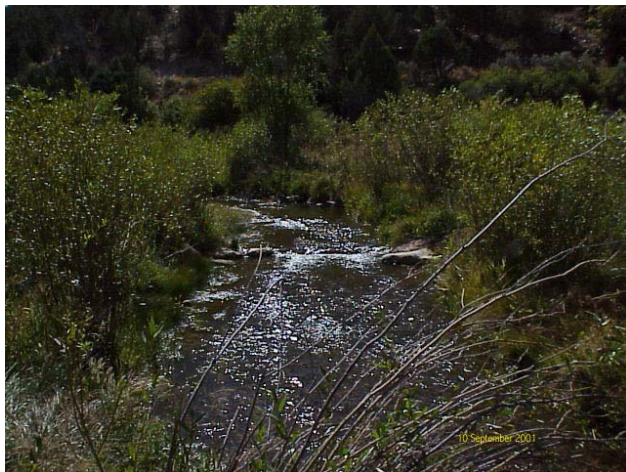
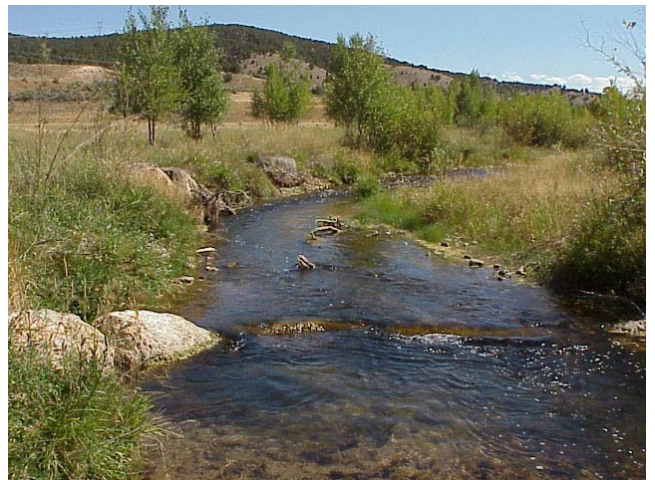
Cross vanes on Thistle Creek at the Bruce Hall project.

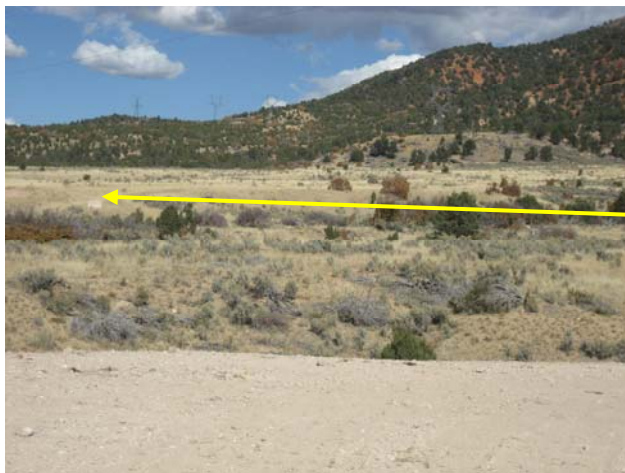
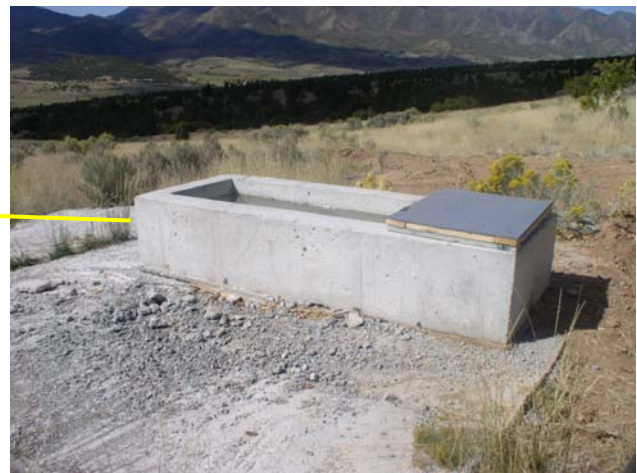
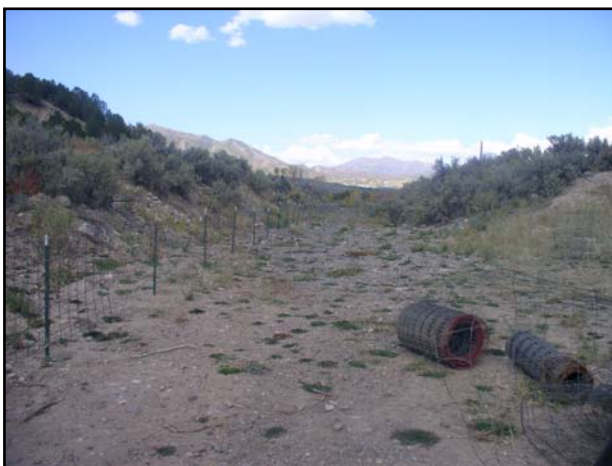
The Hall project also included upland restoration to control erosion. The project removed 84 acres of pinion juniper and 68 acres of decadent sagebrush, reseeding of perennial grasses, fencing, rotational grazing distribution, and installation of 3 water troughs to disperse livestock.

Pictures below show the removal of the pinion juniper, reseeded with native vegetation, and the installation of one of the dispersed water troughs. The project allows the landowner to move his cattle off of his riparian property, and use a rotational grazing system to reduce erosion. Upland pasture fencing was installed to implement rotational grazing and dispersal.

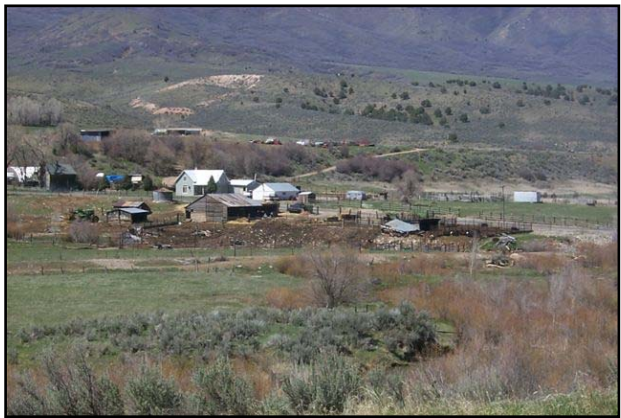
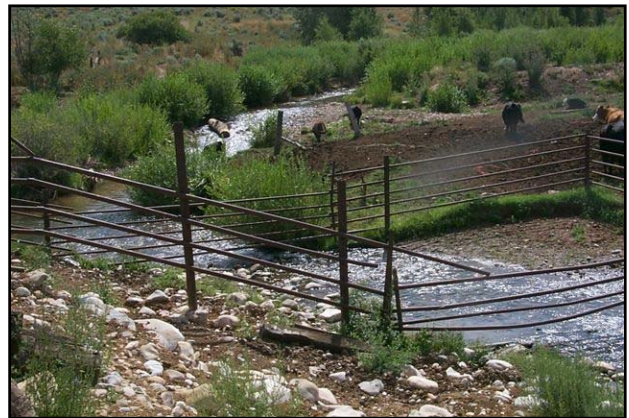
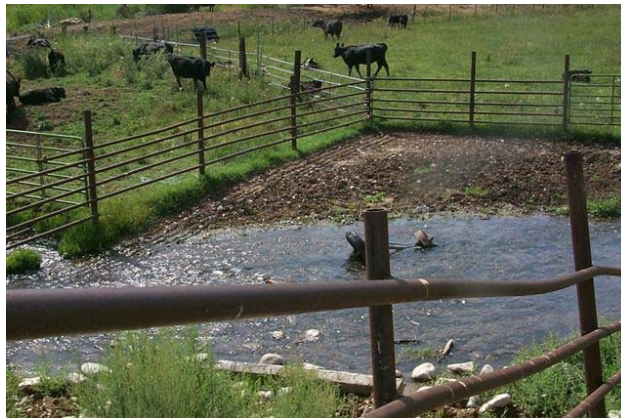
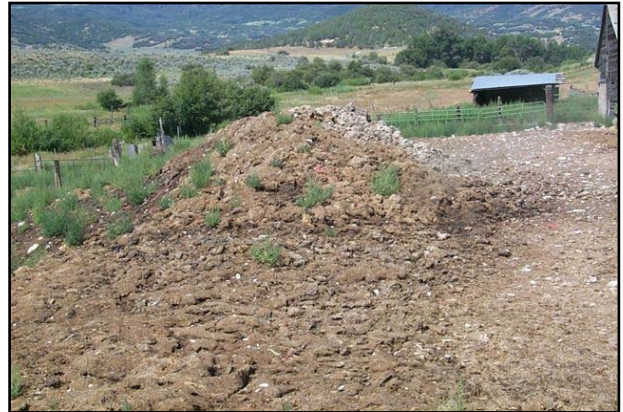
The cows had direct access to the creek for drinking purposes. The corrals sloped directly toward the creek, and during a 25 year/24 hour storm event the runoff could reach the water. There were no barriers to stop the runoff. The corrals consisted of about 69,969 square feet. Manure was piled up adjacent to Bennie Creek for several years.

Below are pictures depicting the animal feeding operation prior to implementation.

To meet the objectives of this project, the owner installed a gravity-flow pipe from the creek to newly installed water troughs that are located within the corrals from which the cattle can drink. He eliminated corrals that included the creek within the corral area. His corral area was reduced from 69,969 square feet to about 43,560 square feet. He installed a livestock fence a minimum of 35 feet away from the stream bank and constructed an earthen berm between the fence and the creek. He planted vegetative cover on the berm. He removed all of the piles of manure that had

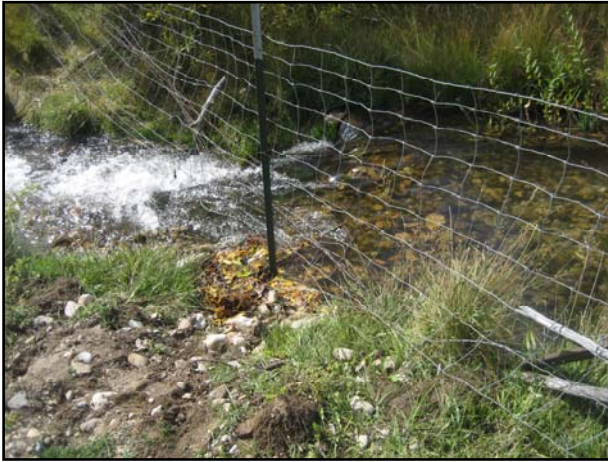
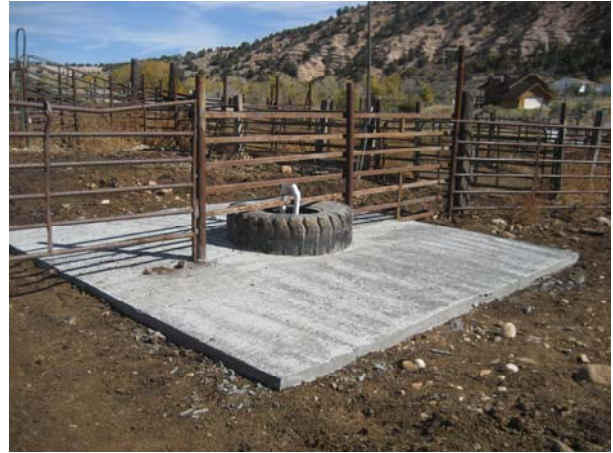
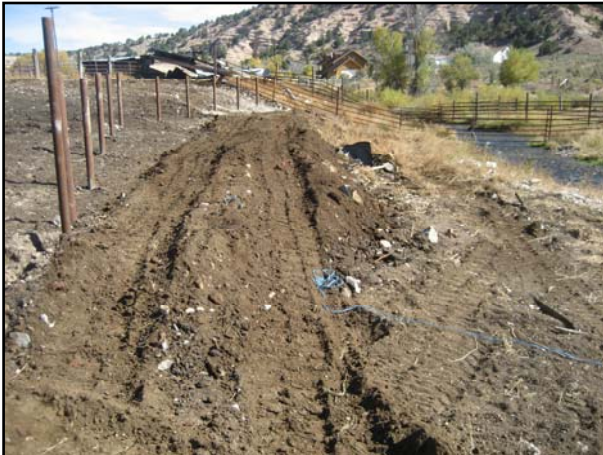
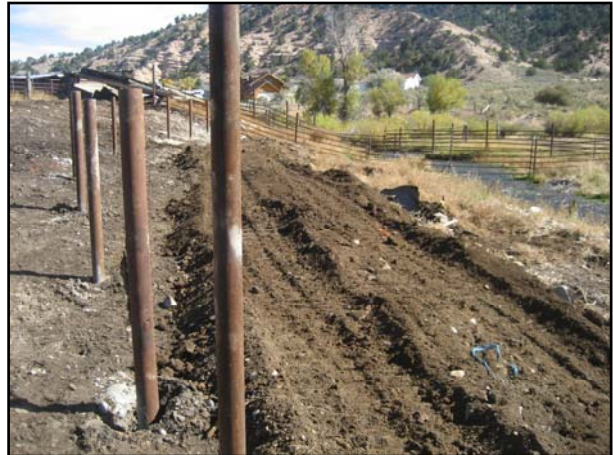
accumulated within the corrals. Pictures below depict some of the practices that were implemented.

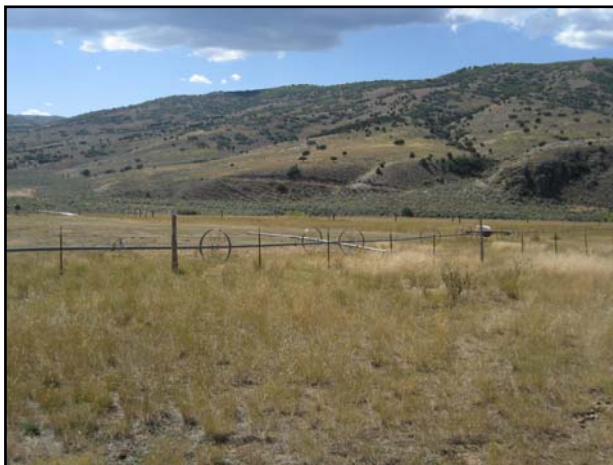
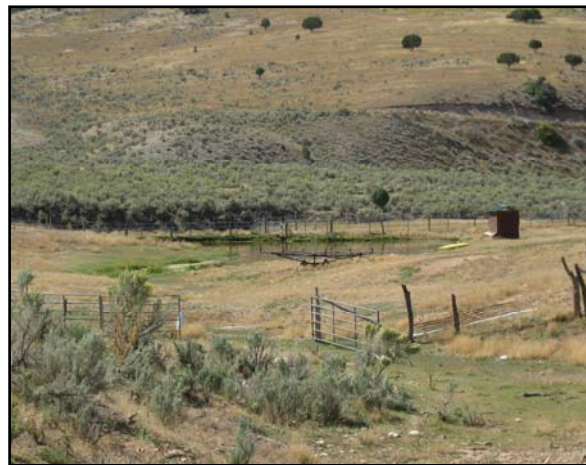
In 2006 the irrigation system was constructed and weed management techniques were applied. The irrigation project consisted of 4,100 feet of underground mainline, 3,410 feet of sprinkler pipe hand line, a 350 gpm pump, and a water storage reservoir.

The pictures below depict the sprinkler irrigation system and the water storage reservoir:

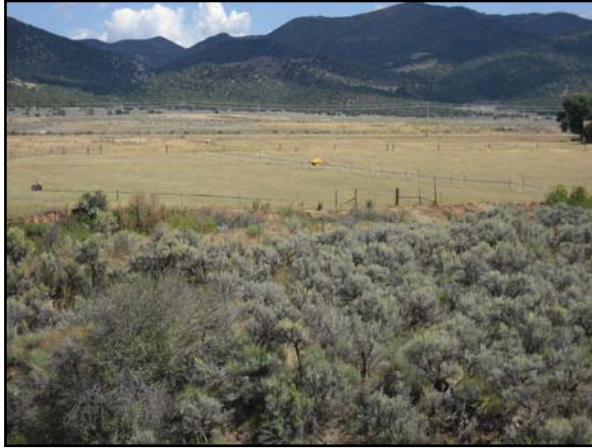
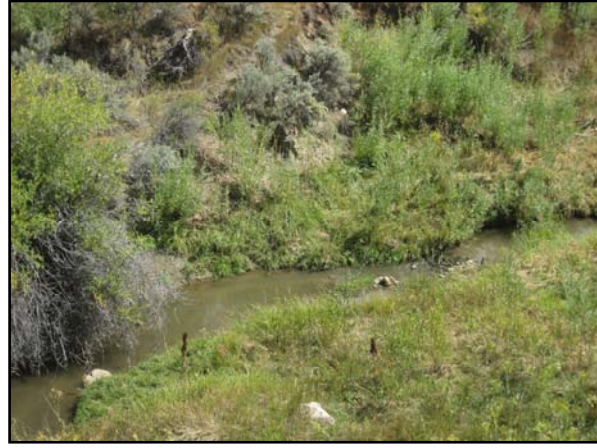
The pictures below show the proximity of the pasture to Thistle Creek and the eroded banks adjacent to the previously flood irrigated pasture. Also shown is Thistle Creek on this landowner's property. With exclusion of livestock, the riparian vegetation is making a significant improvement.

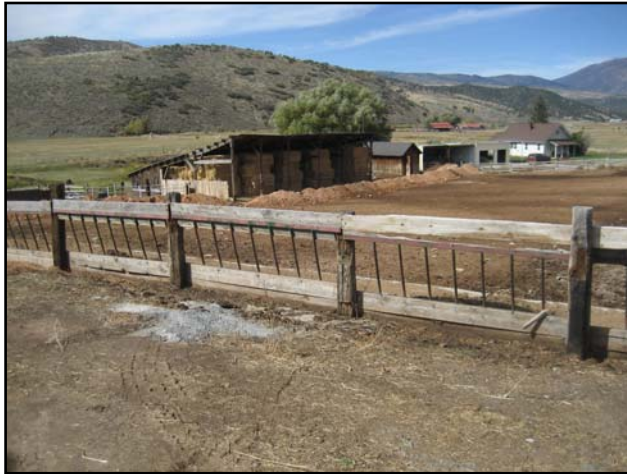
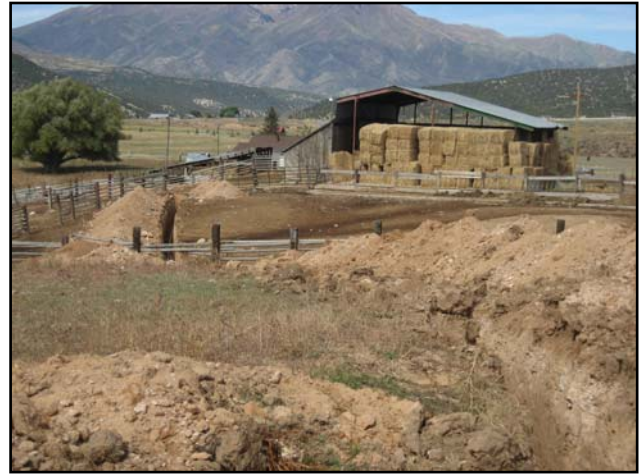
To meet the objectives of this project, the owner provided off stream livestock watering facilities by providing livestock watering troughs. The troughs are supplied with water from a 2,250 gallon storage tank with gravity pressure to each trough. Two waste storage ponds were installed to contain temporary storage of manure and runoff from the feedlot area to keep the manure out of the creek. Both ponds were lined with a flexible impervious membrane to prevent seepage. Also, to provide a location for the ponds, the corrals were reconfigured requiring fences to be built.

The photos below show the corrals and the trench that provided water to the off stream water troughs.

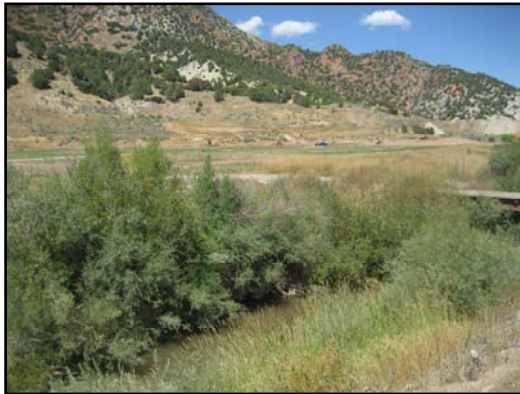
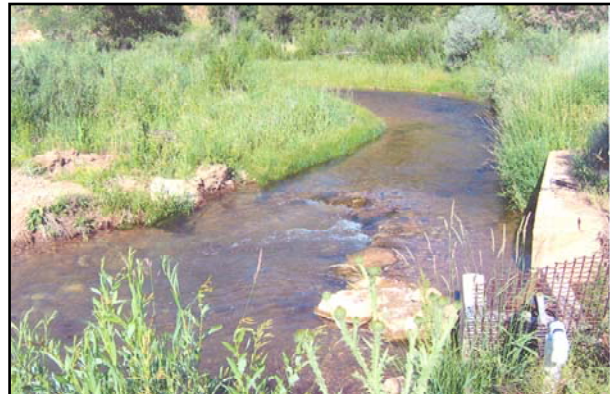
The project included a water diversion structure in Thistle Creek for a subsurface pipeline (1,600 feet), an above ground sprinkler irrigation system on 7.3 acres of land, and pest management on 15 acres. The pest management was followed up with reseeding. To prevent erosion at the site of the diversion structure, a J-hook was constructed in the stream to move water away from the stream bank. The portion of this project funded by Section 319 was the reseeding and the streambank protection at the diversion.

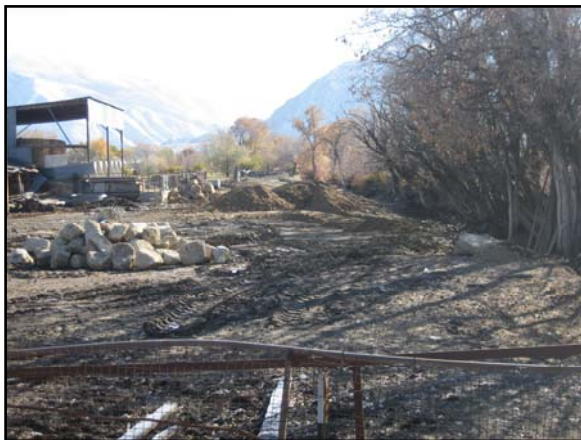
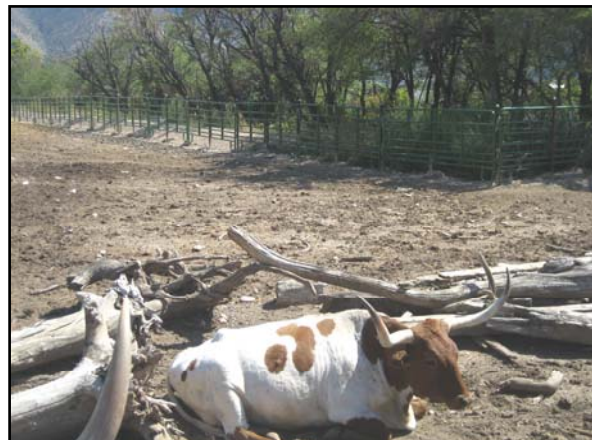
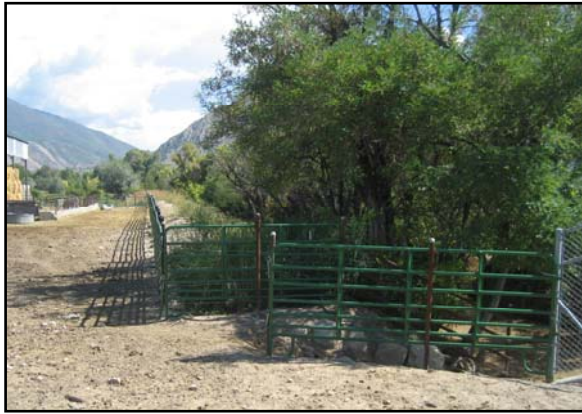
To meet the objectives of this project, the owner constructed an earthen berm between the corrals and the canal, a fence between the corral and the berm, and a limited access livestock watering facility. The berm was vegetated, and the canal bank was lined with rock rip rap to prevent erosion into the berm.

The photos below show the corrals before construction, and after construction. The fence, vegetated berm and limited livestock water access can be seen in the photos.
