CLEAN WATER ACT SECTION 319
NONPOINT SOURCE POLLUTION CONTROL PROGRAM
WATERSHED OR DEMONSTRATION PROJECT FINAL REPORT

UPPER SEVIER RIVER WATERSHED

January 14, 2014

Grant # 10-0422

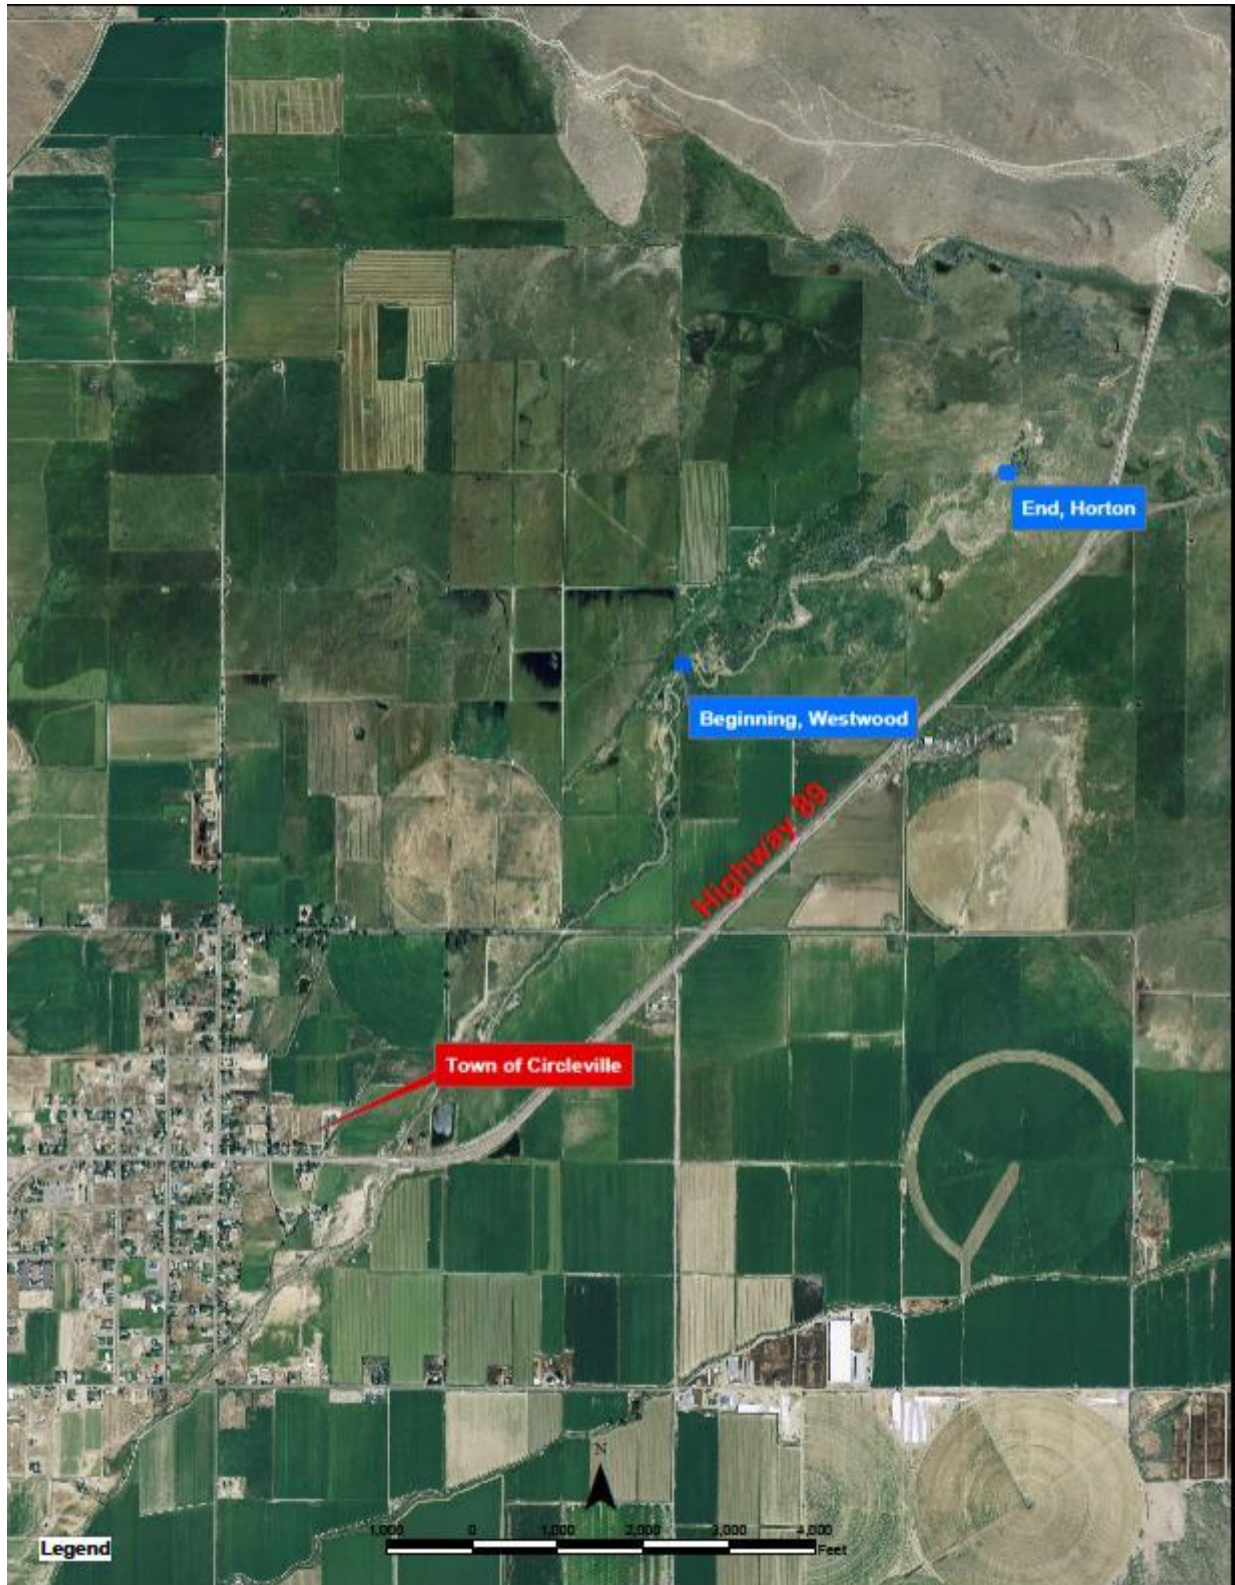
Figure 3-1. Horton/Westwood Stream Restoration Project Location.

Task 1 Project 1: Horton/Westwood Project. The project should improve water quality and stream functions, aquatic habitat, riparian vegetation, and the overall health of the watershed. Fish populations should increase because of improved habitat, riparian vegetation and overall stream condition. Eroding stream banks will be stabilized. Willows and woody riparian trees and shrubs were planted.

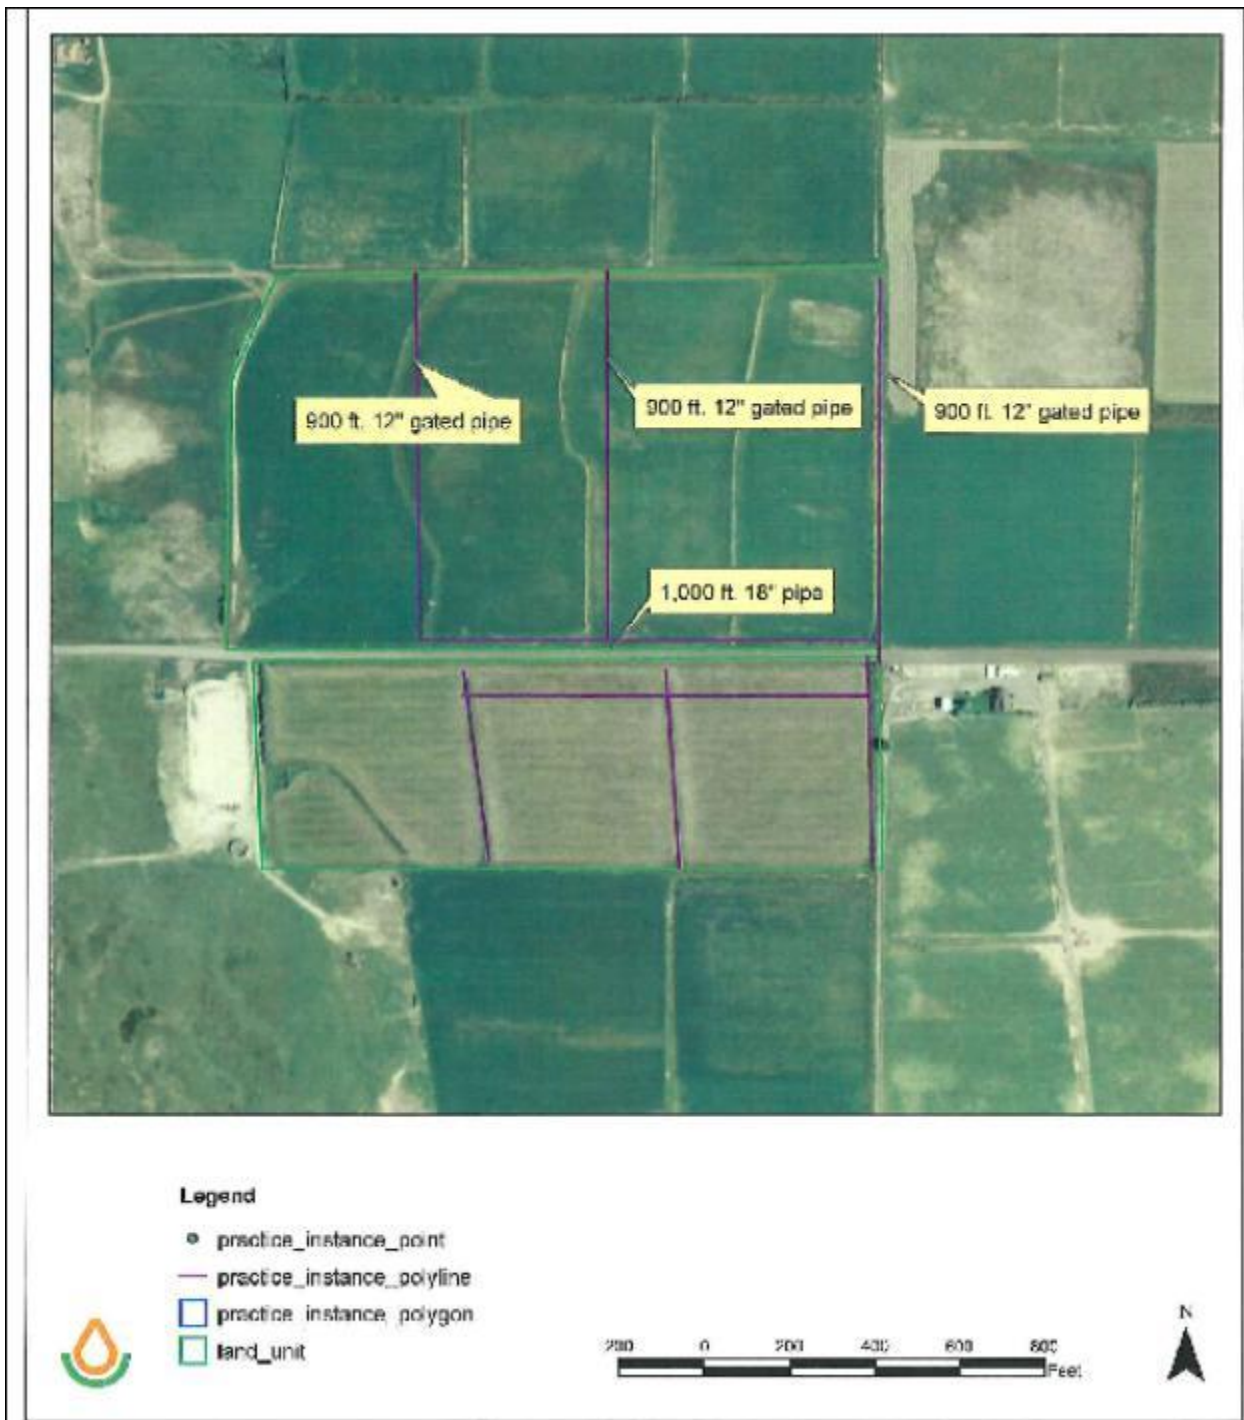
Figure 3-5. Steve Garrett Irrigation Project Overview.

Product: 2,700 feet of gated pipe and 1,000 feet of 18 inch underground pipe was installed on Steve Garrett's property just North of Panguitch on the main stem of the Sevier River. This property is just below the last property worked on in the Panguitch Valley reach of 319 projects. Gated pipe and underground pipe replaced open earthen ditches that were eroding and contributing to sediment input into the Sevier River system. Livestock and horses were removed from the property to reduce phosphorous loading into the Sevier River

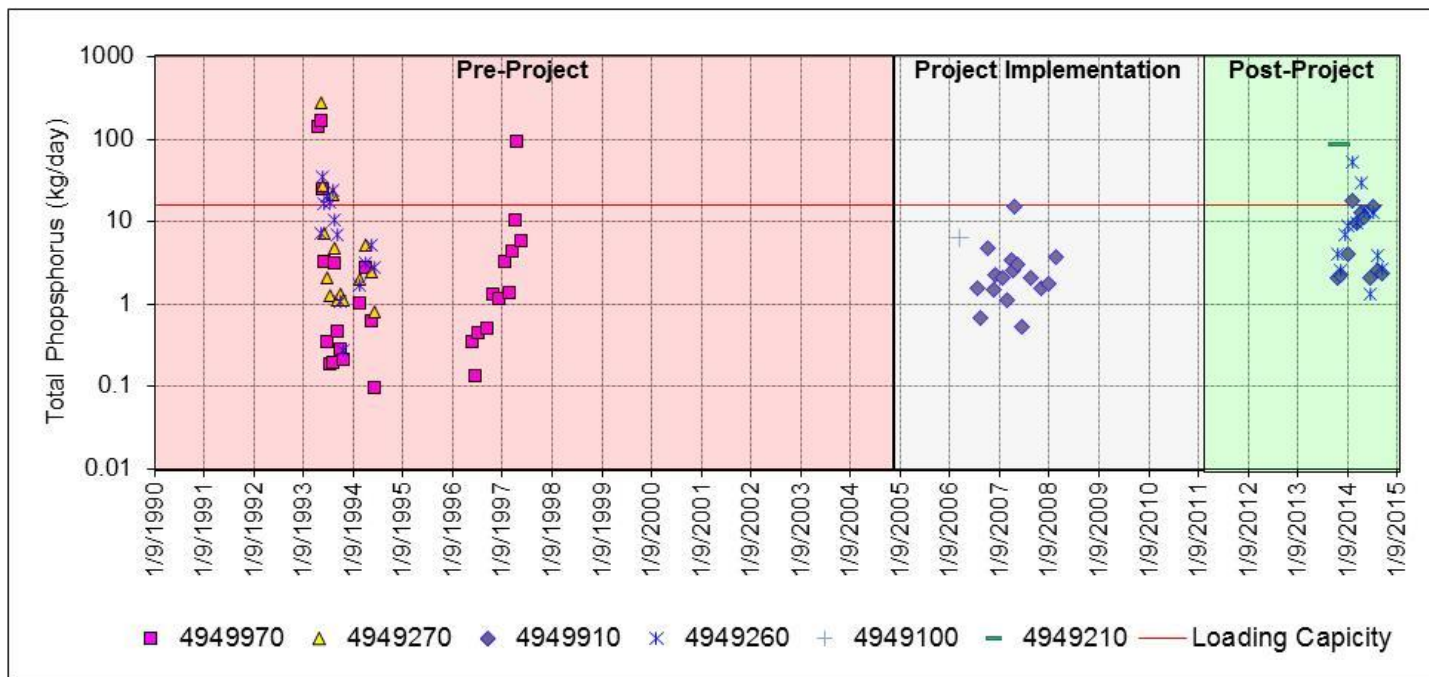
A statistical comparison of pre- and post-implementation TP concentrations and TP load at each monitoring location did not detect changes in water quality associated with project implementation ($p>0.05$). The same result was observed for each site and between sites. There also does not appear to be a visual trend in TP throughout the implementation period (Figure 6-8).

Figure 6-8. East Fork Sevier River Total Phosphorus Loads for Stations in Proximity to the Project Locations (1996-Present).

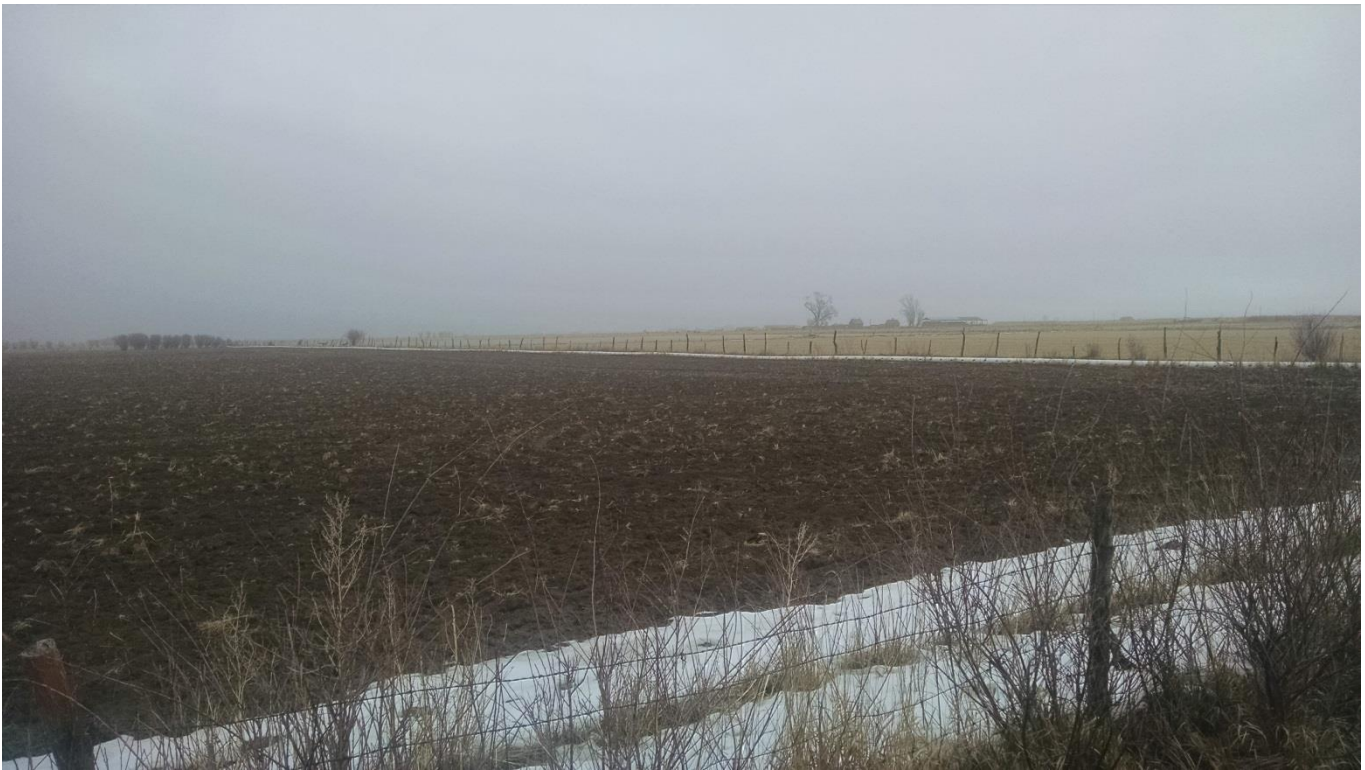
Gated Pipe installed on Steve Garret to reduce Irrigation Return to the Sevier River.

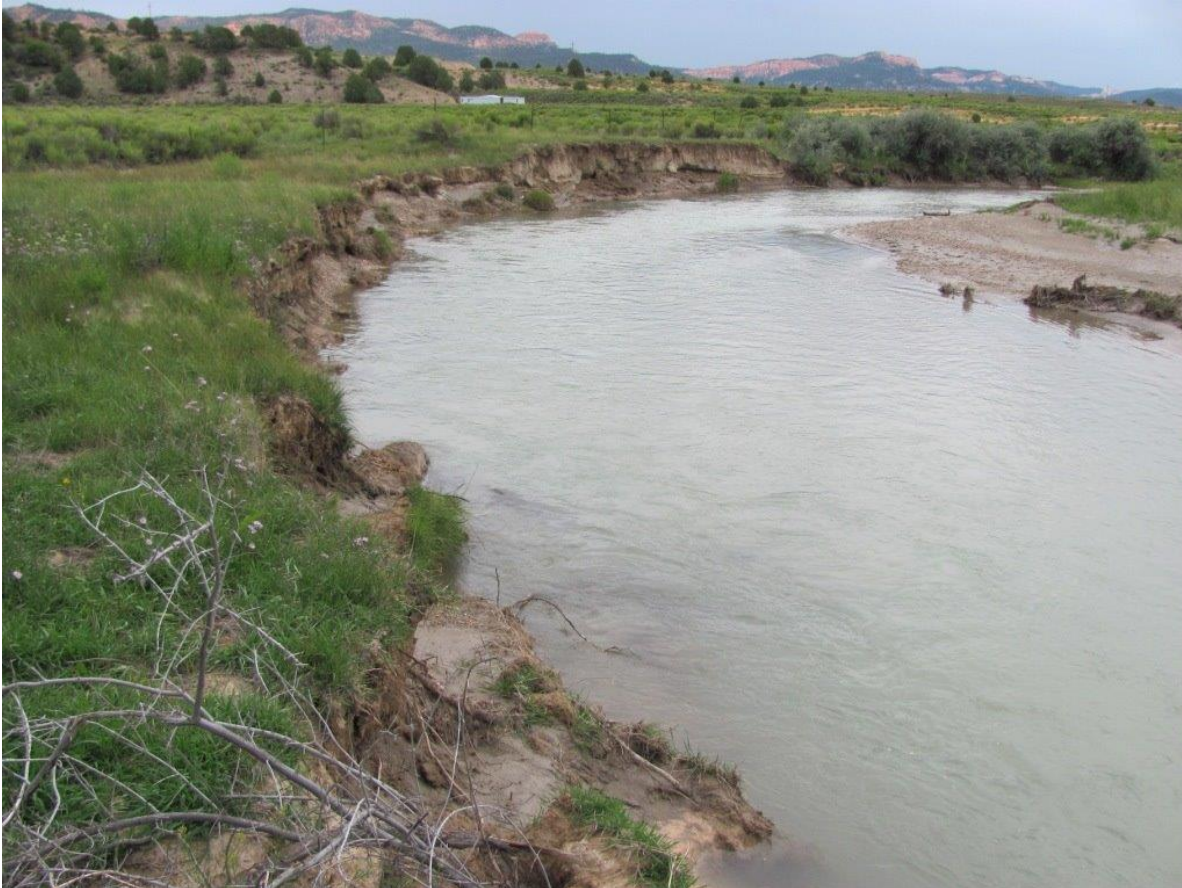
DWR WRI Bank 1 Before Project Implementation.

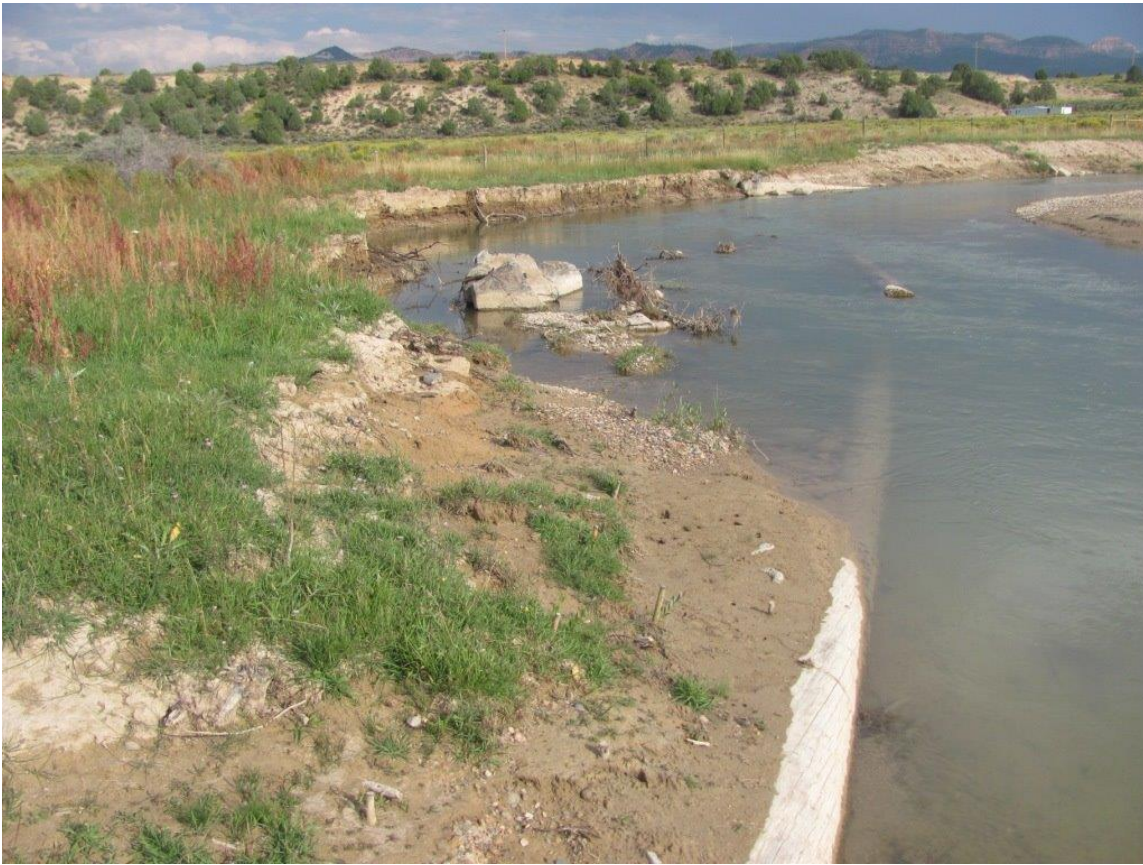
there are problems with 7 vanes covering about 450' of bank. It is important to repair these small sections before they get worse and to complete work on the last bank where we ran out of rock and time. The high flows also washed out some of the new fencing that was constructed. Temporary fencing has been built to control livestock, but the damaged fence sections need permanent repair. The project greatly improved fish habitat in this section of the Sevier River and fingerling trout were stocked for the first time this summer. New vegetation growth is looking very good.

DWR WRI Bank 1 After One Year Needing Minor Repair.

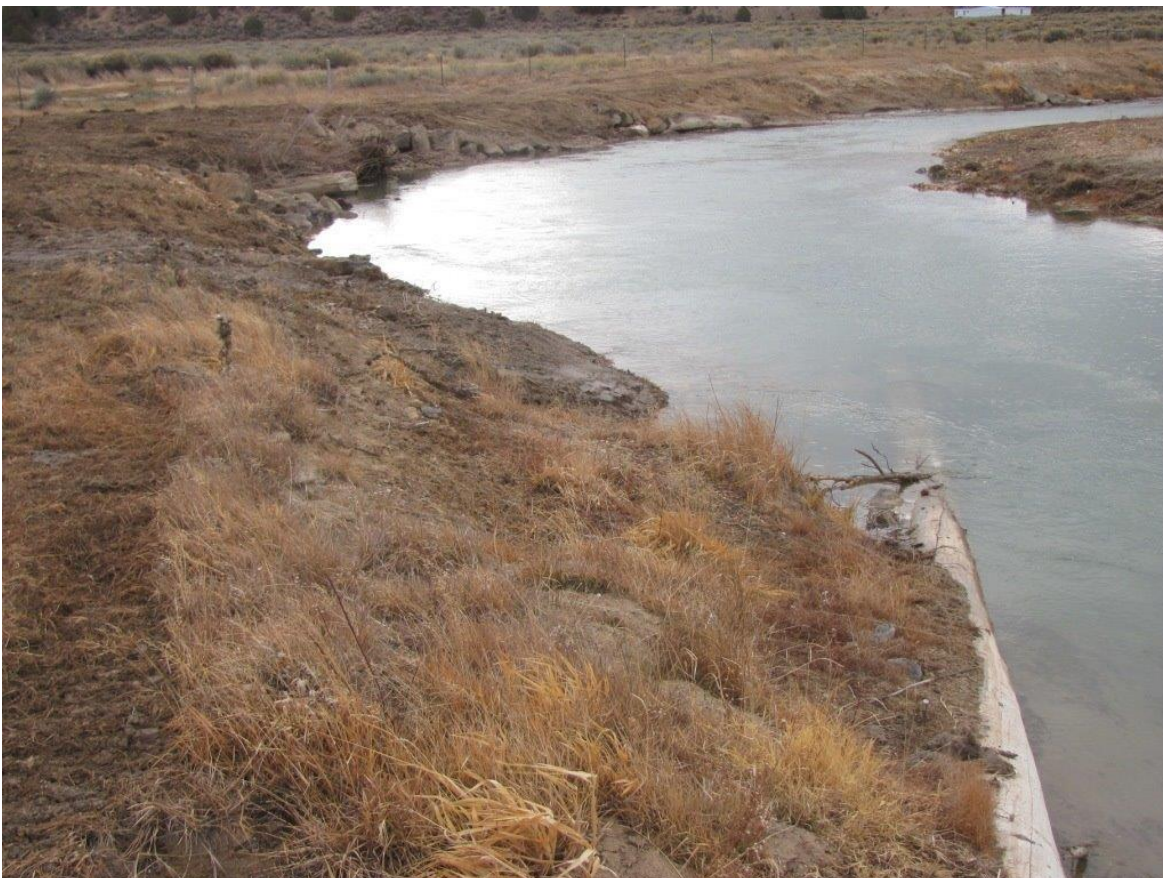
DWR WRI Project Bank 2 After Two Years With Repair Work Completed.

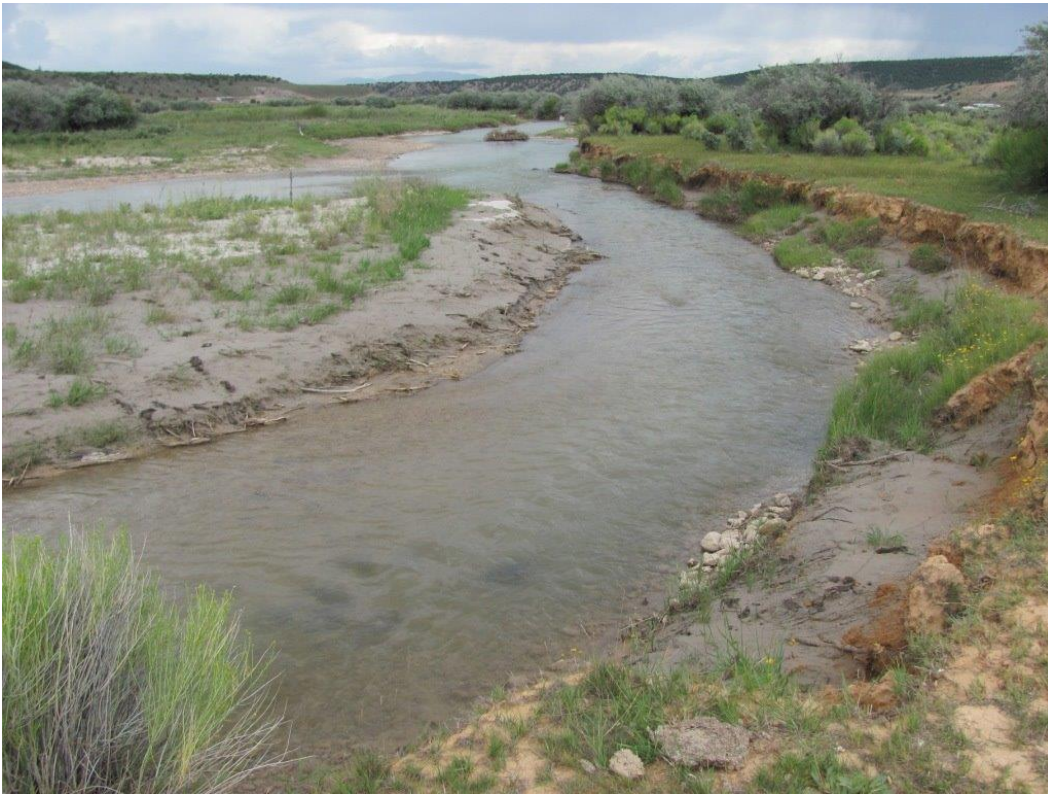
DWR WRI Project Bank 2 before Implementation.

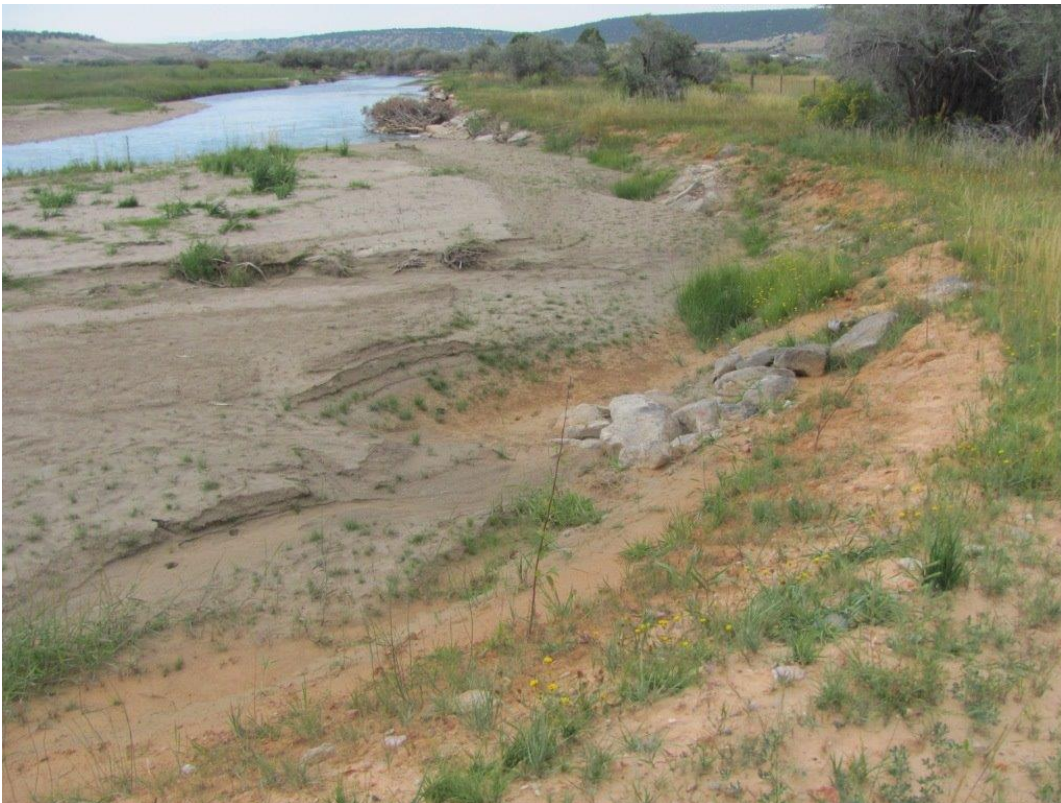
DWR WRI Project Bank 2 After Implementation.

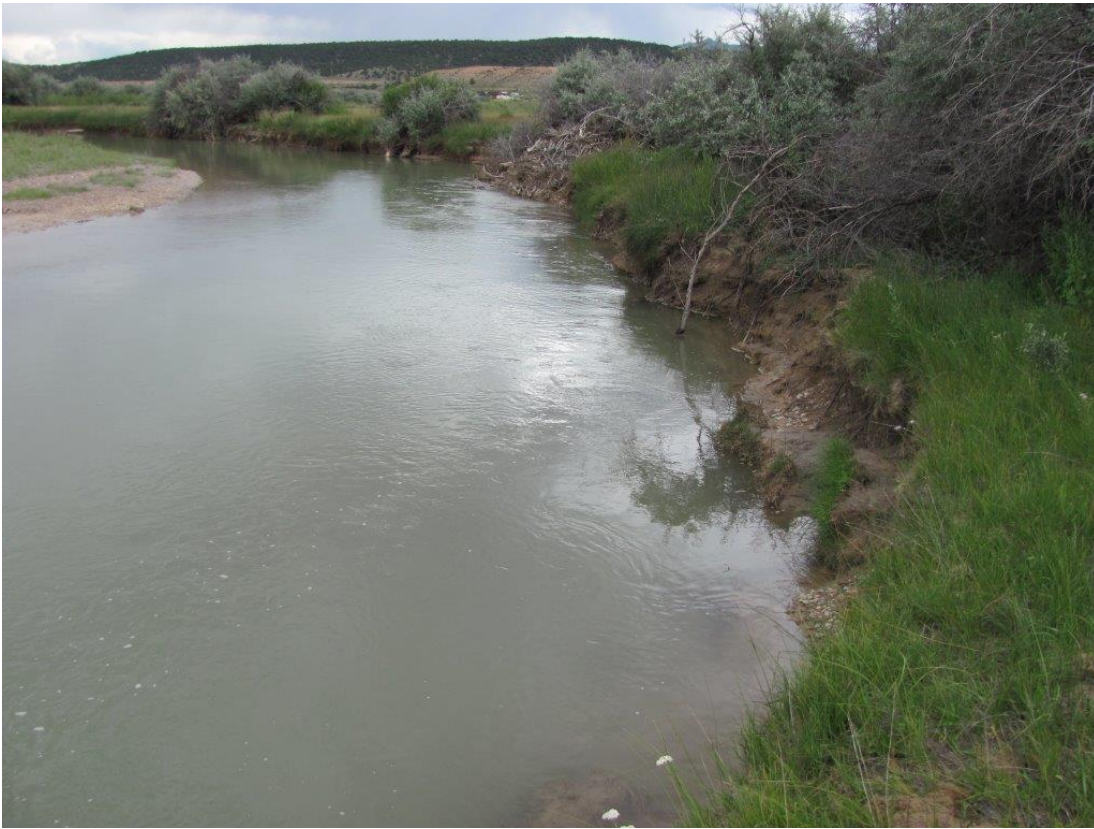
DWR WRI Project Bank 3 Before Implementation

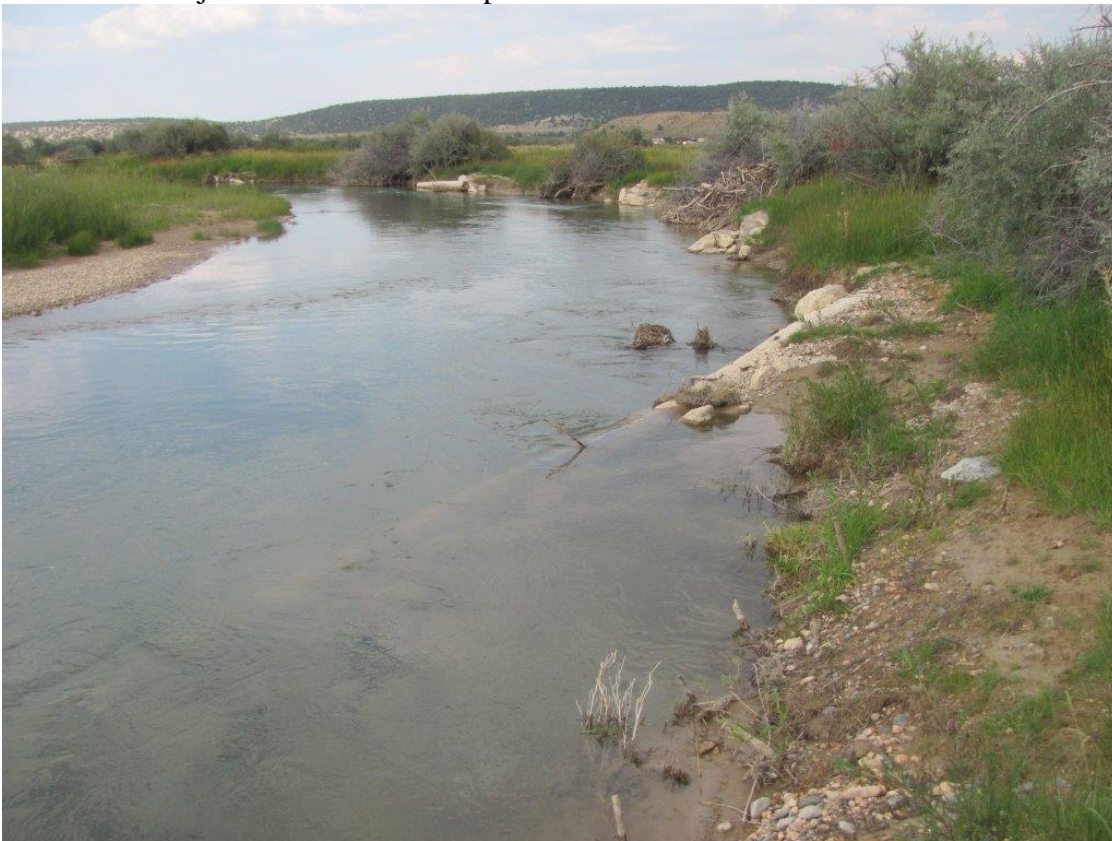
DWR WRI Project Bank 3 After Implementation

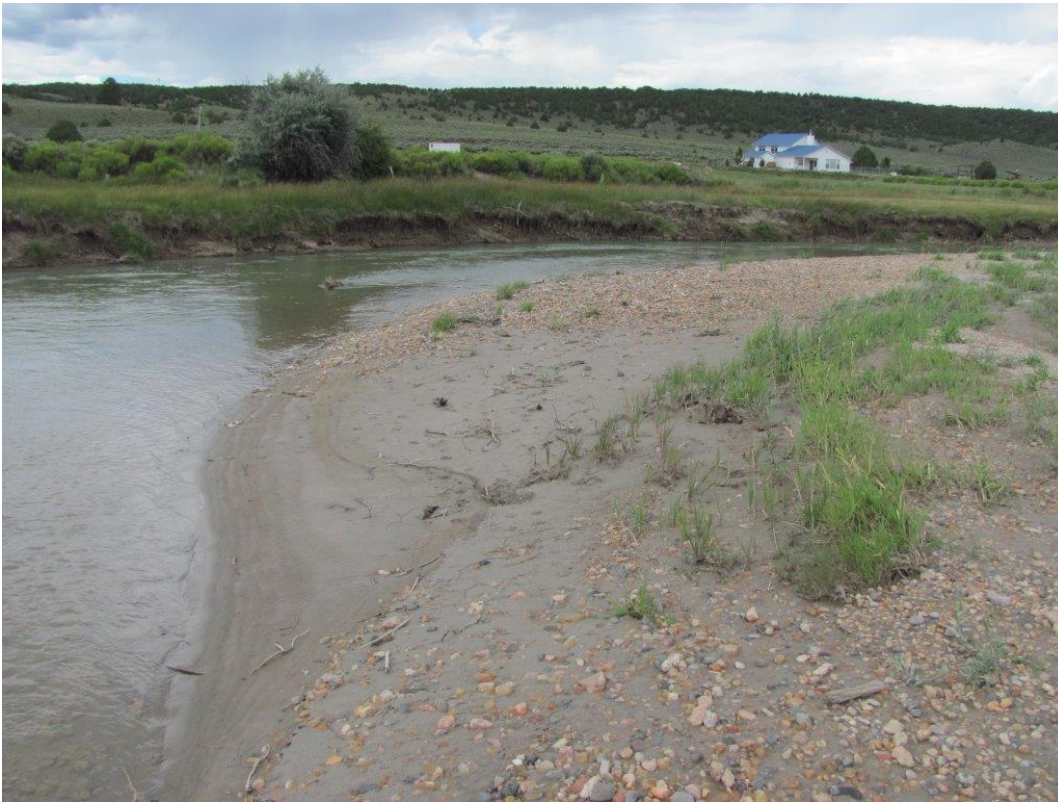
DWR WRI Project Bank 4 Before Implementation.

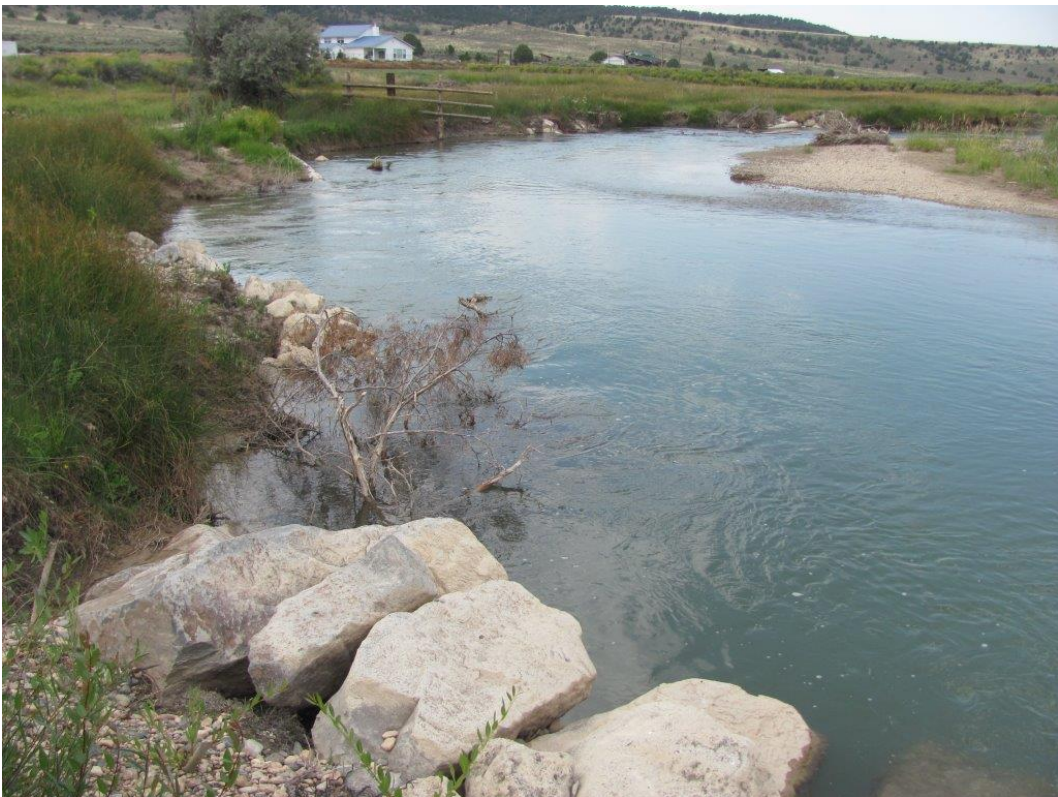
DWR WRI Project Bank 4 After Implementation

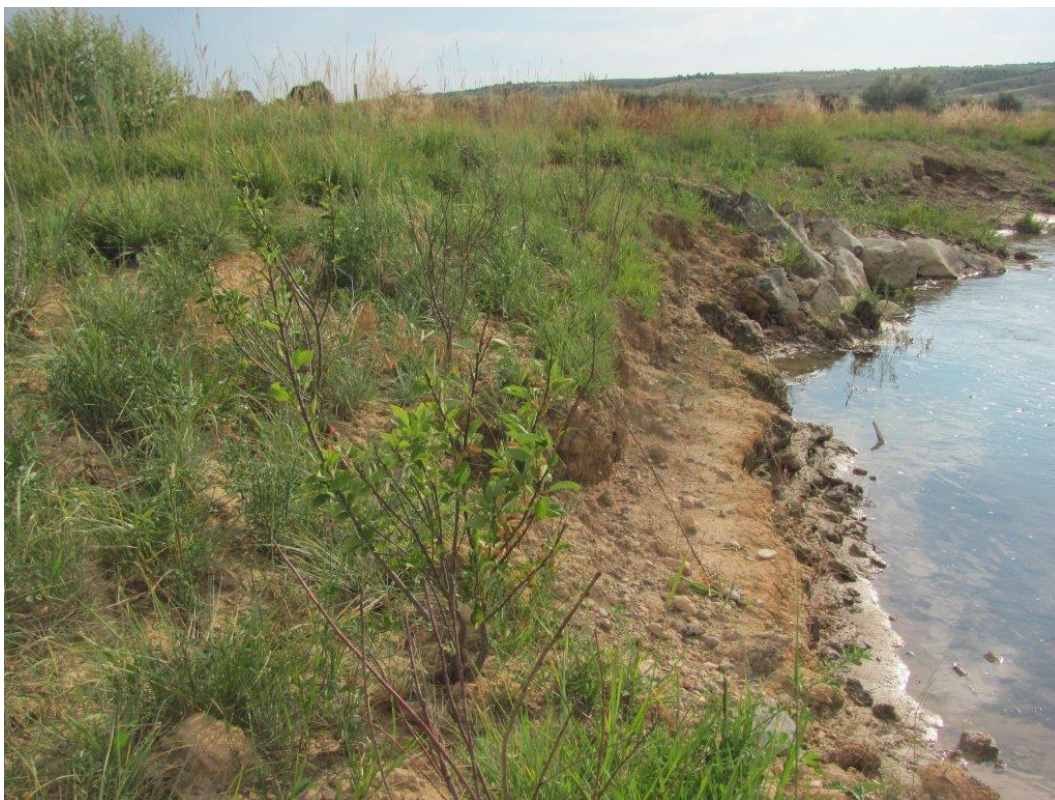
DWR WRI Project After Implementation with Barb Installation and Willow Growth.

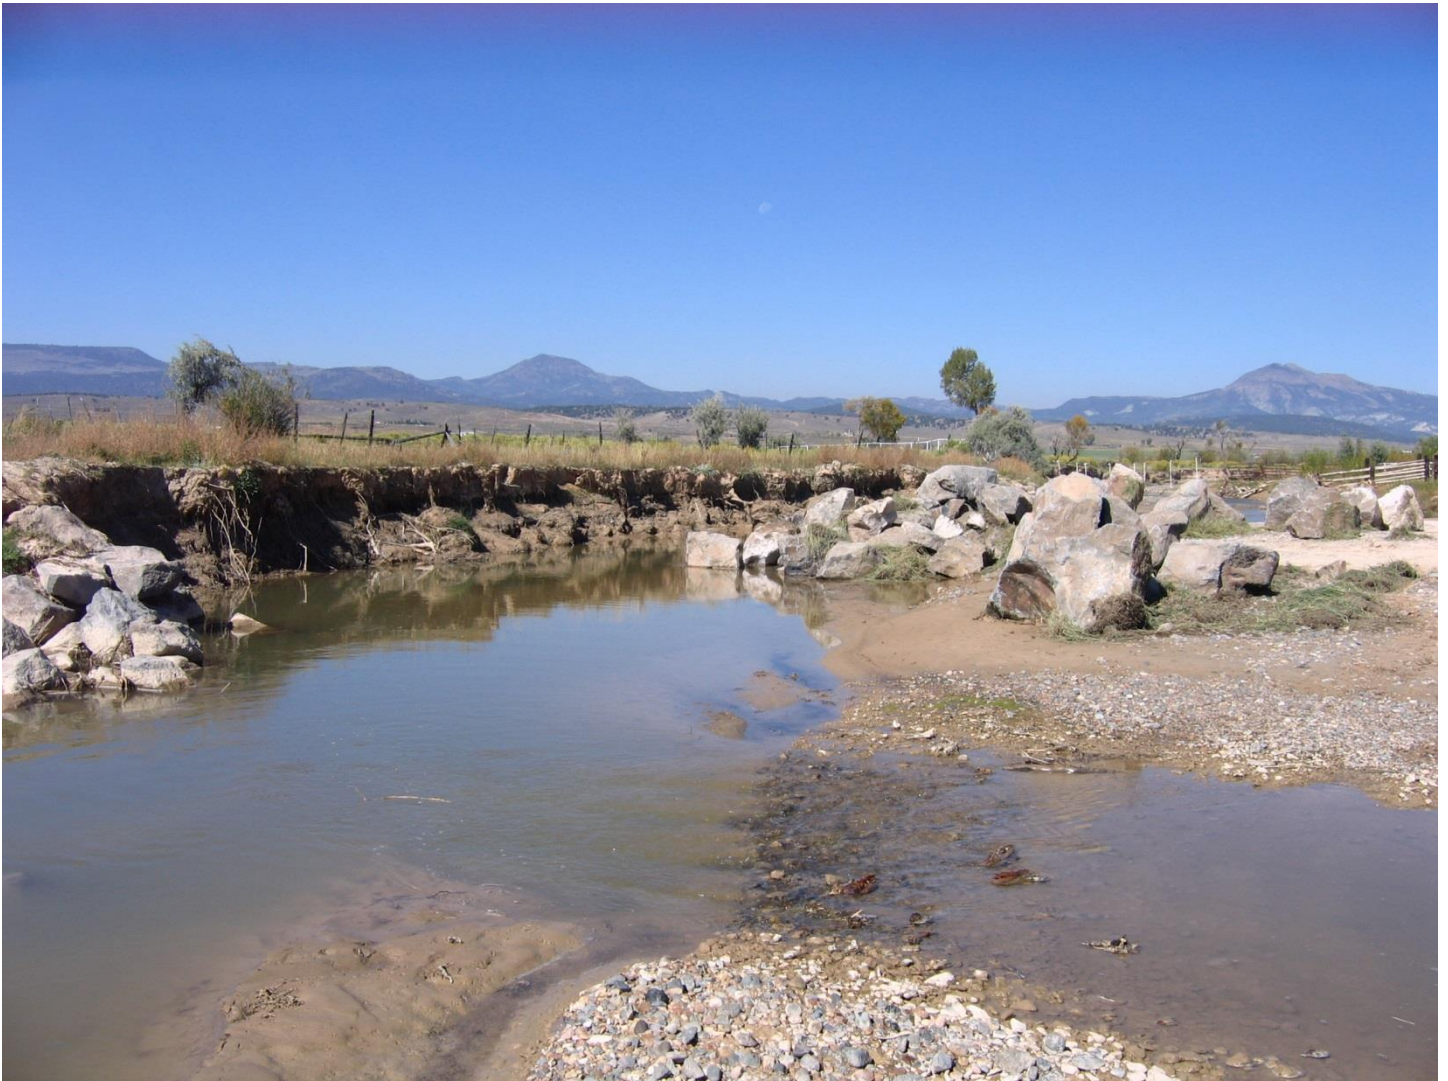
Gregg Excell Bank Erosion Before Project Implementation

Product: In fall 2010 approximately 1,055 feet of stream bank was treated with rock structures, riparian plantings, and riparian fencing for grazing management. The spring following the installation of this project produced an extremely large amount of run off and several places that work was completed got washed away. The remaining money in this contract was used to repair these failed structures. We also had 35 high school freshmen come and plant willows, native grasses, and woody riparian species to help control erosion.

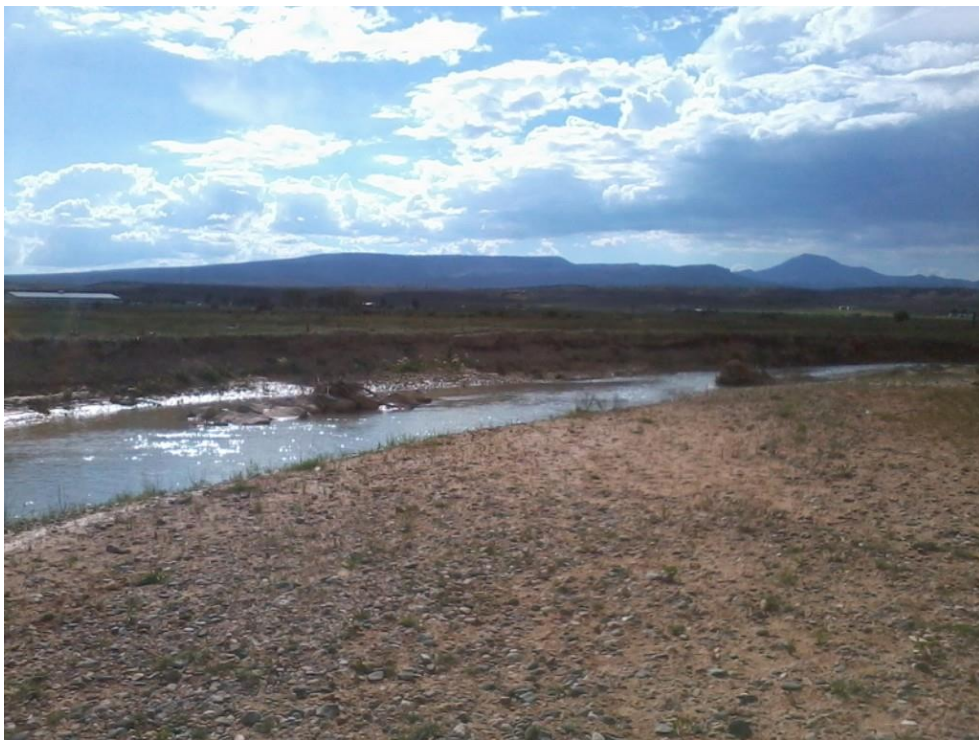
Gregg Excell Bank 1 Before

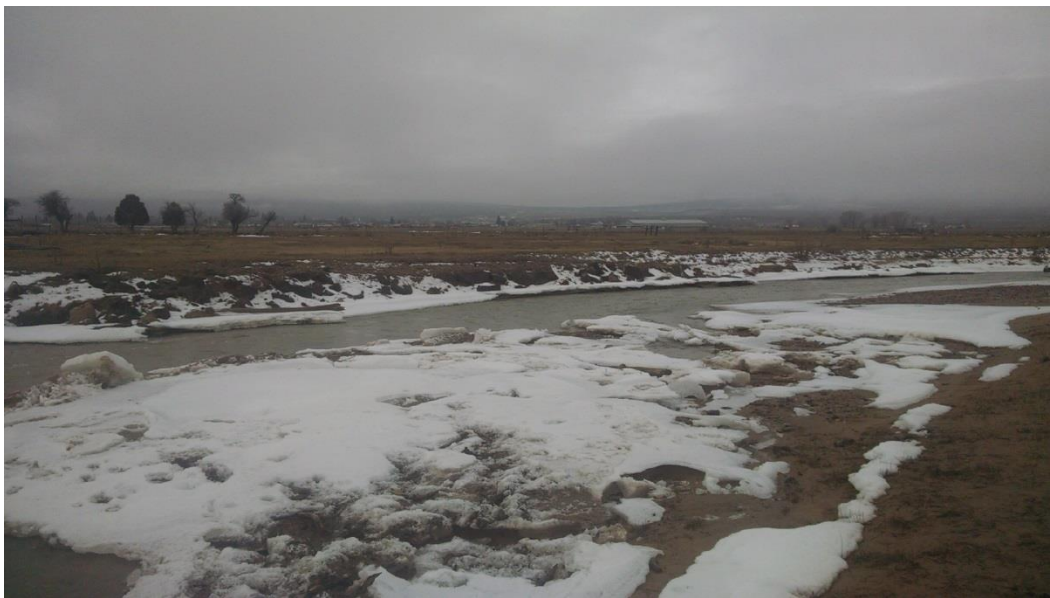
Gregg Excell Bank 1 After

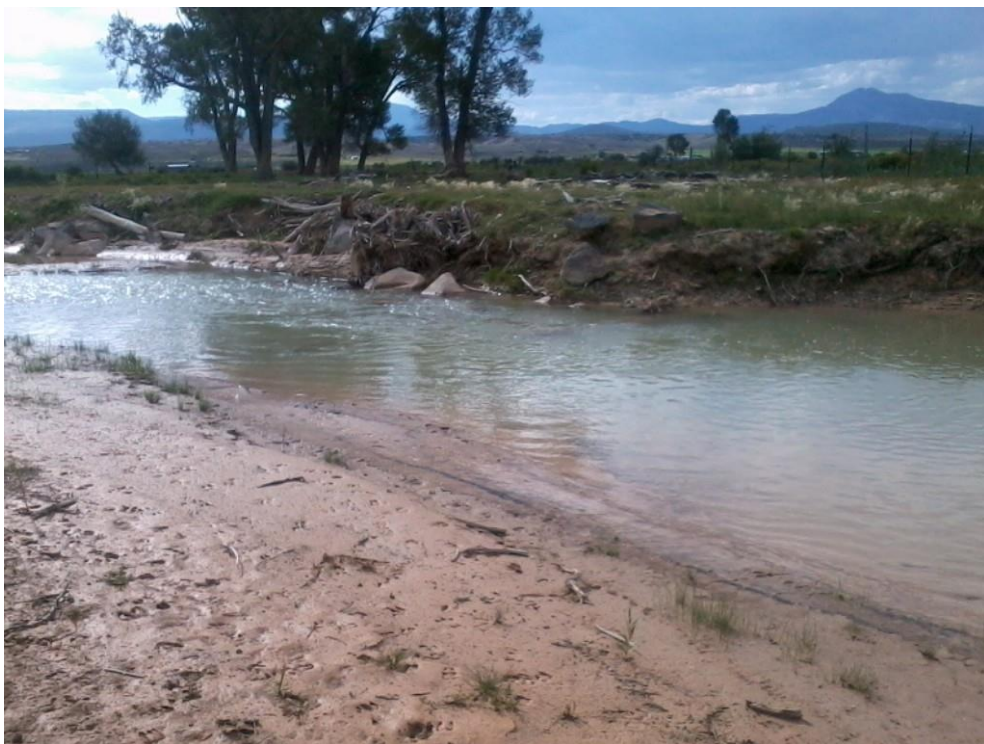
Gregg Excell Bank 2 Before

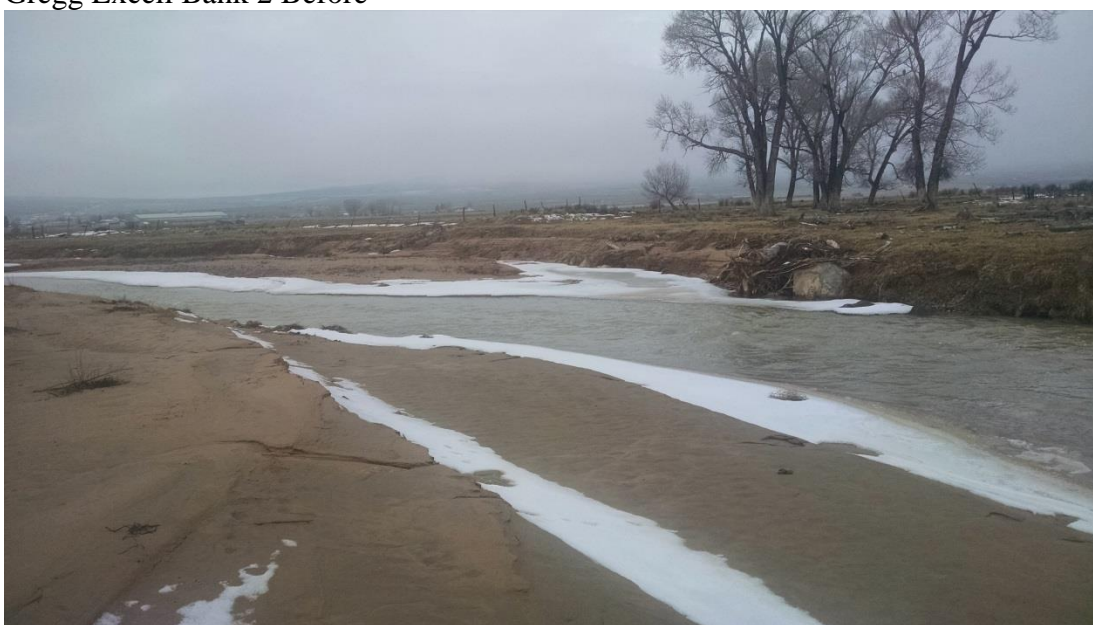
Gregg Excell Bank 2 After Showing Barb Installation

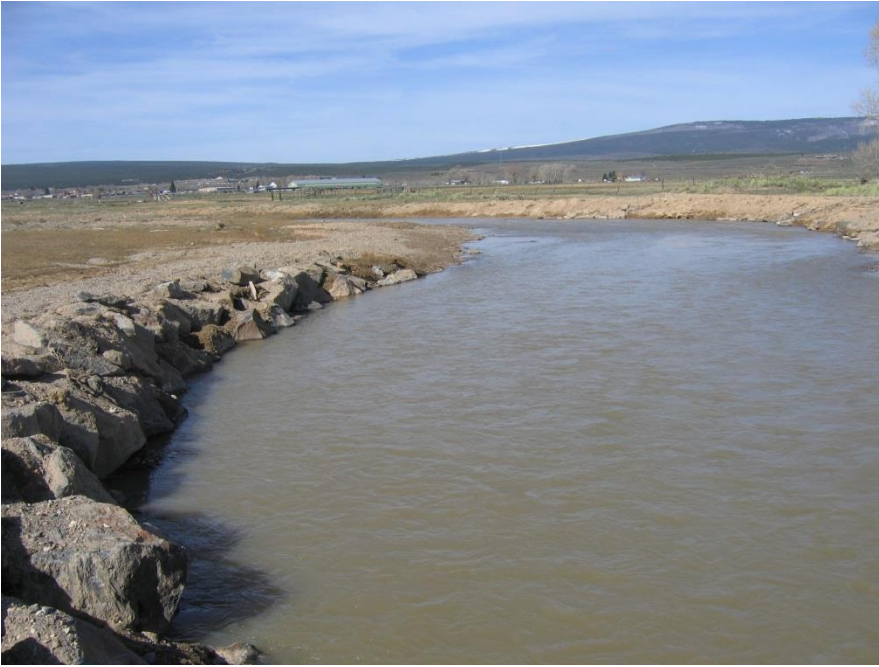
Greg Excell After Implementation showing Rock Installation and Bank Sloping.

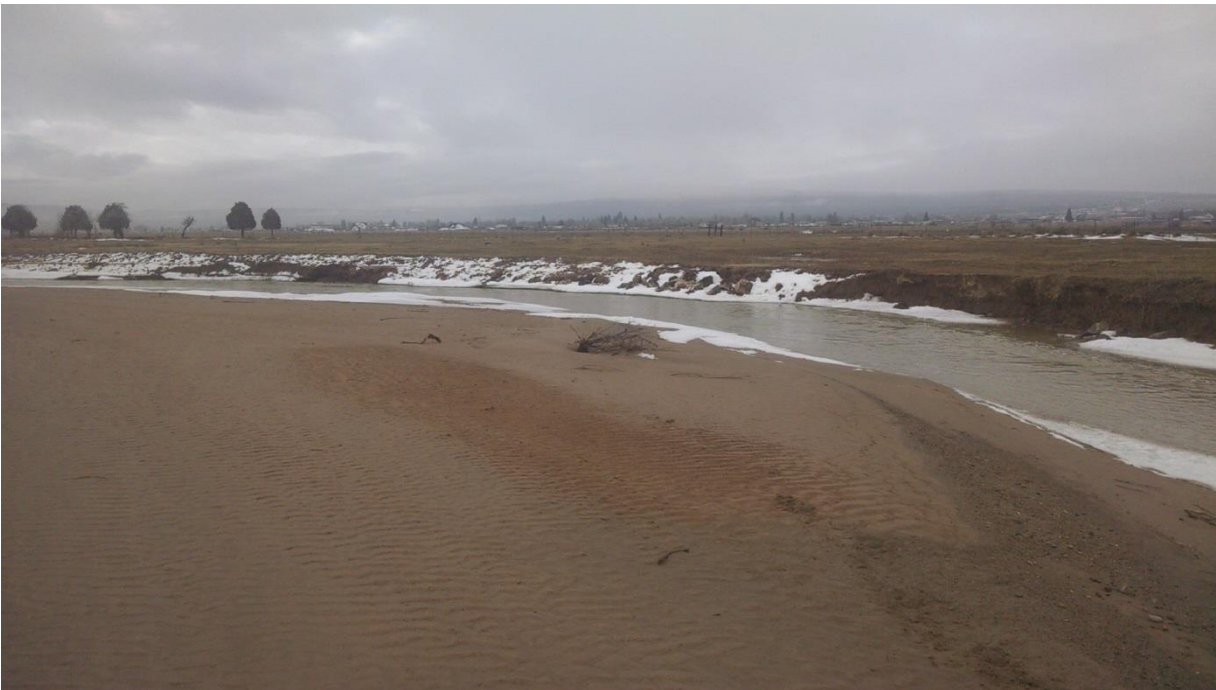
Gregg Excell After Showing Gank Sloping.

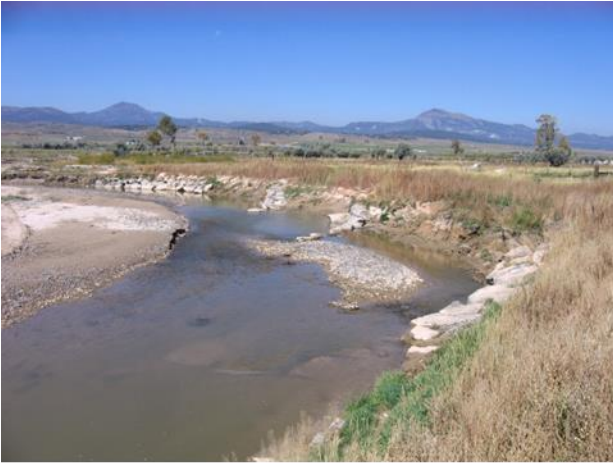
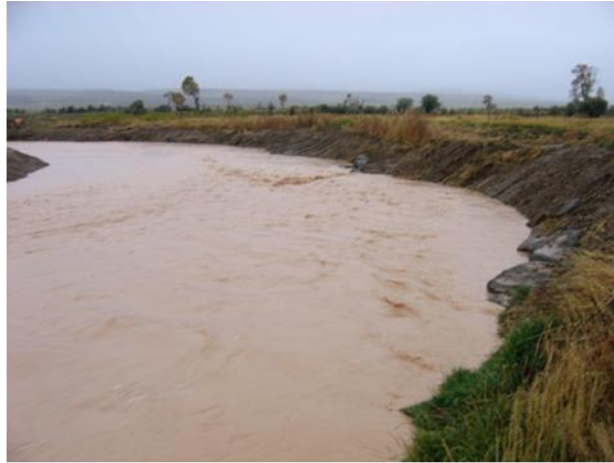
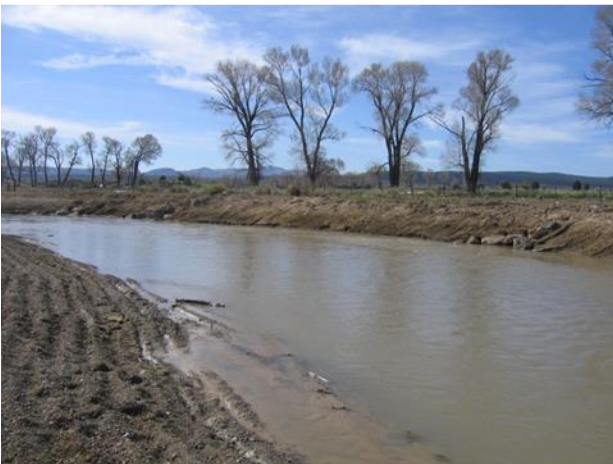
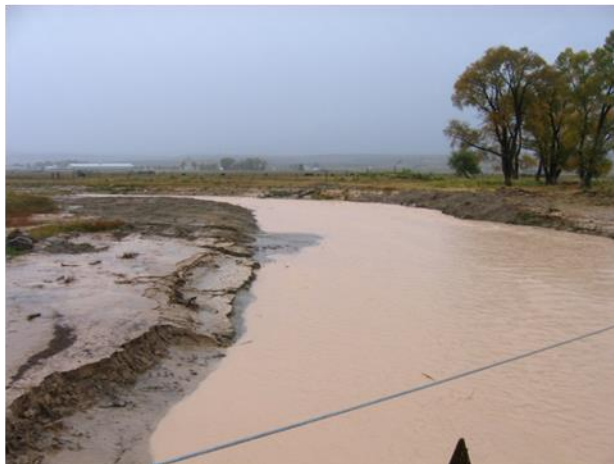
Gregg Excell Project with Bank Stabilization Completed and during Flood Conditions.
