CLEAN WATER ACT SECTION 319
NONPOINT SOURCE POLLUTION CONTROL PROGRAM
WATERSHED OR DEMONSTRATION PROJECT FINAL REPORT

UPPER SEVIER RIVER WATERSHED

January 14, 2014

Grant # 10-0422

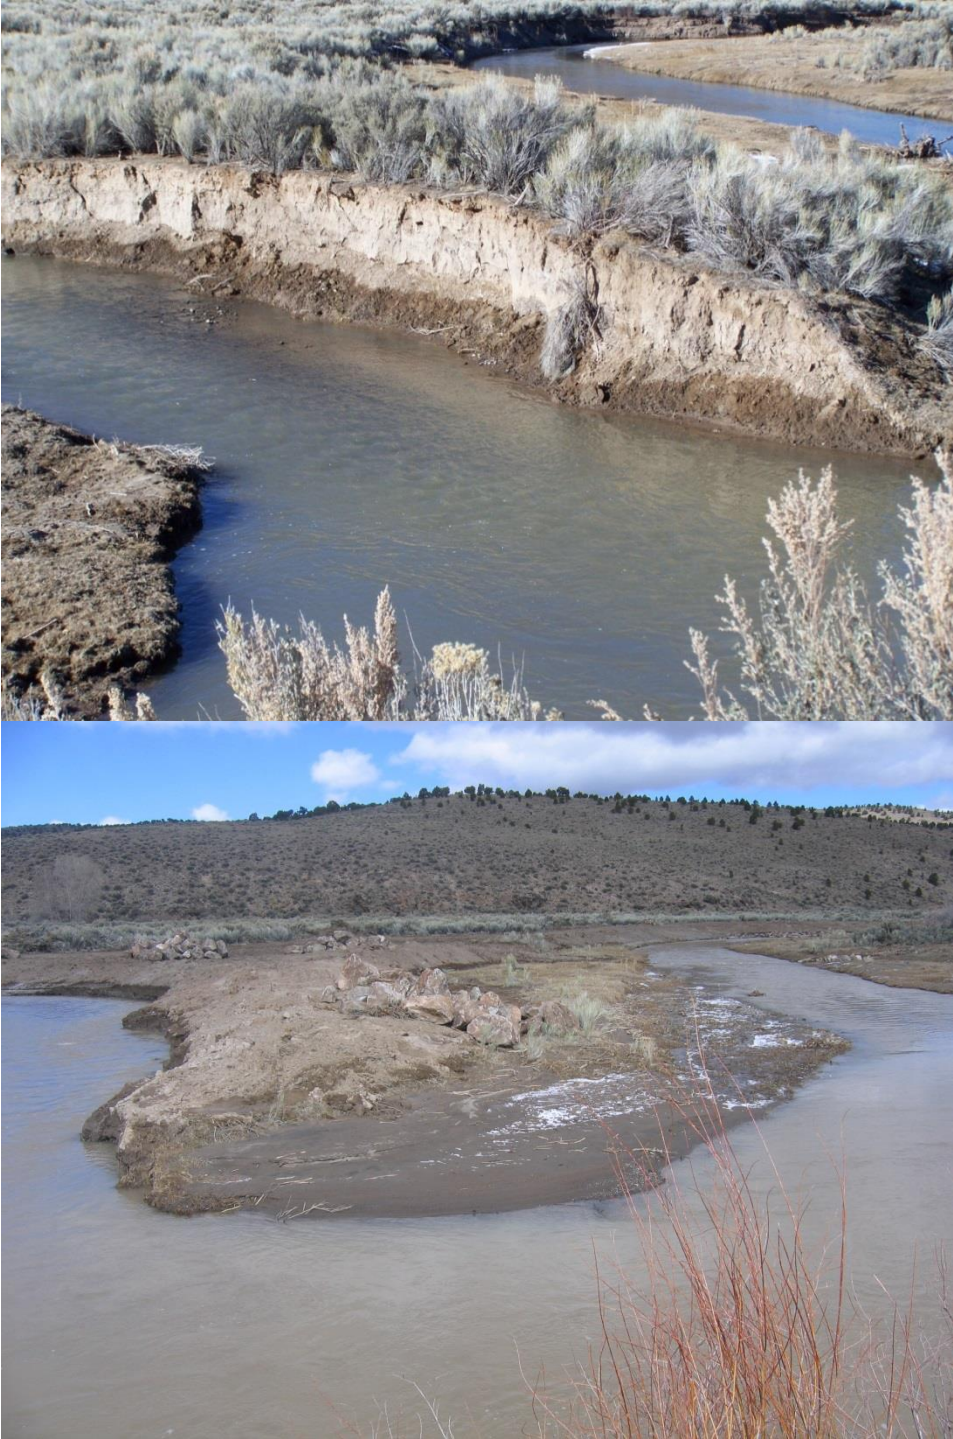
Tim Westwood Project Before and After Implementation.

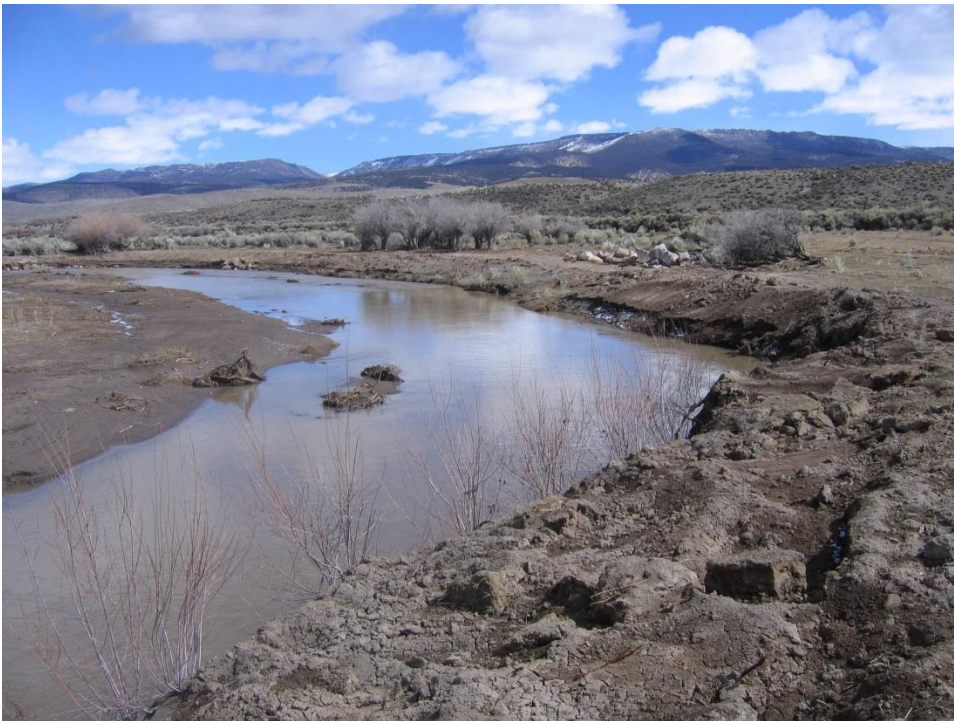
Tim Westwood Project with Willow Growth and minor Bank Erosion After Implementation.
