# Section 319 Nonpoint Source Pollution Control Program Watershed Project Final Report

## Wallsburg Watershed Improvement Project

FY 2014

The Wasatch Conservation District  
Daniel Gunnell (District Resource Coordinator)

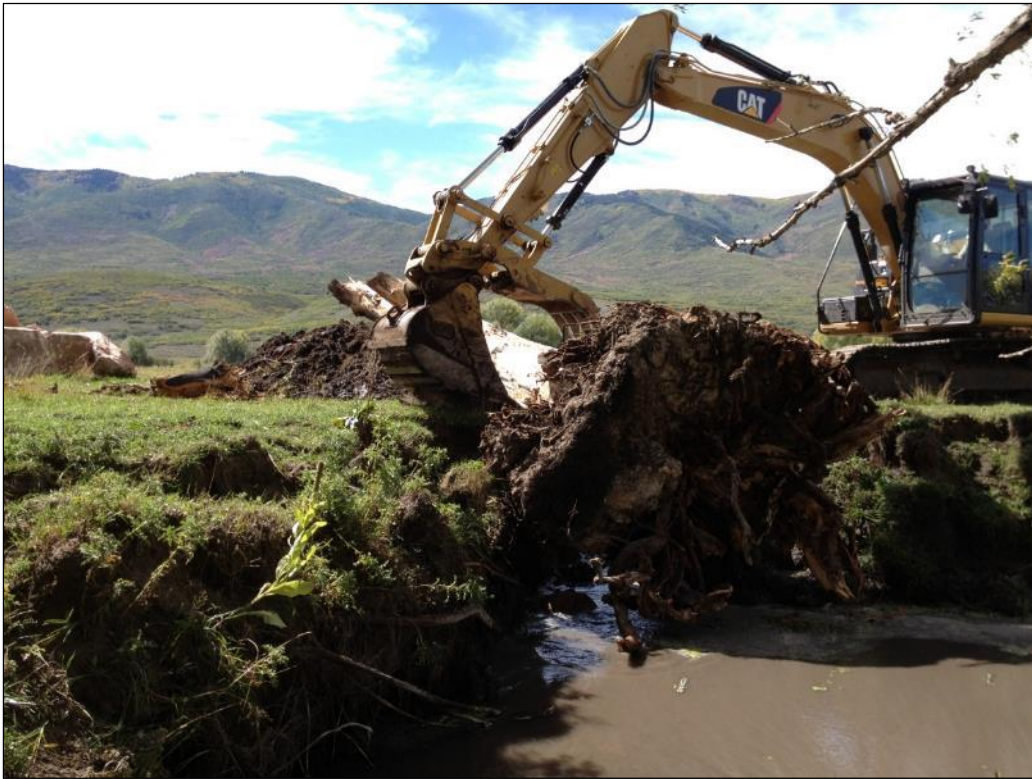
*Figure 1: Project Work on Main Creek in the Wallsburg Watershed*

To date, 3.22 miles of stream have been restored. In some sections meanders were reinstalled, banks were pulled back to a 3:1 slope. The disturbed areas were seeded and a wide assortment of riparian vegetation was planted. Other sections used soil lifts wrapped with coconut fiber mesh. A seed mixture was spread below the fabric and native vegetation was planted. Over 10,000 willow cuttings were inserted through the coconut fiber. 5 miles of fencing has been installed. Unrestricted access to the stream by livestock has been reduced. Water gaps and crossings were installed to allow cattle selective water access and movement between pastures.

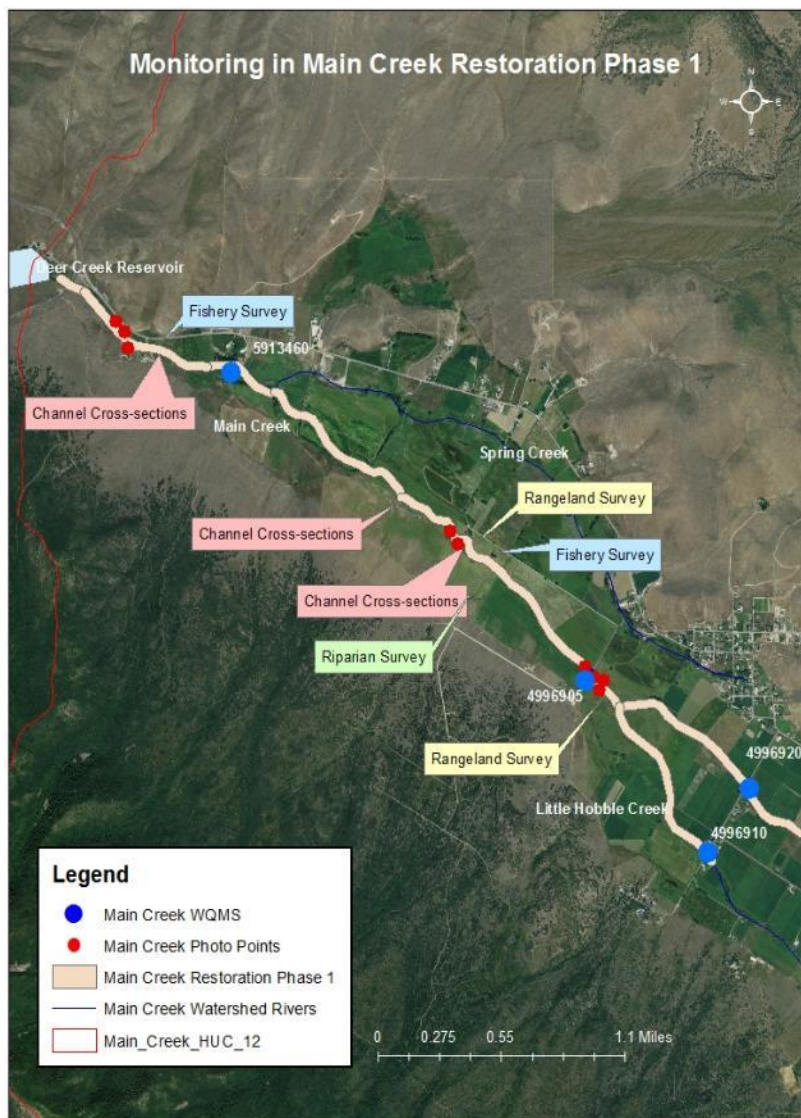
Map 2: Monitoring Strategies within the Wallsburg Watershed.

Division of Water Quality. Refer to Map 2 for monitoring strategies. Effectiveness monitoring may be quantitative (e.g., laboratory analysis of total phosphorous (TP), and E. coli concentrations in water from specific sub-basins, or in water exiting private property) or qualitative (e.g., visual observation of sediment reduction in the water passing through a fenced riparian area), depending on the BMP implemented and the scope and overall size of the project. Although quantitative monitoring methods can document actual concentrations of TP and E. coli, the size of the stream restoration projects and the small timeframe allotted for accumulating monitoring results, forces the chemical grab samples to be inefficient and incapable of reflecting

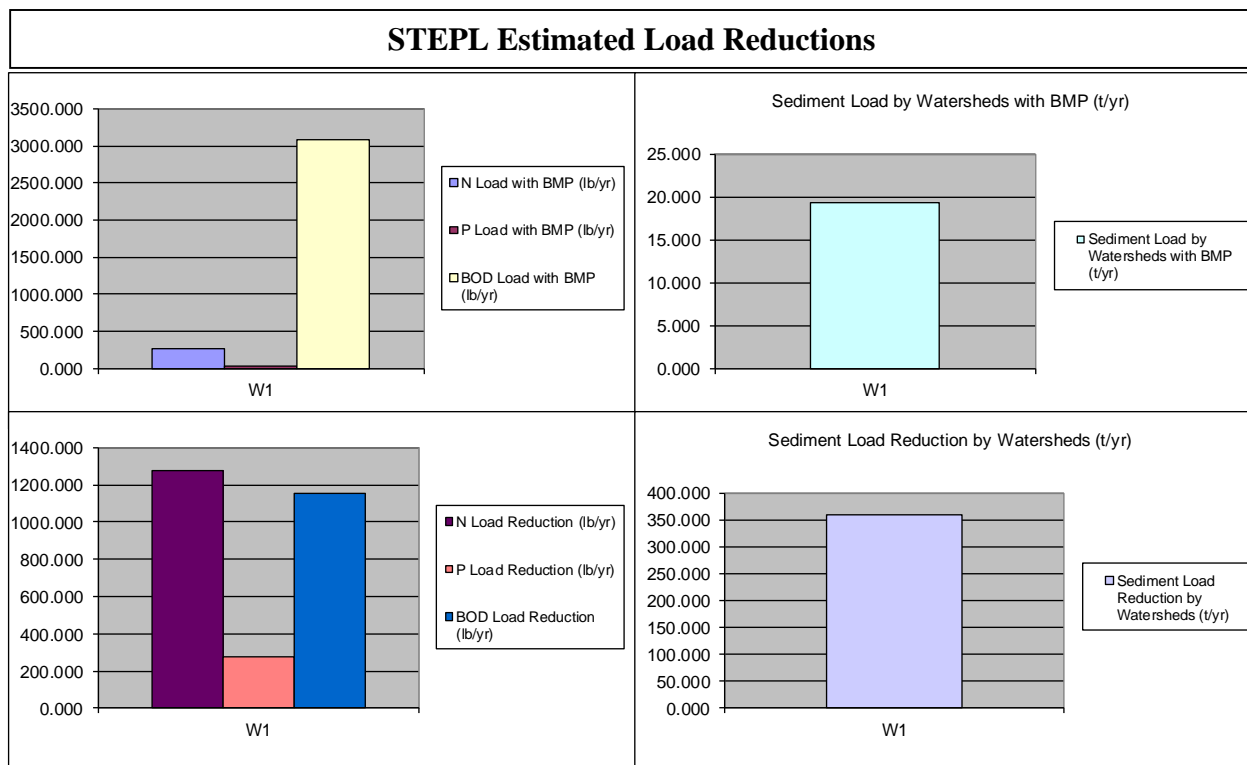
Graph 3: STEPL Estimated Load Reductions.

The upper left graph demonstrates the drainage load of N, P, and BOD with the BMP in place. Lower left are the load reductions. Upper right is the sediment load with the BMP in place, while the lower right is the sediment load reduction.

Shown below, Graph 3 demonstrates the load reductions of nitrogen, phosphorus,

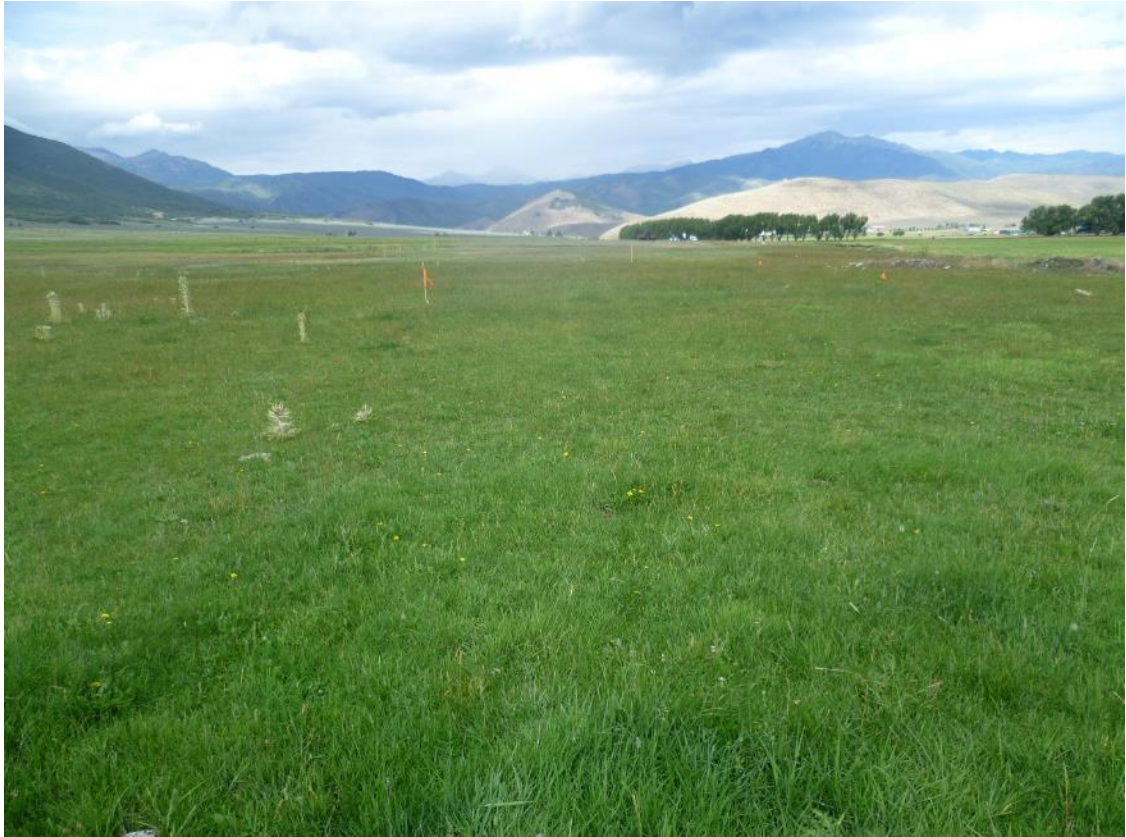
*Figure 4: Main Creek Before: Flags show where meanders will be reinserted.*

**Product:** 3.22 miles of stream have been restored. In one section, the NRCS engineer decided that pulling the banks back to a 3:1 slope was the best option. (Phase 2) This section of stream was arrow straight and prone to down-cutting. Meanders and were reinstalled along with the sloping. (Refer to figures 4 through 6 in the appendix.) 1,693 feet of stream was increased to 3,250. Rock clusters were installed throughout the section to help reduce water energy, slow water flow and reduce erosion. To further increase bank stabilization, 8,690 riparian plants were installed from a local nursery.

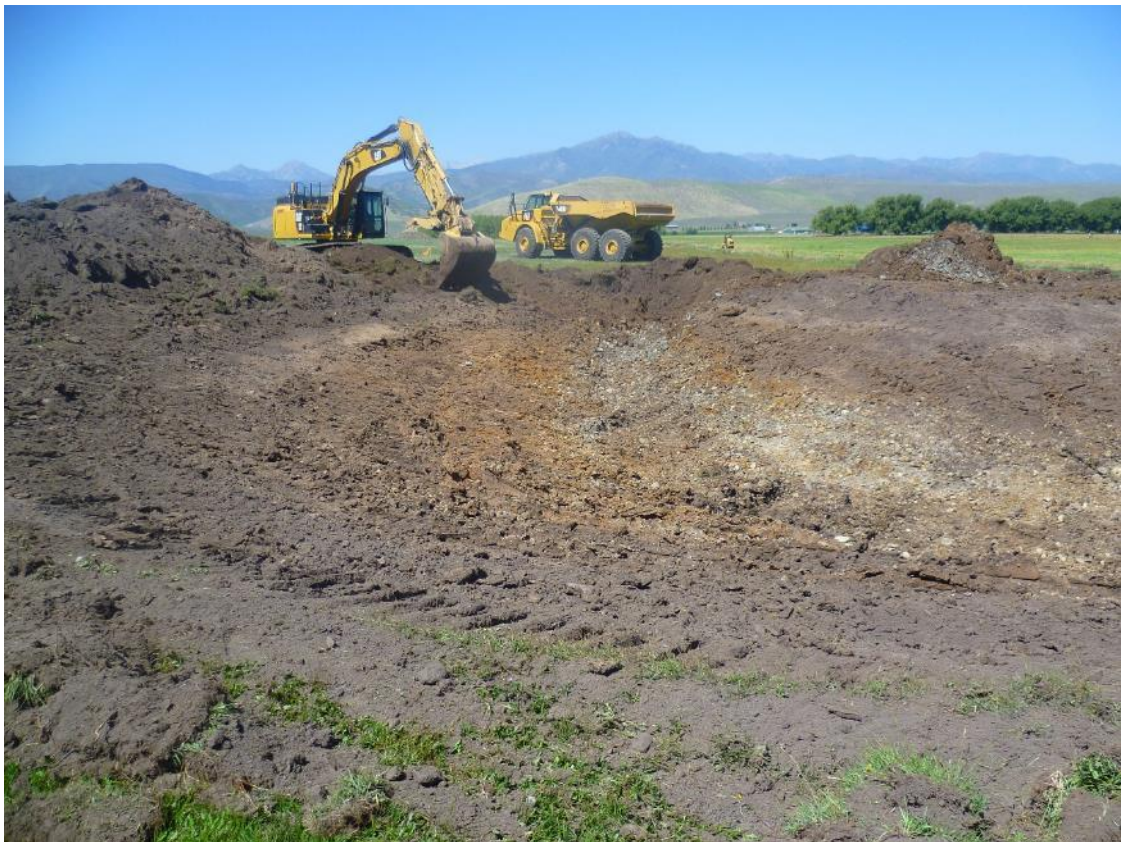
*Figure 5: Main Creek During: Banks are being sloped and stream meanders added.*

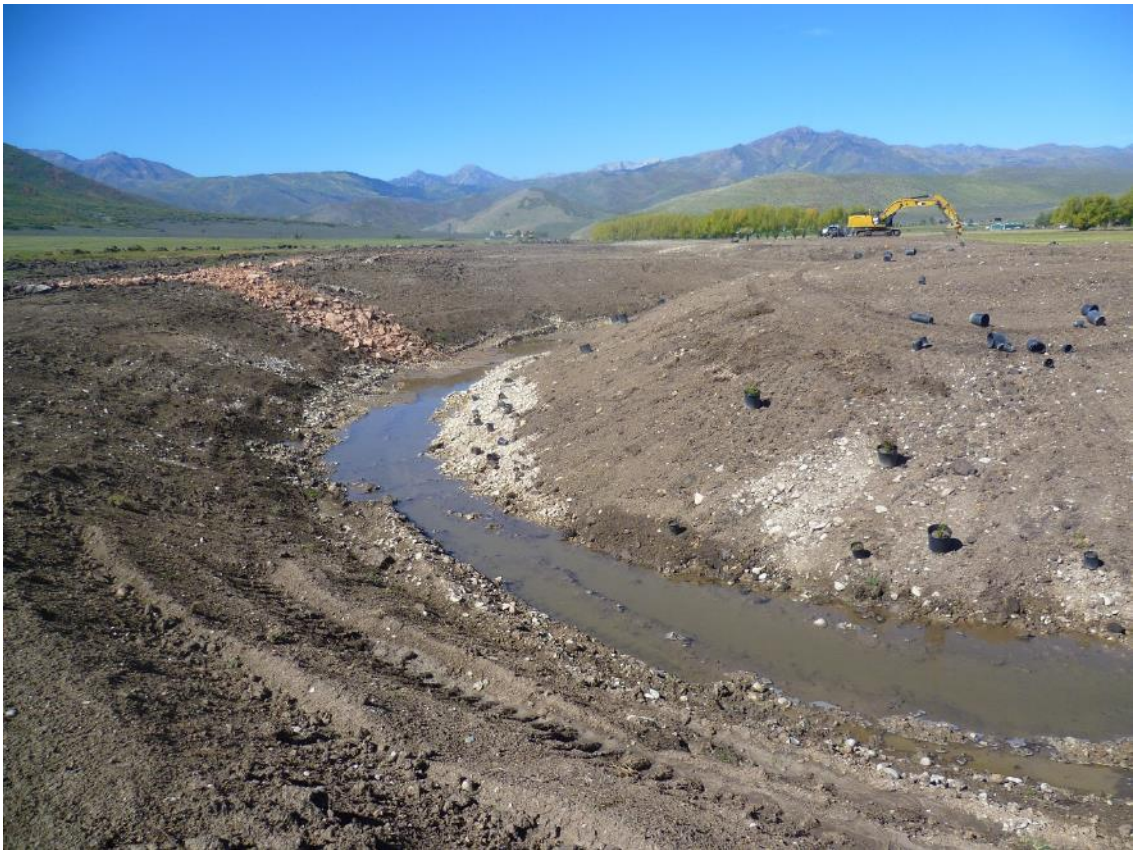
*Figure 6: Main Creek During 2: Riparian vegetation planting.*

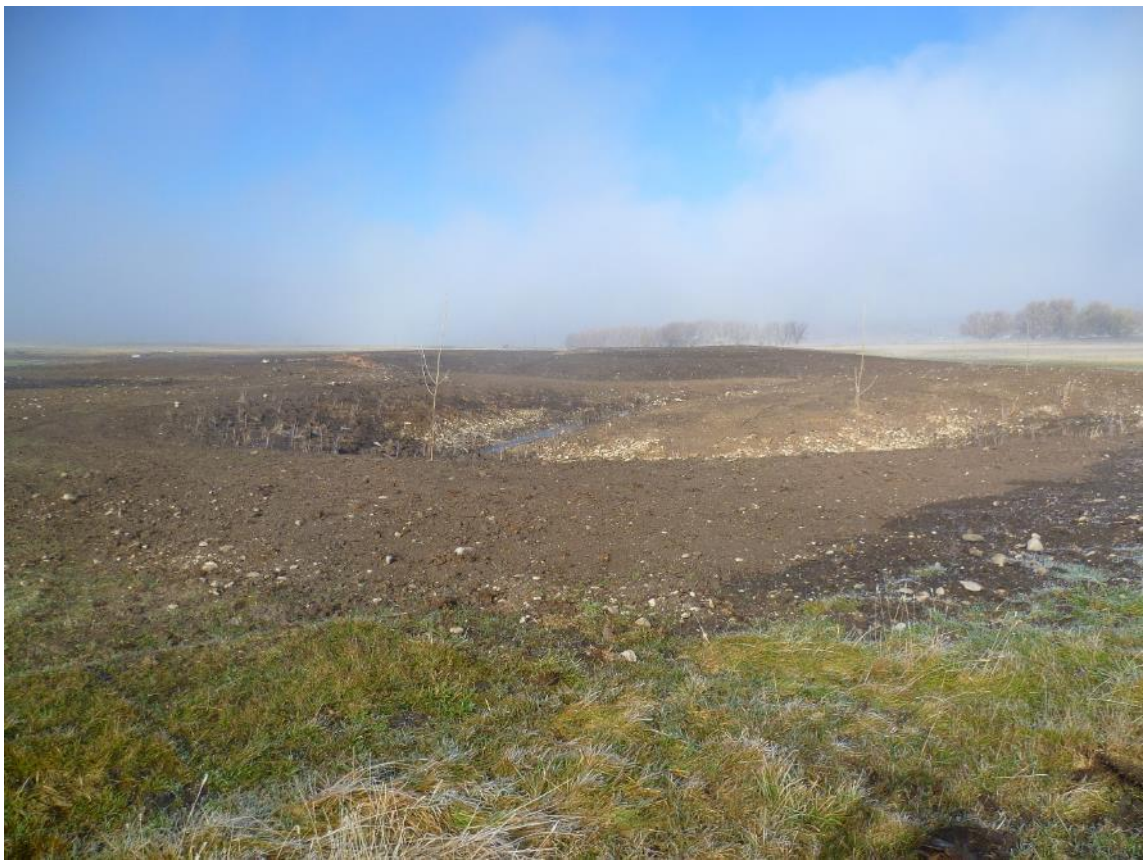
*Figure 7: Main Creek After. Seeding installed, vegetation planted.*

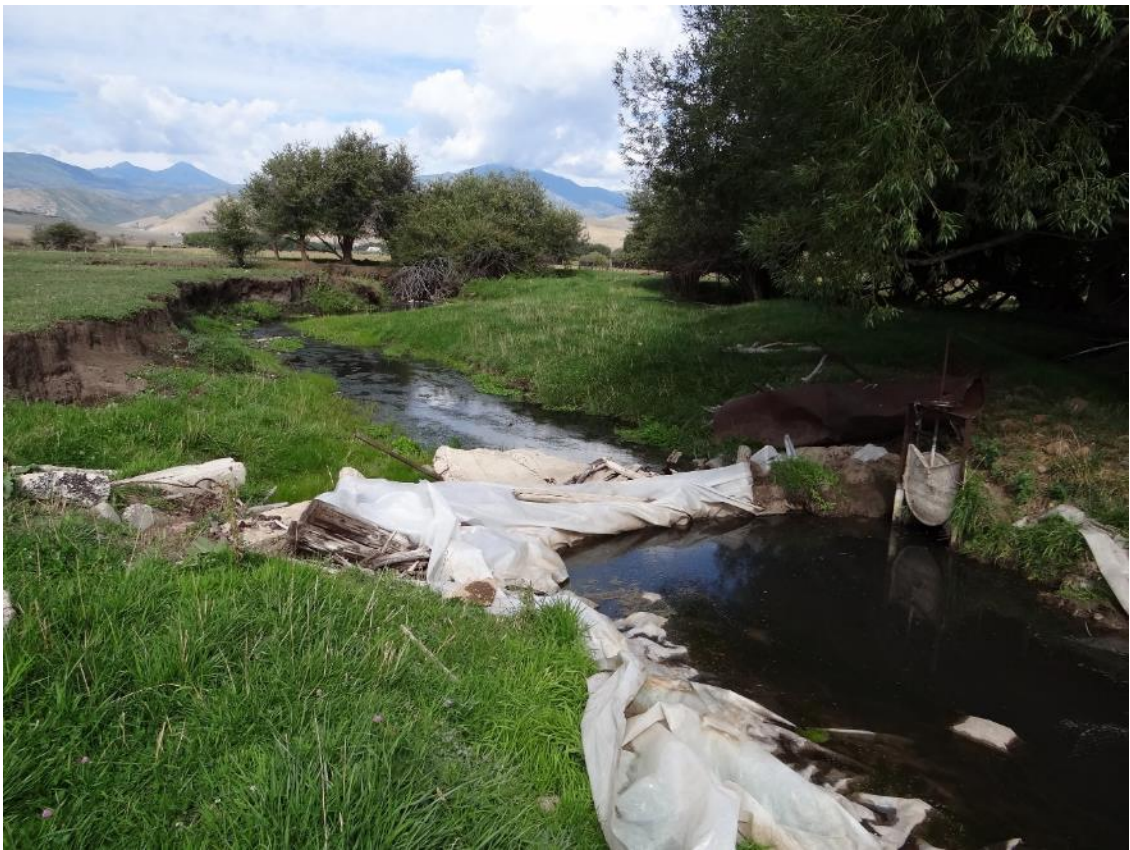
*Figure 8: Main Creek Before: Cross vane diversion site.*

In other sections, (Phase 1) soil lifts and coconut fiber laybacks were used. (Refer to figures 8 through 10 in the appendix.) Soil lifts indirectly enhance stream habitat through the creation of a stable stream bank toe and reduced sedimentation from erosion (Schueler, 2004). Many areas only required one soil lift, while another stretch of stream channel was deep enough to require three. Using soil lifts allows the inclusion of small flood plains on near the thalweg. River energy is more easily dissipated with the lifts. Each lift was wrapped in coconut fiber. Coconut fiber is used to immediately reduce bank erosion. A riparian seed mixture was spread below the fiber and more than 10,000 willow cuttings were inserted through the fiber matrix. An additional 3,990 riparian potted plants were installed. The added vegetation will increase bank stabilization and improve stream shading. Stream temperature will decrease as the amount of vegetation increases.

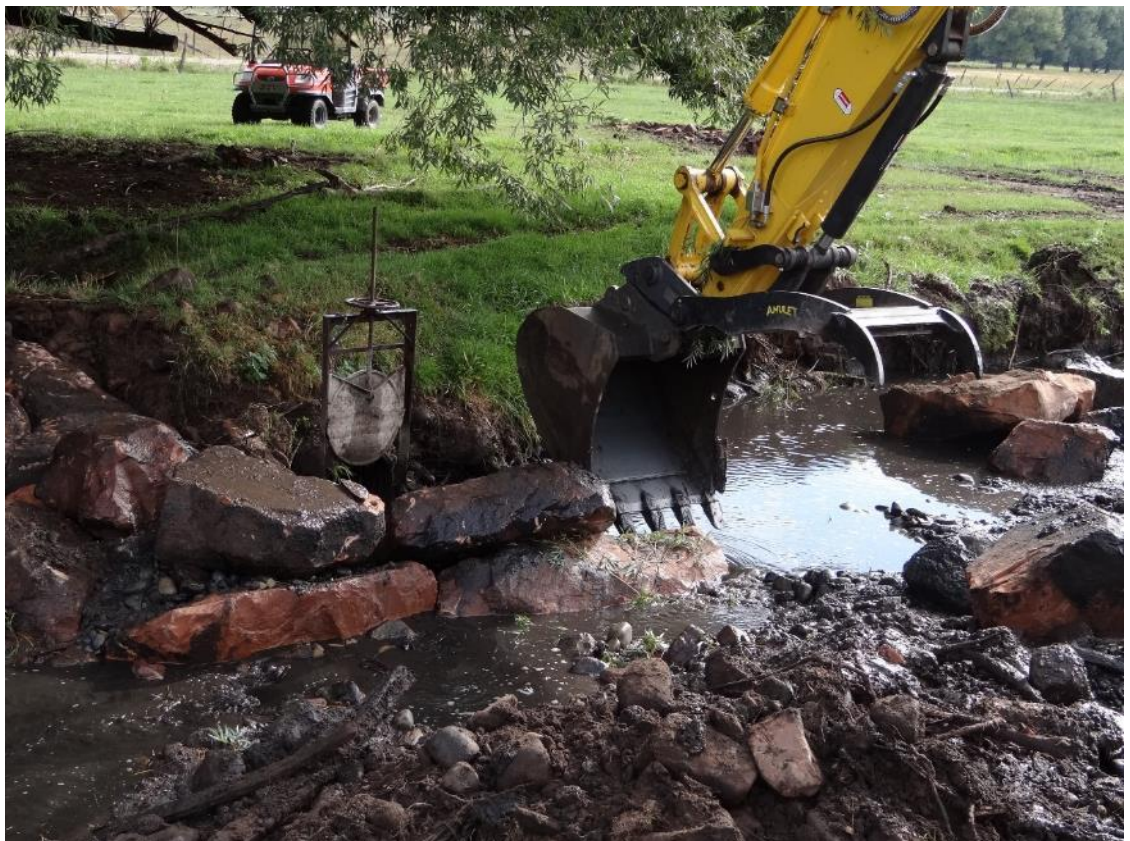
*Figure 9: Main Creek During: Cross vane installation and rock placement.*

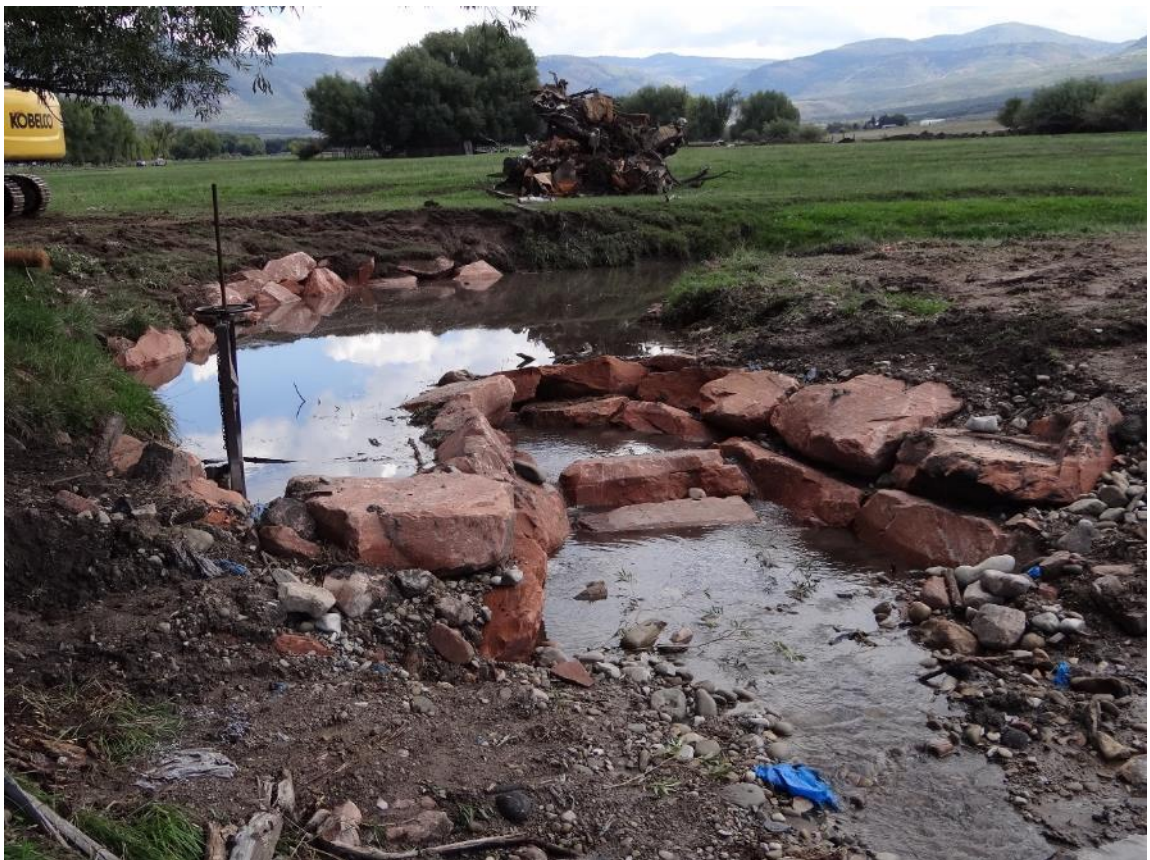
*Figure 10: Main Creek After: Cross vane installed, cars removed.*

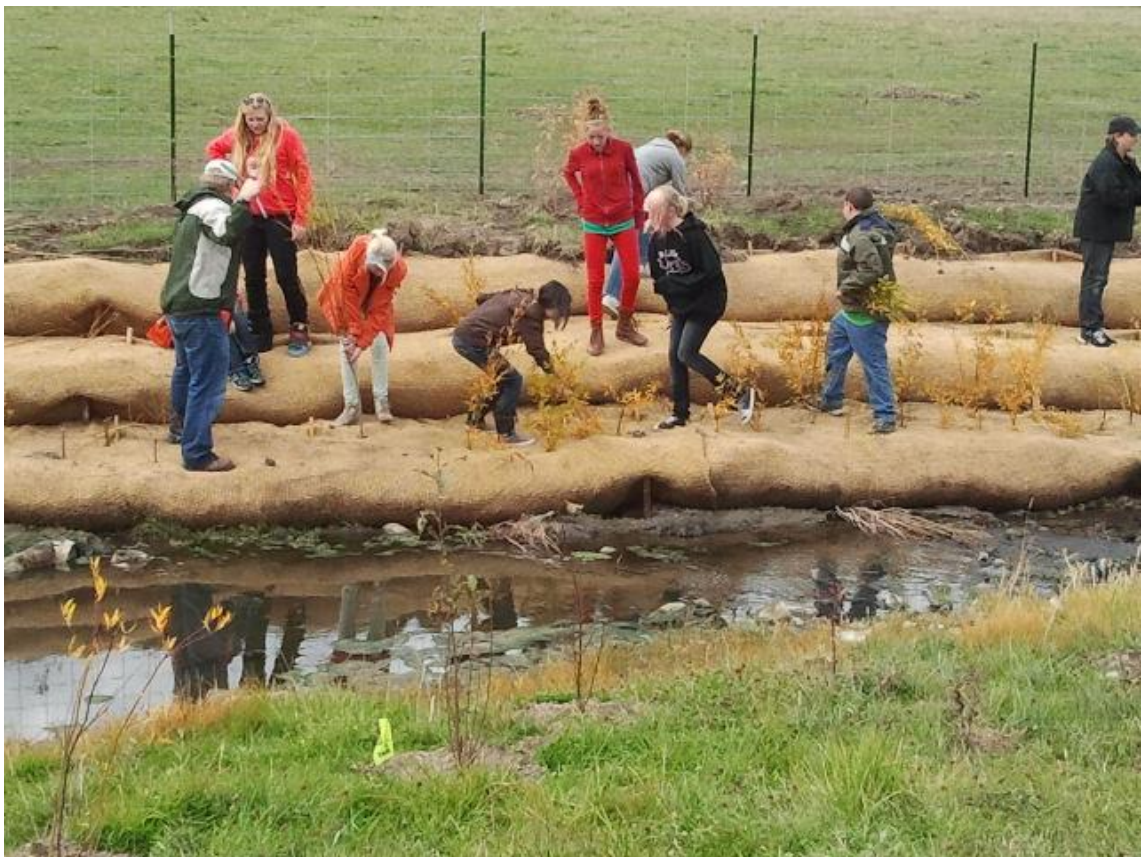
*Figure 11: Volunteers planting willow pole cuttings on Main Creek.*

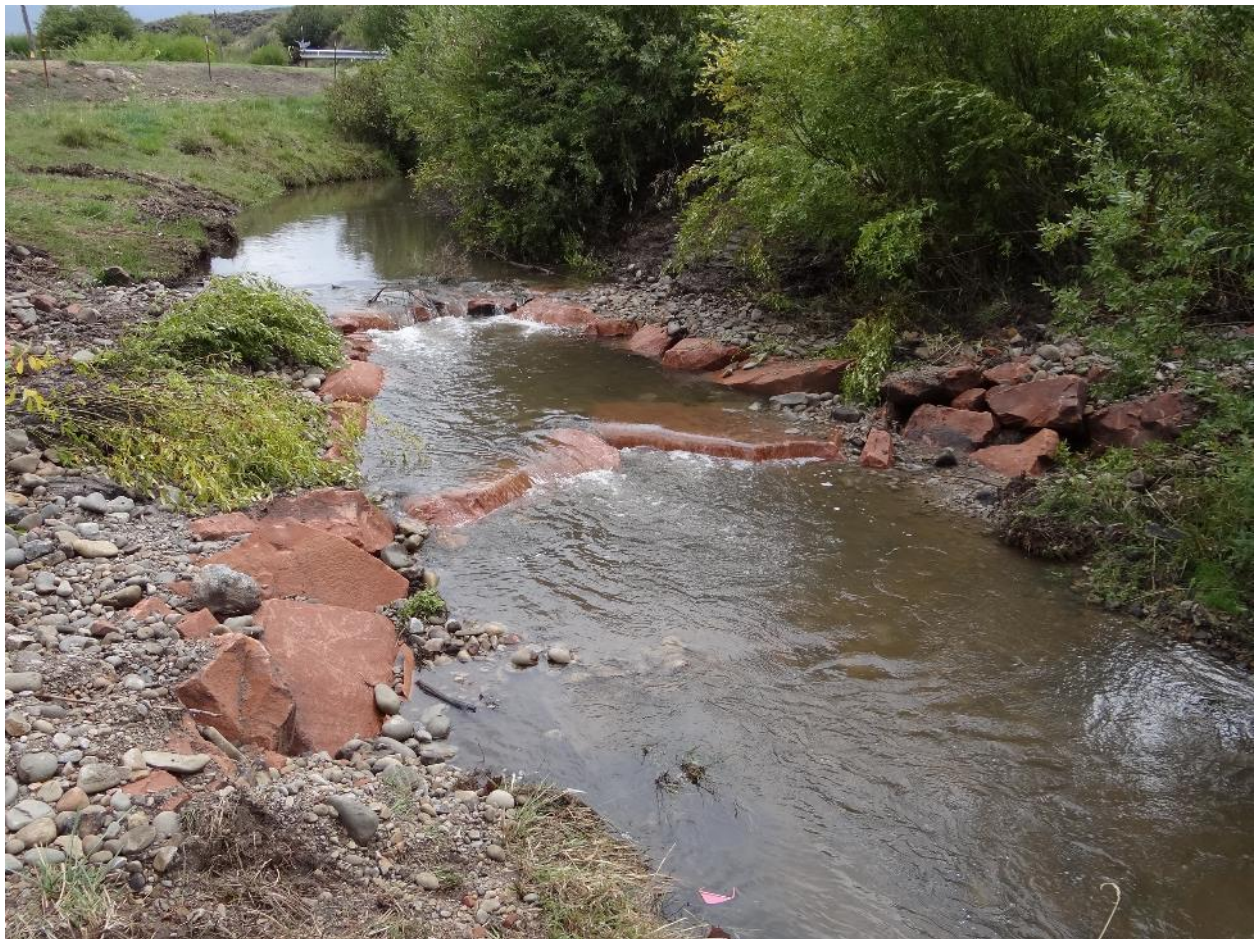
*Figure 13: Main Creek, Wallsburg Watershed. Cross vane.*

J-hooks were used help control the flow of the water. Cross vanes (refer to Figure 13 in the appendix) were installed to help control down cutting, reduce stream velocity and retain sediments. These in stream structures will help reduce erosion and allow vegetation to become established in areas with bare riparian zones.
